Date: February 01, 2011
File #: 11 - 011345
Folder Name: 437 BANFIL ST
PIN: 012823340016

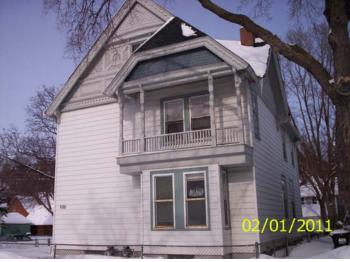
South and east sides

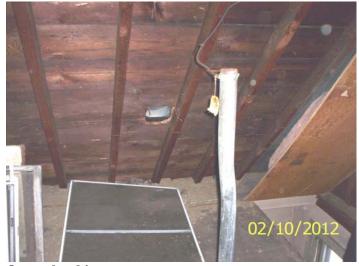
Open plumbing vent

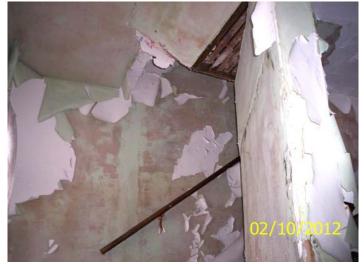
Water damaged walls and ceiling

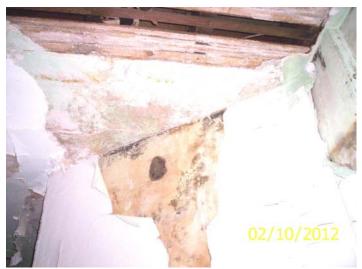
Water damaged walls and ceiling, mold

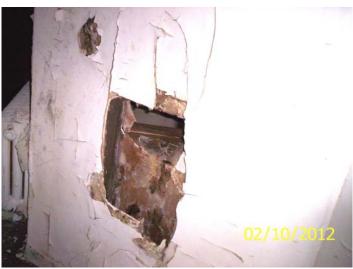
Water damaged, open wall, mold

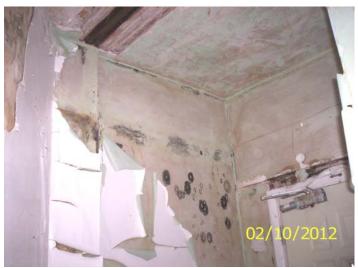
Water damaged walls and ceiling, mold

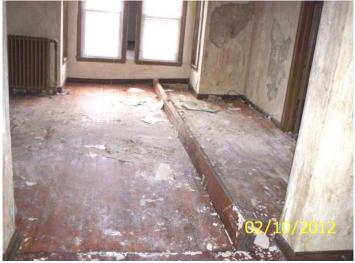
Water damaged, buckled, sloping floor

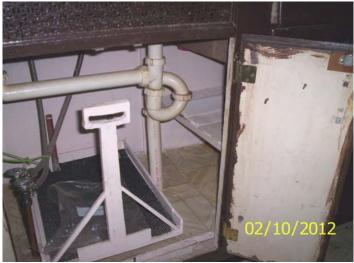
'S'trap unvented plumbing

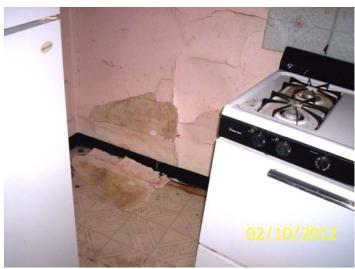
Water damaged floor covering and wall

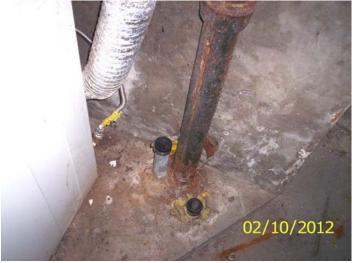
Open plumbing in basement

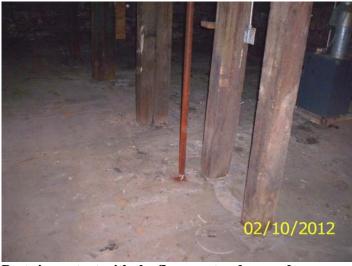
Posts in contact with the floor, water damaged

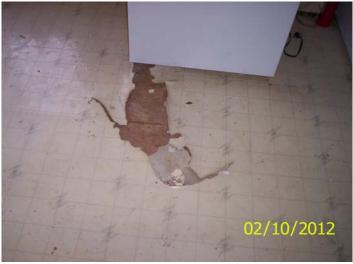
Damaged, open kitchen floor covering

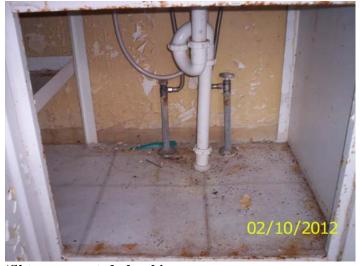
'S' trap unvented plumbing

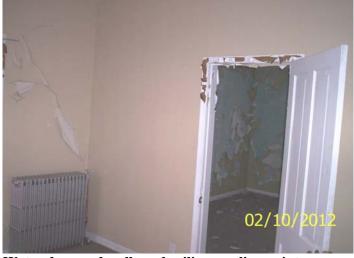
Water damaged walls and ceiling, peeling paint
