## MEMORANDUM

DATE: Tuesday, November 27, 2012  
TO: Amana Construction  
ATTN: Mr. Moses Wazwaz  
PROJECT: 25 Empire Drive, St. Paul, MN  
PROJECT NO.:  
WRITTEN BY: Chris Scheevel

### Background and Description of Structure

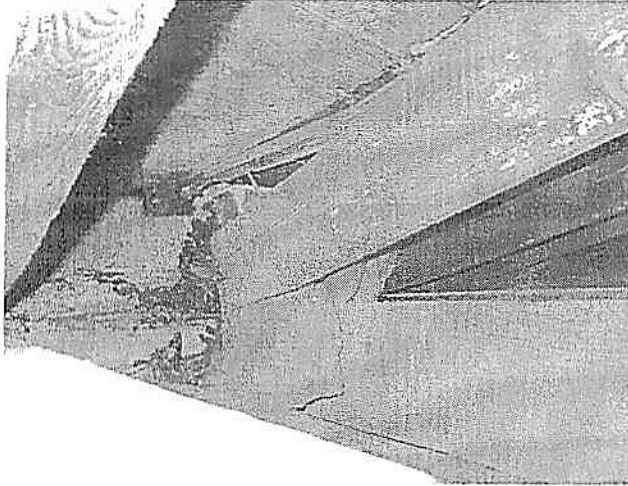
1. Several roof trusses are crushed at their end bearing on the south wall. Water stains indicate water penetration created a suitable environment for decay fungi to attack and weaken the trusses (Photo 1). There is no discernable strength in the trusses at this location. It is our professional opinion that these trusses pose an unsafe condition.
2. The exterior limestone walls are sufficiently bowed to require further analysis to determine the stability of the walls (Photo 2). The walls do not appear to present an unsafe condition but this cannot be verified without further analysis. This analysis is outside the scope of this investigation.
3. One of the steel members in the X-bracing system is buckled, possibly due to movement of the exterior walls.

Photo 1: Failed Roof Truss

1. The south ends of the roof trusses require shoring to prevent a sudden collapse. We recommend this shoring be accomplished immediately and before a significant snowfall. Please see the attached sketch for recommended shoring loads and locations..
2. Due to the bowing of the exterior limestone walls, we recommend the walls be analyzed to determine the wall stability under gravity and wind loads.
3. We recommend the X-bracing be analyzed to determine the cause of buckling, and reinforced or replaced, as required.

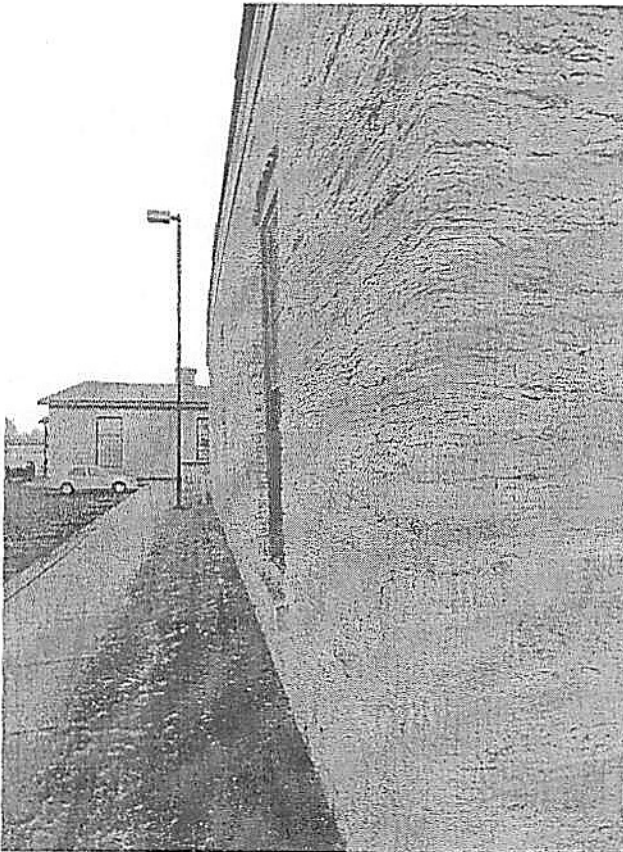
Photo 2: Bowed Exterior Limestone Wall
