# Structural Design Associates, Inc.

September 20, 2011

Re: Property at 2073 Ford Parkway, St. Paul, Minnesota

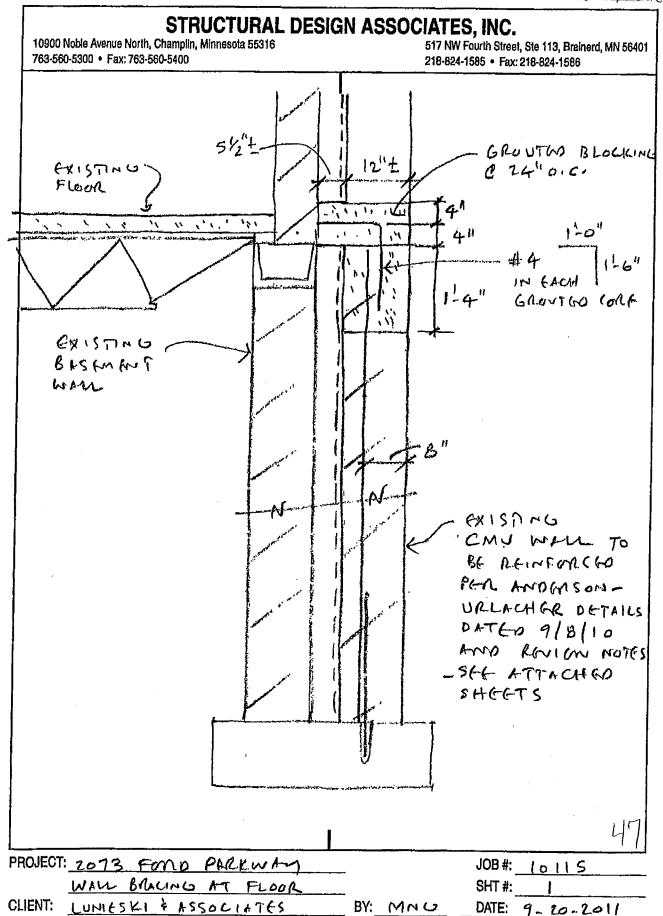
10900 Noble Avenue North, Champlin, Minnesota 55316 763-560-5300 • Fax: 763-560-5400	IGN ASSOCIATES, INC. 517 NW Fourth Street, Ste 113, Brainerd, MN 5640 218-824-1585 • Fax: 218-824-1586
EXIST ING ROLFING VEYLIFT (TILVATION)  EXIST ROLF JOIST  ESTECL DECK VEYLIFT ELEU, E  ORIENTATION  EXIST CMU  WALL FIELD VEYLIFT THICKNESS	Payan Fictor up. Limbte By a strain Confes  12 12 12 12 12 12 12 12 12 12 12 12 12 1
ROJECT: 2073 FORD PARKWAY	JOB#: 10115
WALL BRACING AT TOP	
JENT: LUNIESKI & ASSOCIATES	BY: MNO DATE: 9-20-2011

We are attaching two preliminary sketches for bracing the outside wall at the floor level and at the top.

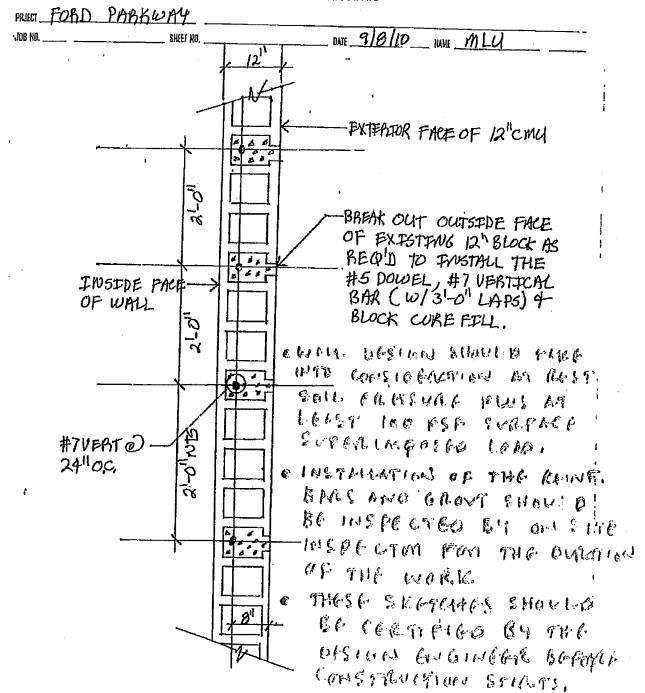
B) 12" BASEMENT BLOCK WALL PLAN DETAIL

THIS CHINE CTIAN : "LEDS. TO BE CHECKED FOR
