Jack Pixley Sweeps

Customer: Vander, Nick - 04/23/2013 Job

Service Address: 2228 Bush Ave E

Internal Inspection

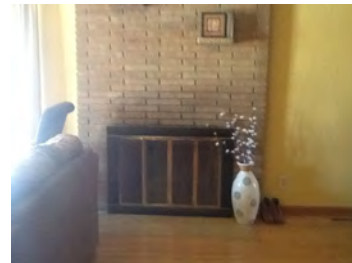
The glass doors on the front of the fireplace should be replaced as one side is stuck shut, there is exposed wood in both the lintel and ash dump areas, also there are gaps around the bricks and bottom flue in the smoke chamber area. Because of the exposed wood and the gaps found this fireplace should not be used.

Our recommendation for these discrepancies would be to remove the exposed wood in the lintel area and parge the smoke chamber and seal off the ash dump completely, also replace the glass doors.

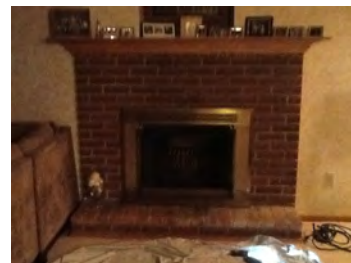
The lower level damper does not work properly, there is exposed wood in the lintel area, and the bottom flue tile is not supported on all sides. Again, because of the exposed wood this fireplace should not be used.

Our recommendations are to remove the exposed wood, parge the smoke chamber, and replace the existing damper with a Top Mount Damper.

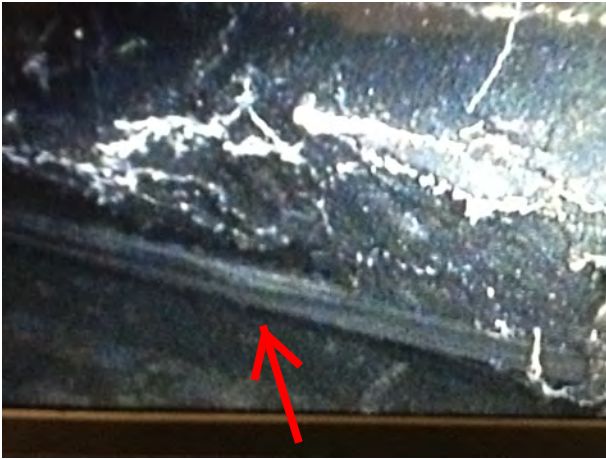
- ☒ The ceiling of the ash pit was built with wood; this is a potential fire hazard. Main level fireplace
- ☒ Wood was found in lintel area. Both
- ☒ Smoke Chamber has voids. Both

Wood in lintel area main level fireplace

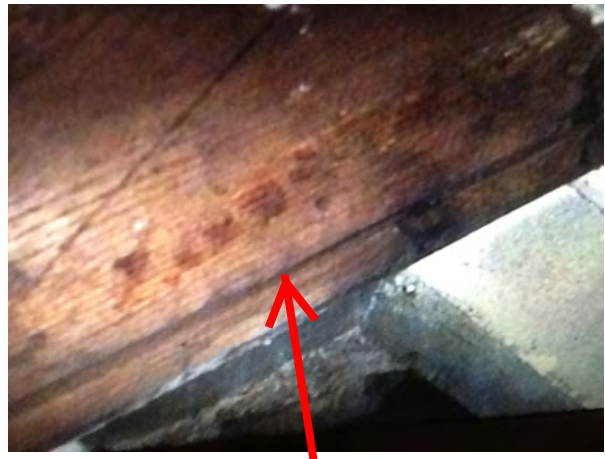
Wood in ash dump of main level fireplace

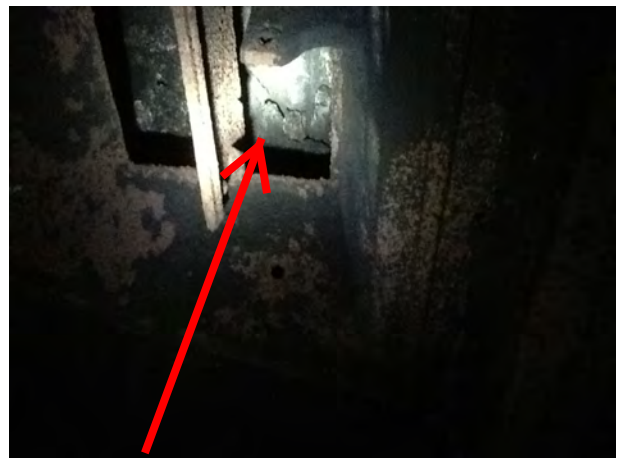
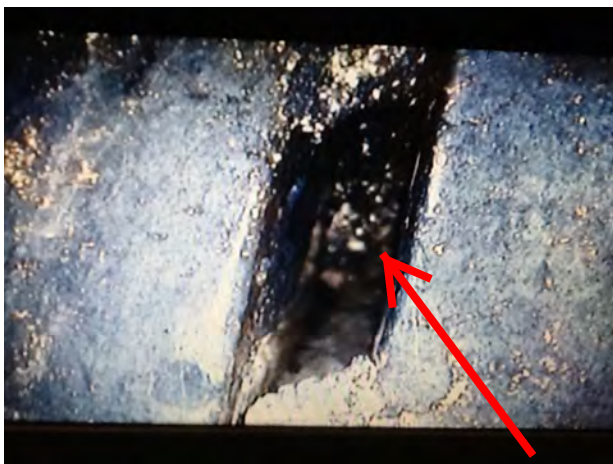
Gaps around the bricks and the bottom flue tile in main level smoke chamber

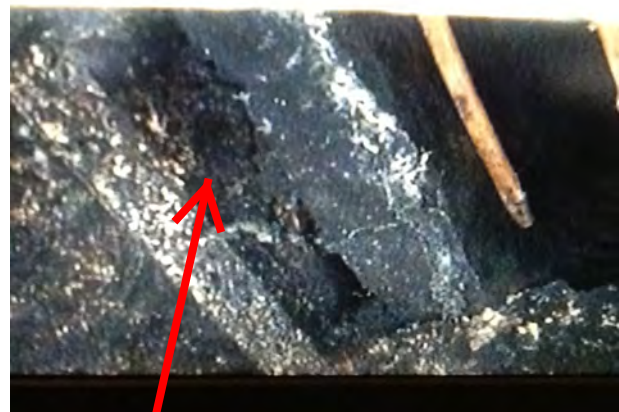
15 brick per course, 6 courses down, 1 round flue tile 8" ID, 2 - 7 x11 flue tiles 18 1/2' to ground, 7 1/2' to roof line, 5/12 pitch on roof. Brick size is 11 5/8" x 2 5/16"

Our recommendation for this is to remove the wash and 6 courses of brick and rebuild these areas.

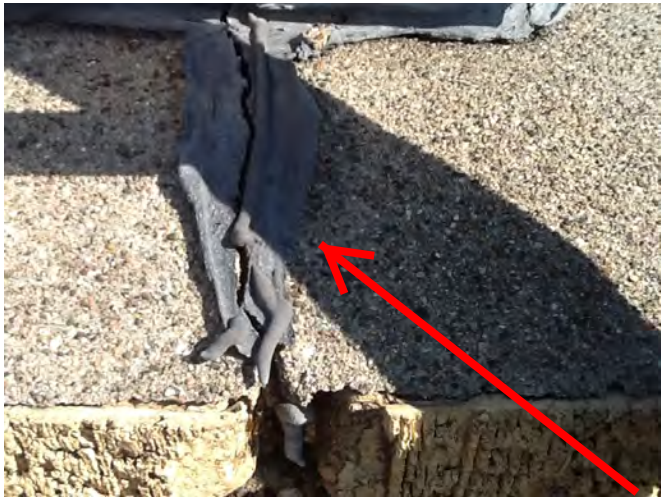
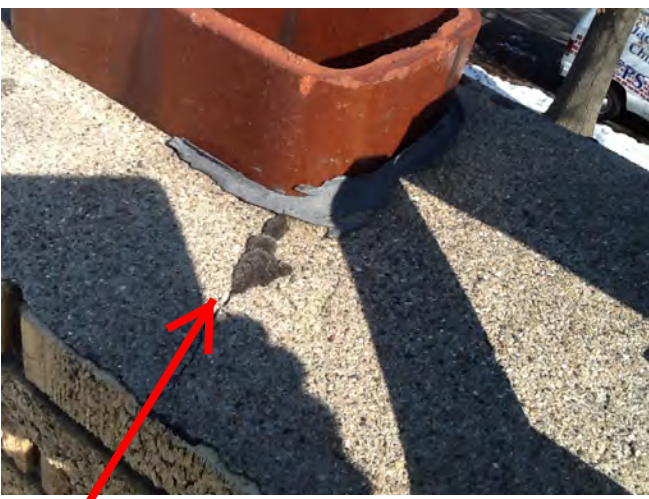
The other area to report is the top of the chimney specifically the wash at the top of the chimney and 6 courses of brick down. The wash has cracks in it allowing water to seep down into the bricks and mortar which is making the bricks spall and the mortar deteriorate.

Cracks in wash at the top of the chimney

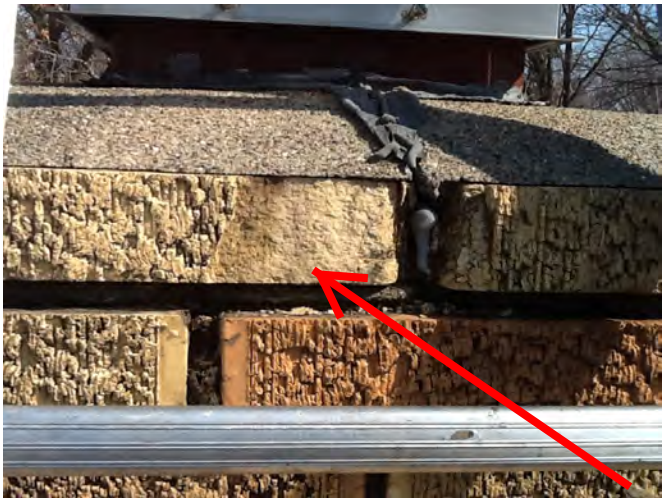
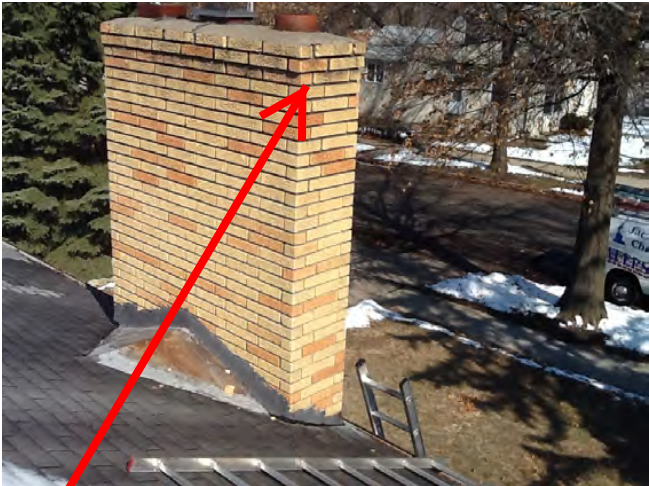
Spalling brick and deteriorating mortar joints
