Appeal documentation for 461 McKnight.
Owners: Patty McDonald & Carl Anderson

Fire Inspection Correction Notice lists:

Exterior – SPLC 34.08 (7) – All parking spaces shall be paved with asphalt, concrete, or durable dustless surfacing. Before any existing spaces may be paved, site plan approval must be obtained as specified in the St. Paul Zoning Code. Contact DSI Zoning at 651-266-9090. – Finish paving the driveway.

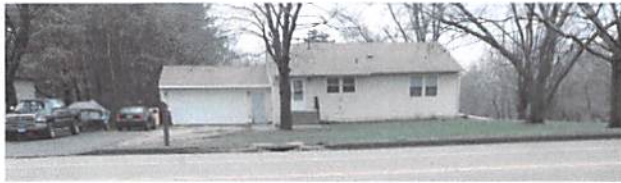
We are asking for a variance on this. This driveway is half paved and half class 5 crushed aggregate. (*Photo 1 & 2*) It is crushed aggregate for a reason—to help keep the garage from flooding. It does this by percolation and directing the water to the side.

Photo 1: 461 McKnight: Right portion of drive is Class 5

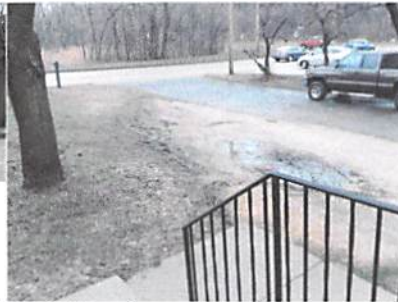
Photo 2: View from steps (after snow melt). Photo 3: View from steps during a big rain.

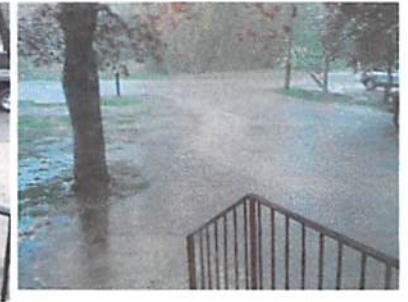
Every time it rains there are flooding issues. (*Photo 3*) This is due to the inadequate storm sewer system which sends massive amounts of water flow over the end of the driveway, down the driveway in toward the house/garage (see *Diagram 4* for information on storm sewer issues). By making the driveway paved and not Class 5 it will increase the volume of water that flows towards the house/garage/backyard.

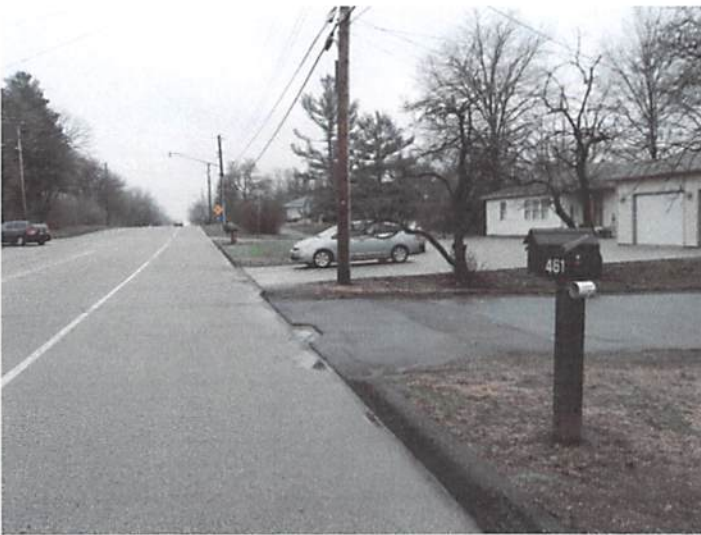
Photo 4: You can see Mailand Road is just past 475 McKnight and the fire hydrant, which is 45 yards away from the driveway at 461 McKnight.

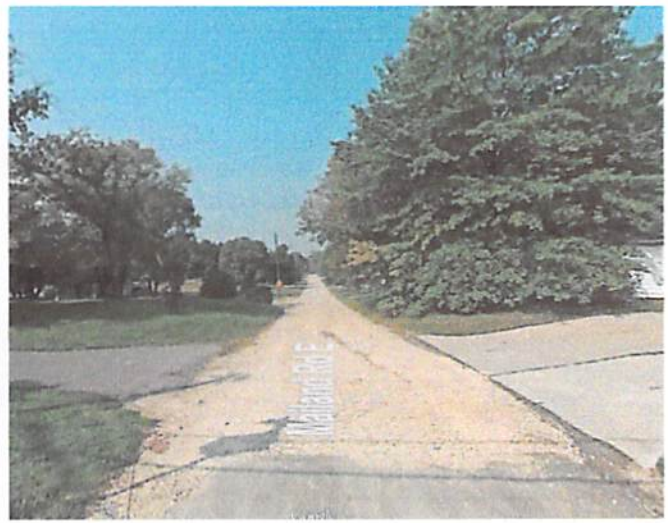
Photo 5: Mailand Road. The road just down the street 45 yards.

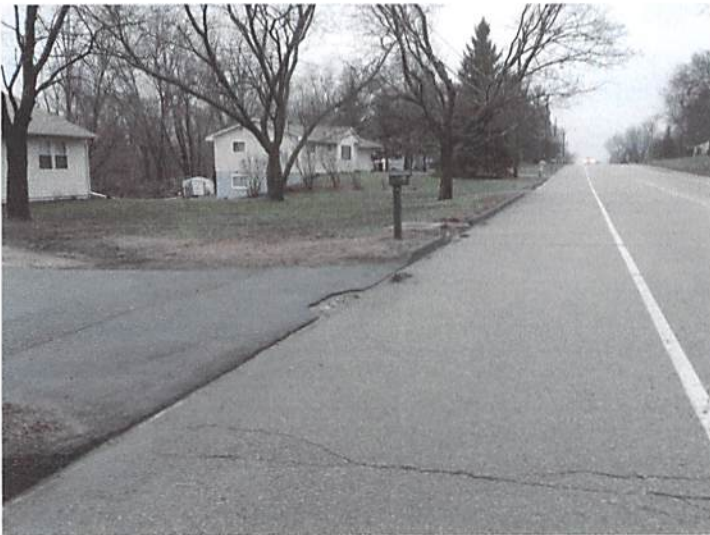
Photo 6: Another view of the storm sewer run off drain near the driveway at 461 McKnight.

The street drains in front of 461 McKnight are part of this system--which means the water on the street backs up to the point of least resistance and flows down that path. That path is the driveway at 461 McKnight. (see Photo 6)

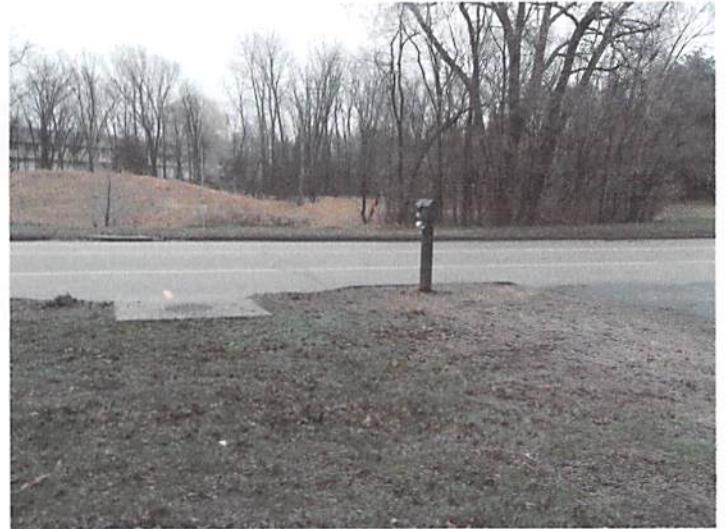
Photo 7: Across the street from 461 McKnight. You can see the storm sewer run off drain in the foreground and the holding pond (in Maplewood) on the other side of the street.

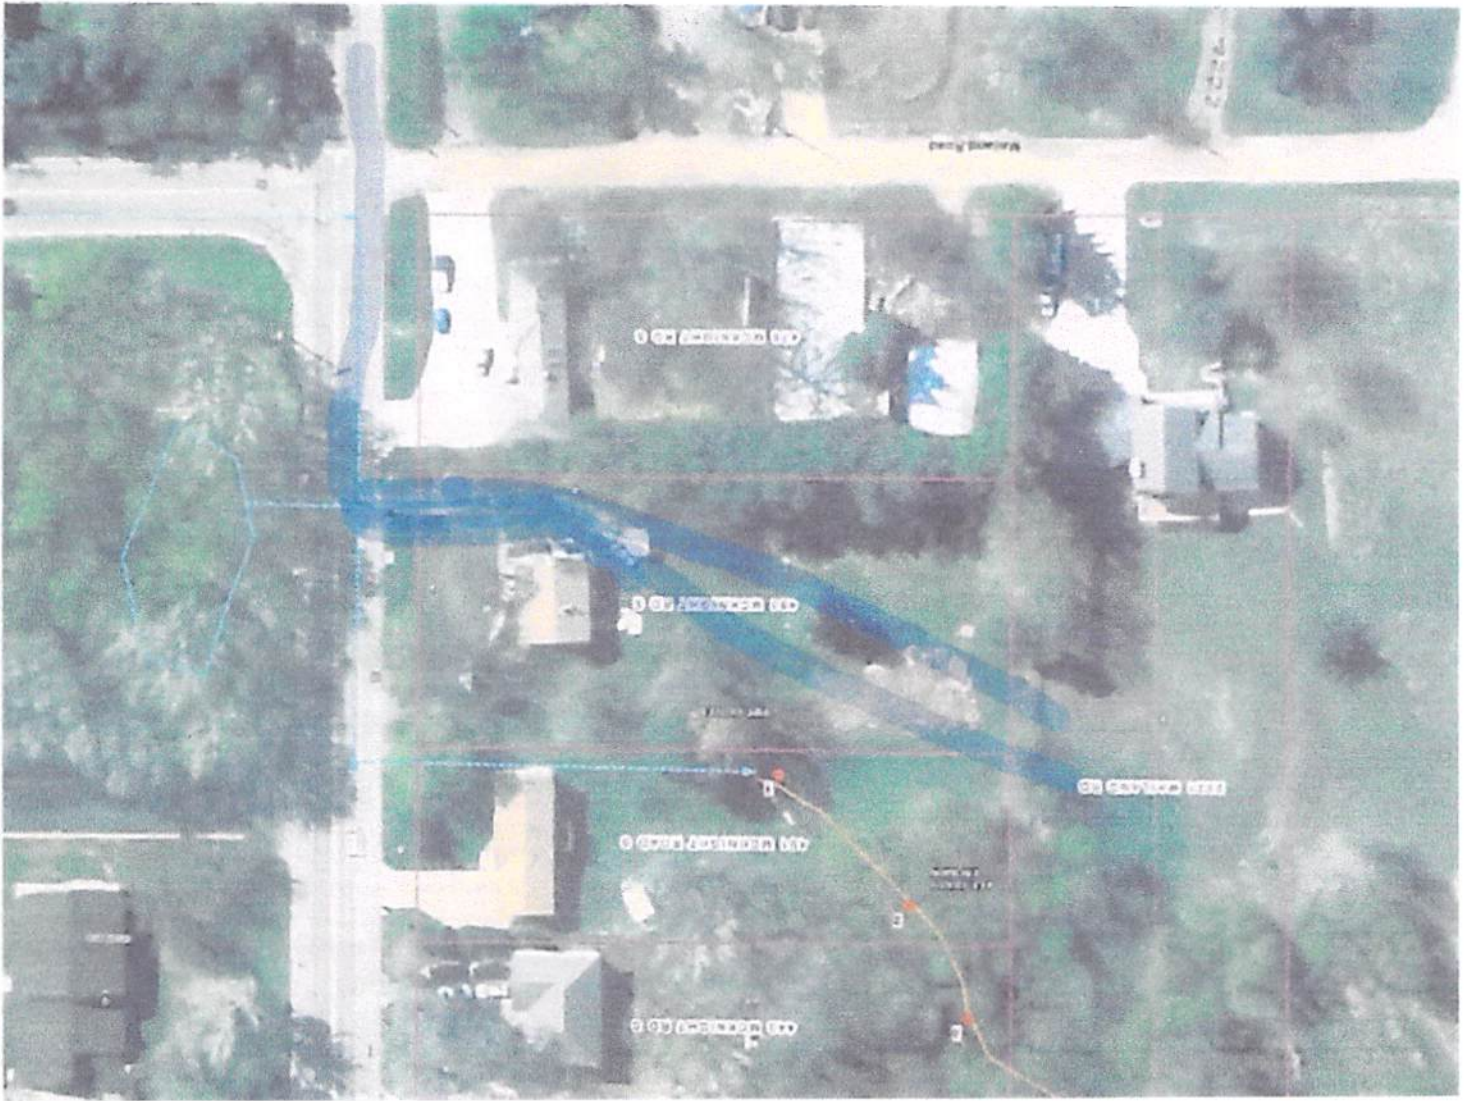
This has been an ongoing issue for years. Before the garage was there the water flowed straight down into and across the backyard. The flow was of such high volume and with such force that it washed away the new septic field. (*Diagram 1*) It was so severe that the city made the owners hook up to the city sewer—which involved installing a small pumping station to pump the septic sewage the 50+ yards to the where the septic ends two houses down.

Brown area under flow is the septic field, or what was the septic field.

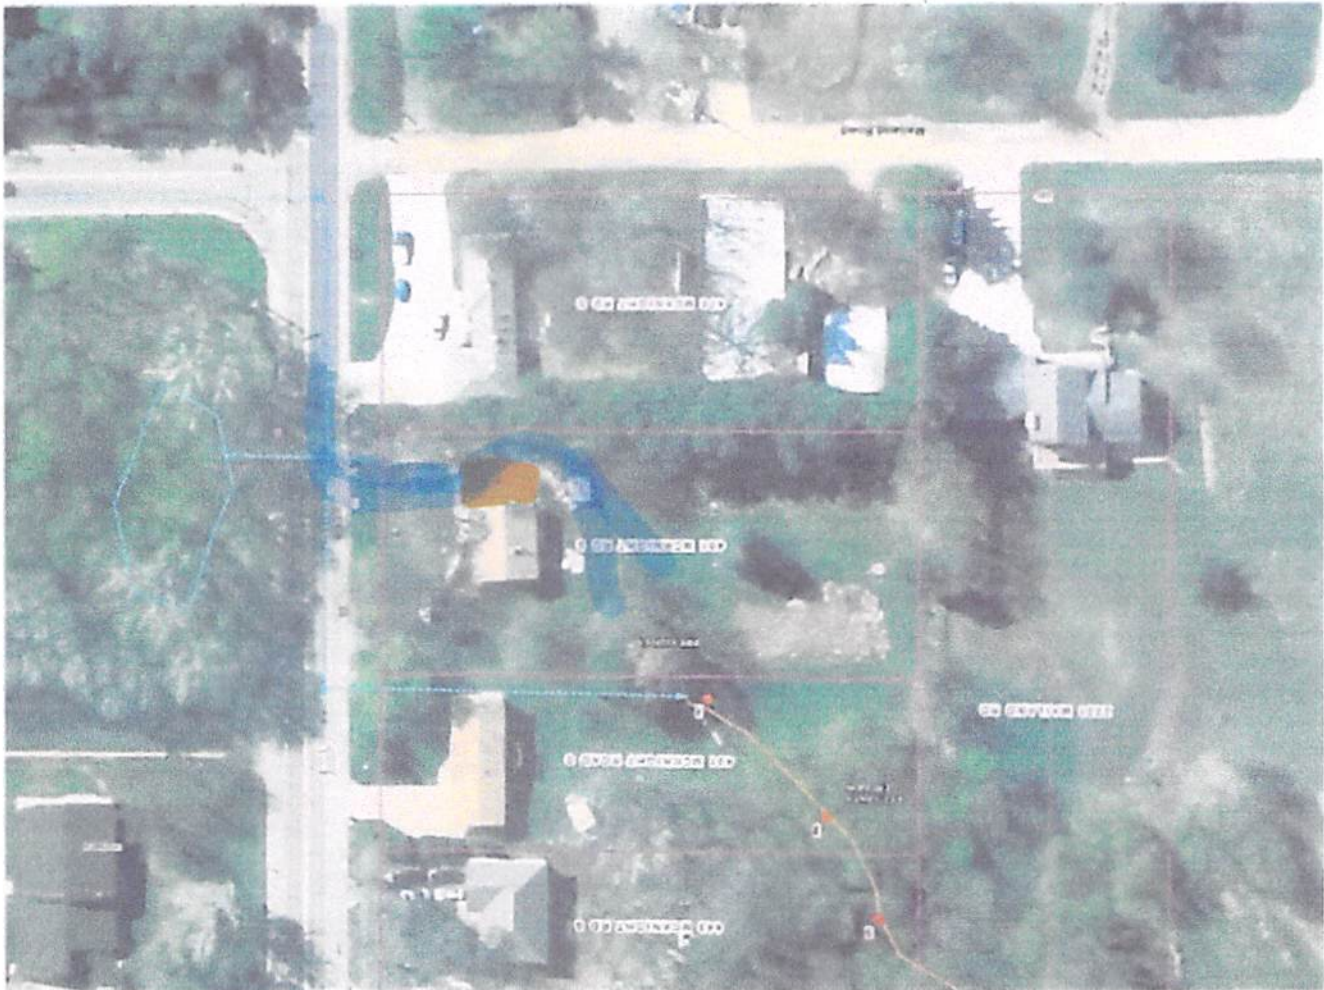
Diagram 2: water flow after garage

The next phase of the water issue was that the water would go around the back and across the backyard—taking mud across the patio and yard (*Diagram 2*). We have worked on that (with landscaping, berms and directing water flow) and now have the water flowing only to the side of the yard and into a green space where the water percolates down—eventually. (*Diagram 3*)

Water flow cuts into earth along the wall of the south side of the garage creating a mud flow that covers the patio and part of the yard.

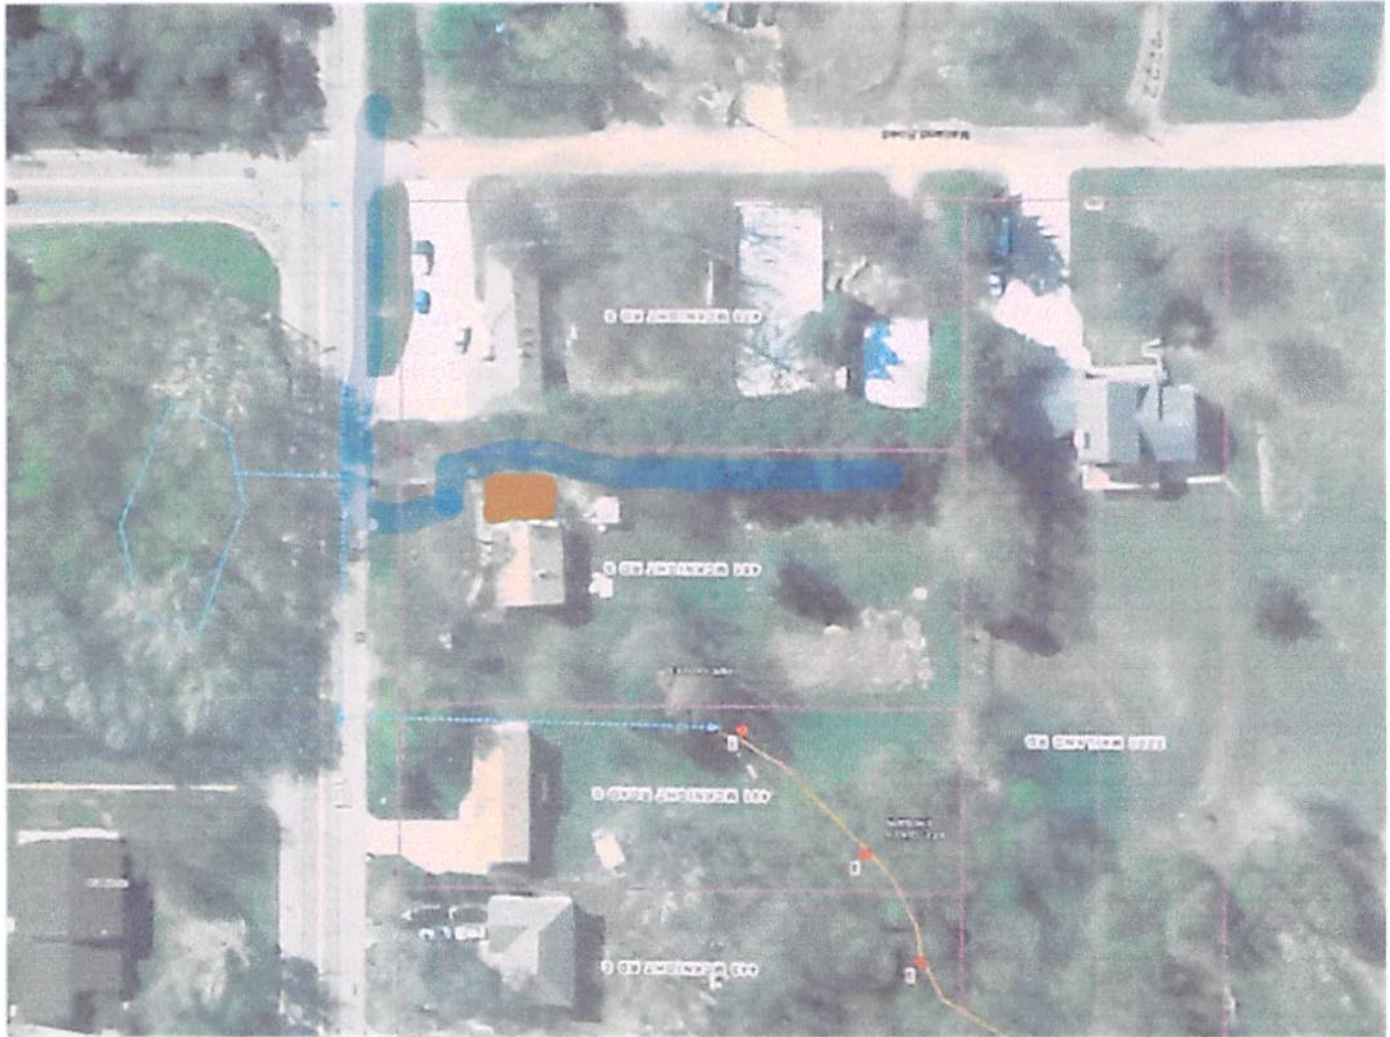
Diagram 3: current water flow since we've been working on the problem

A big part of this happy solution is the current class-5 driveway. The water now flows around the garage and along side of the yard into the back where it eventually percolates down.

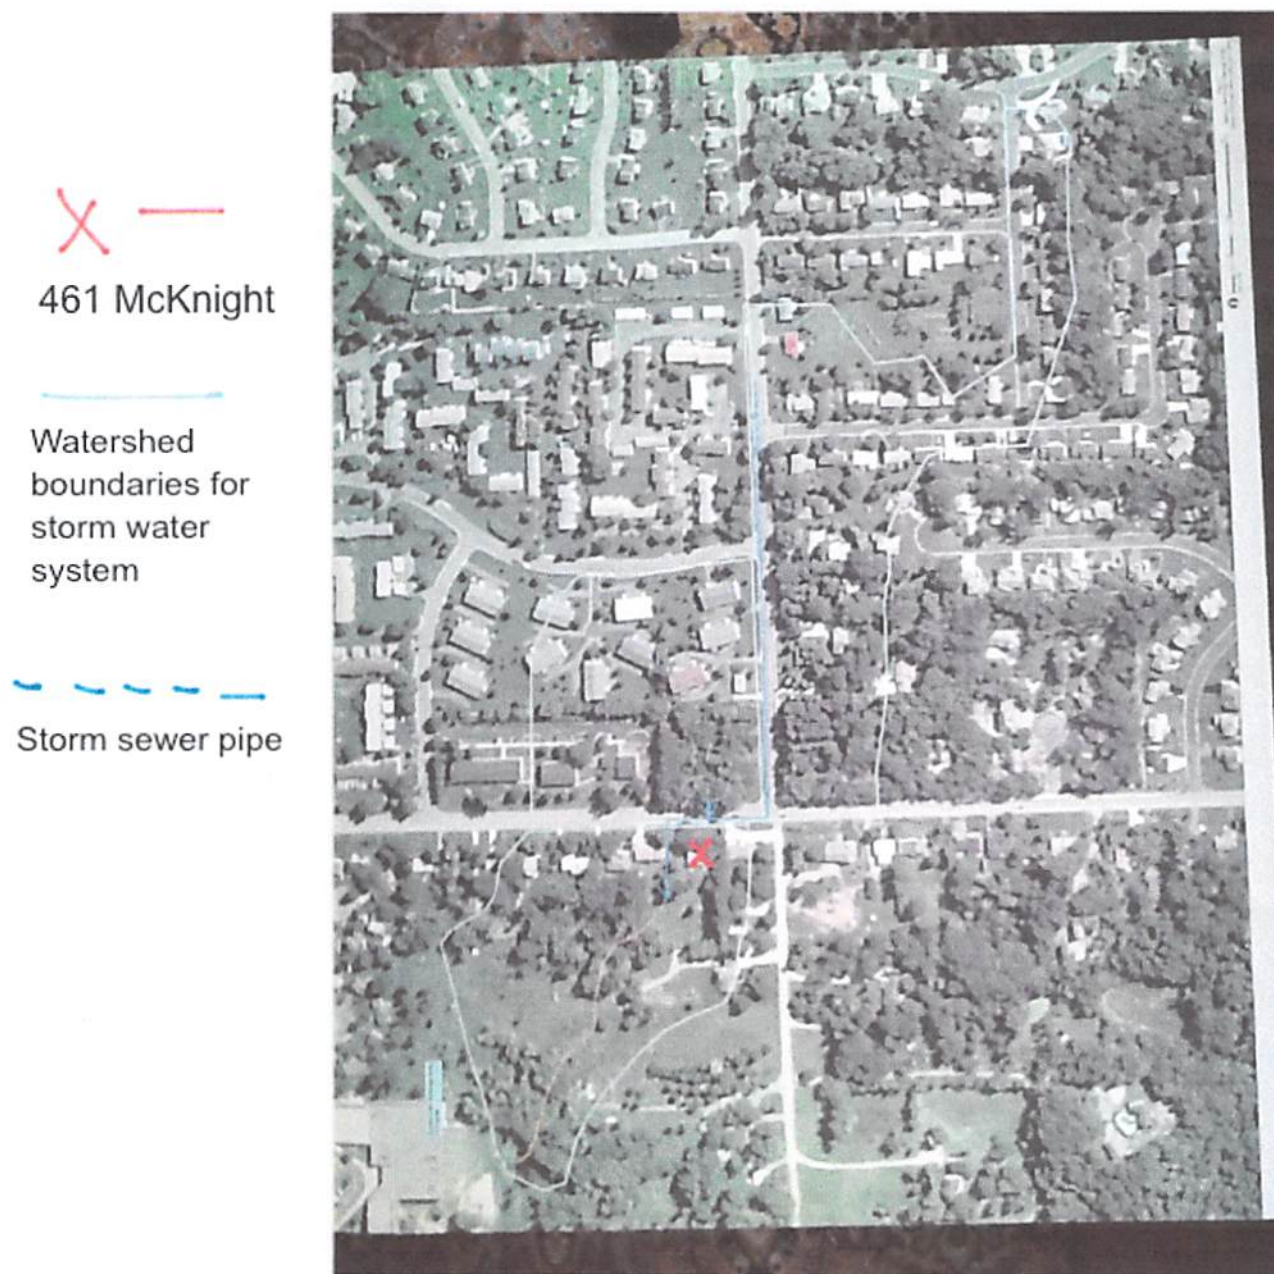
Diagram 4: storm sewer contribution to the problem.

32.5 Acres (mostly from Maplewood) flow into the storm sewer drain, then into the pond, under the street and into our yards. The holding pond doesn't actually hold much-- it just directs a large volume of water into this storm drain--which frequently still overflows the system.

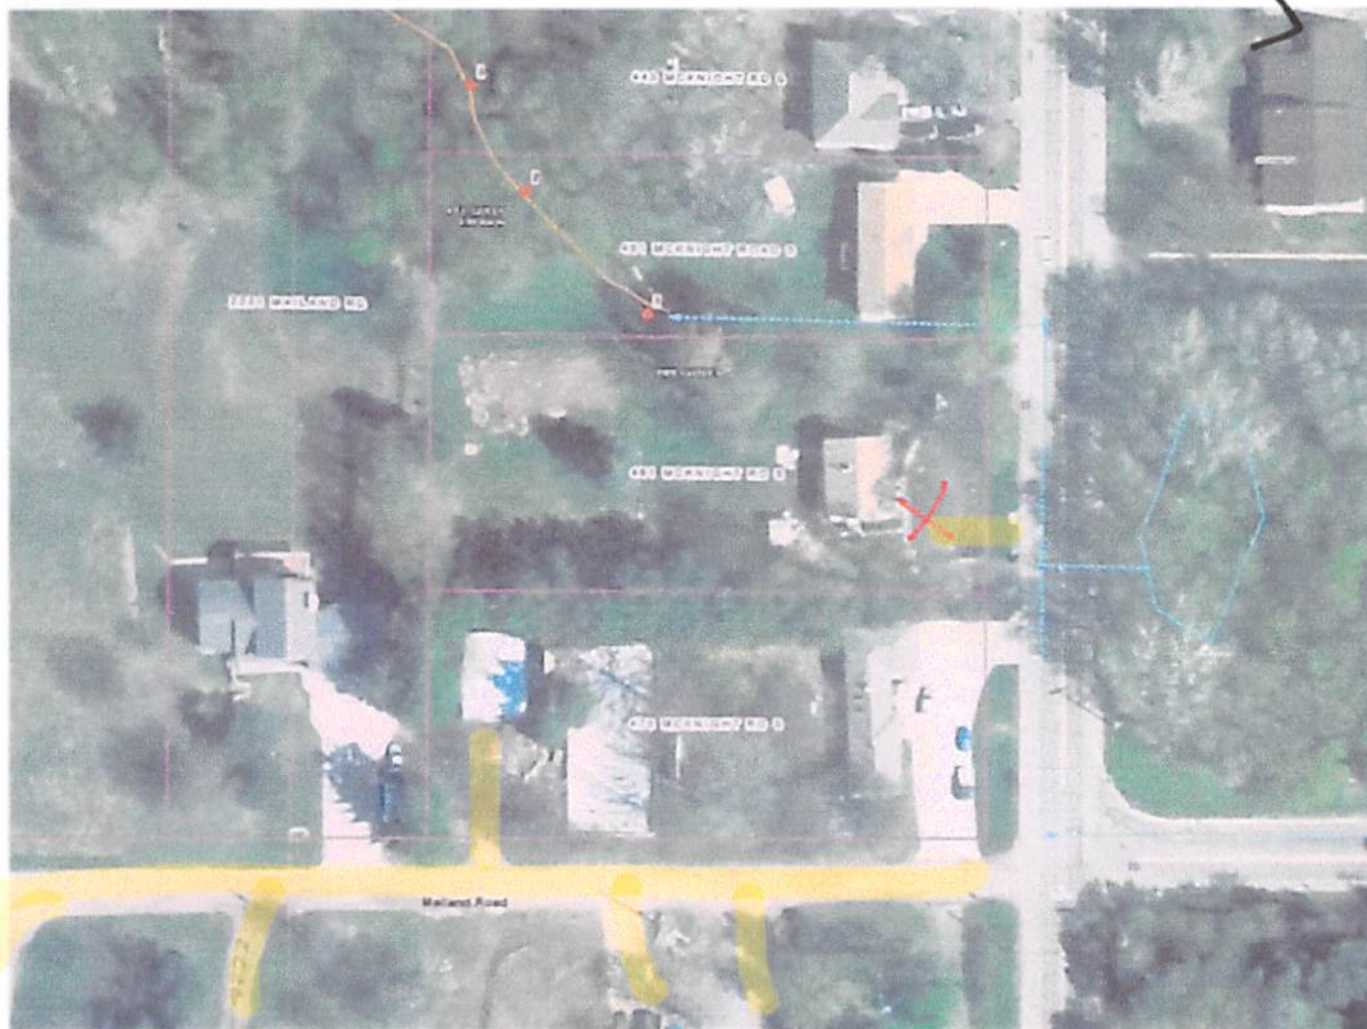
Diagram 5: class 5 road & neighbors

Class 5 road and driveways

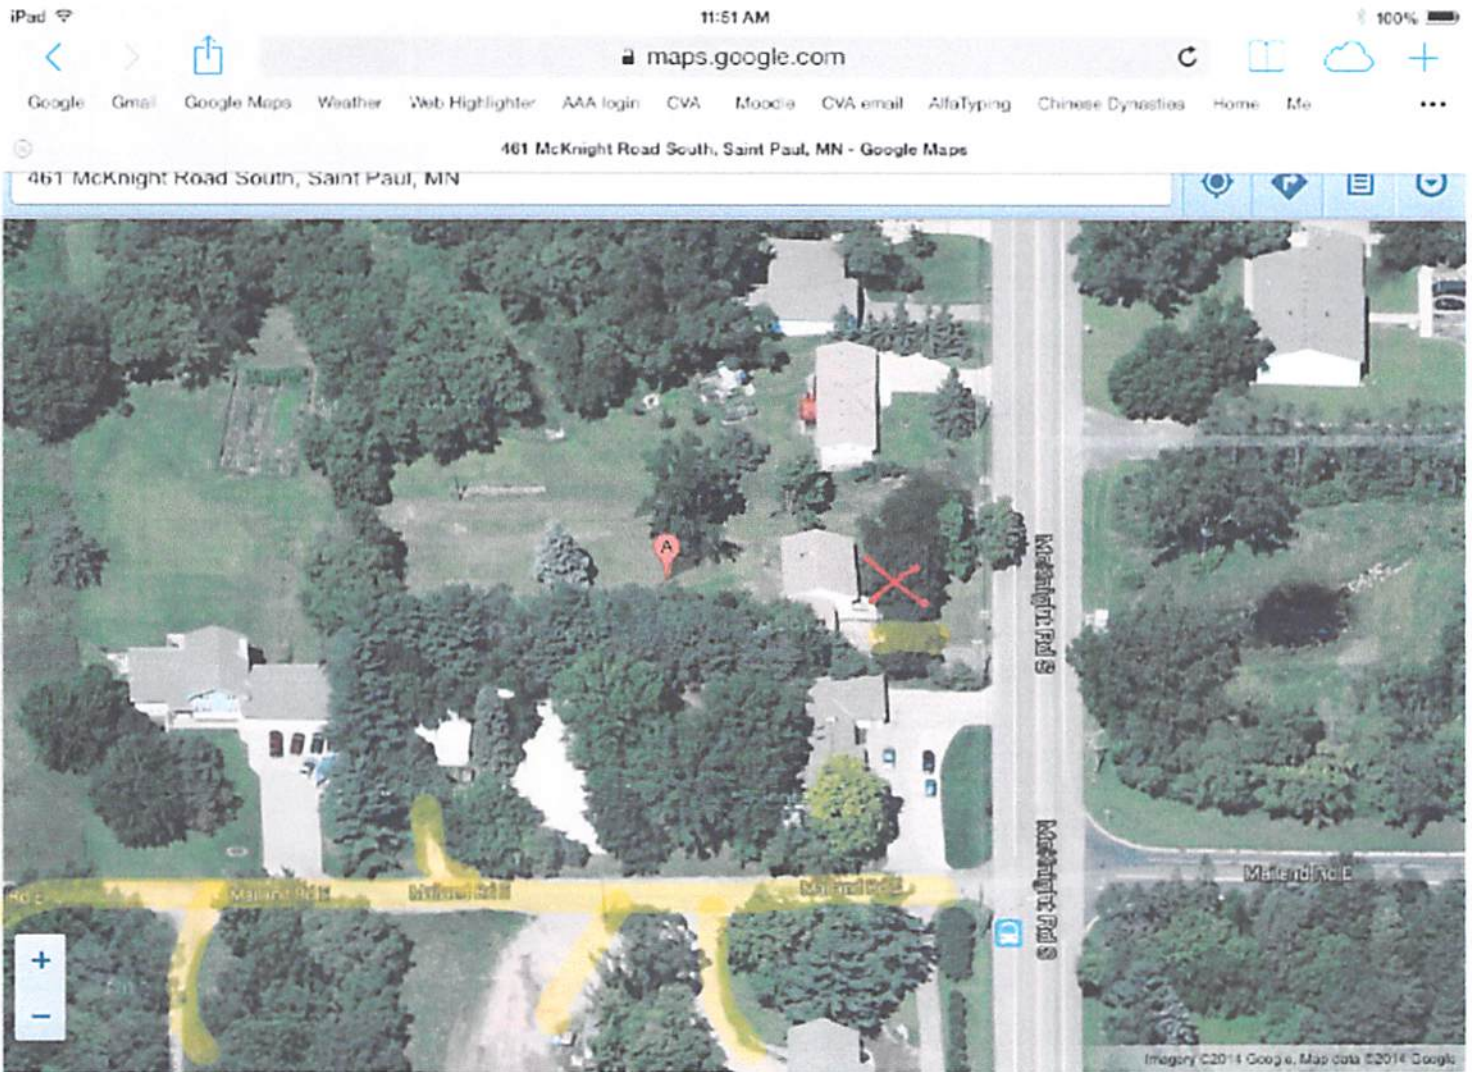
Diagram 6: current view - with Garage

Class 5 road and driveways
