Date: September 08, 2014
File #: 14 - 320006
Folder Name: 318 FRONT AVE
PIN: 252923420224

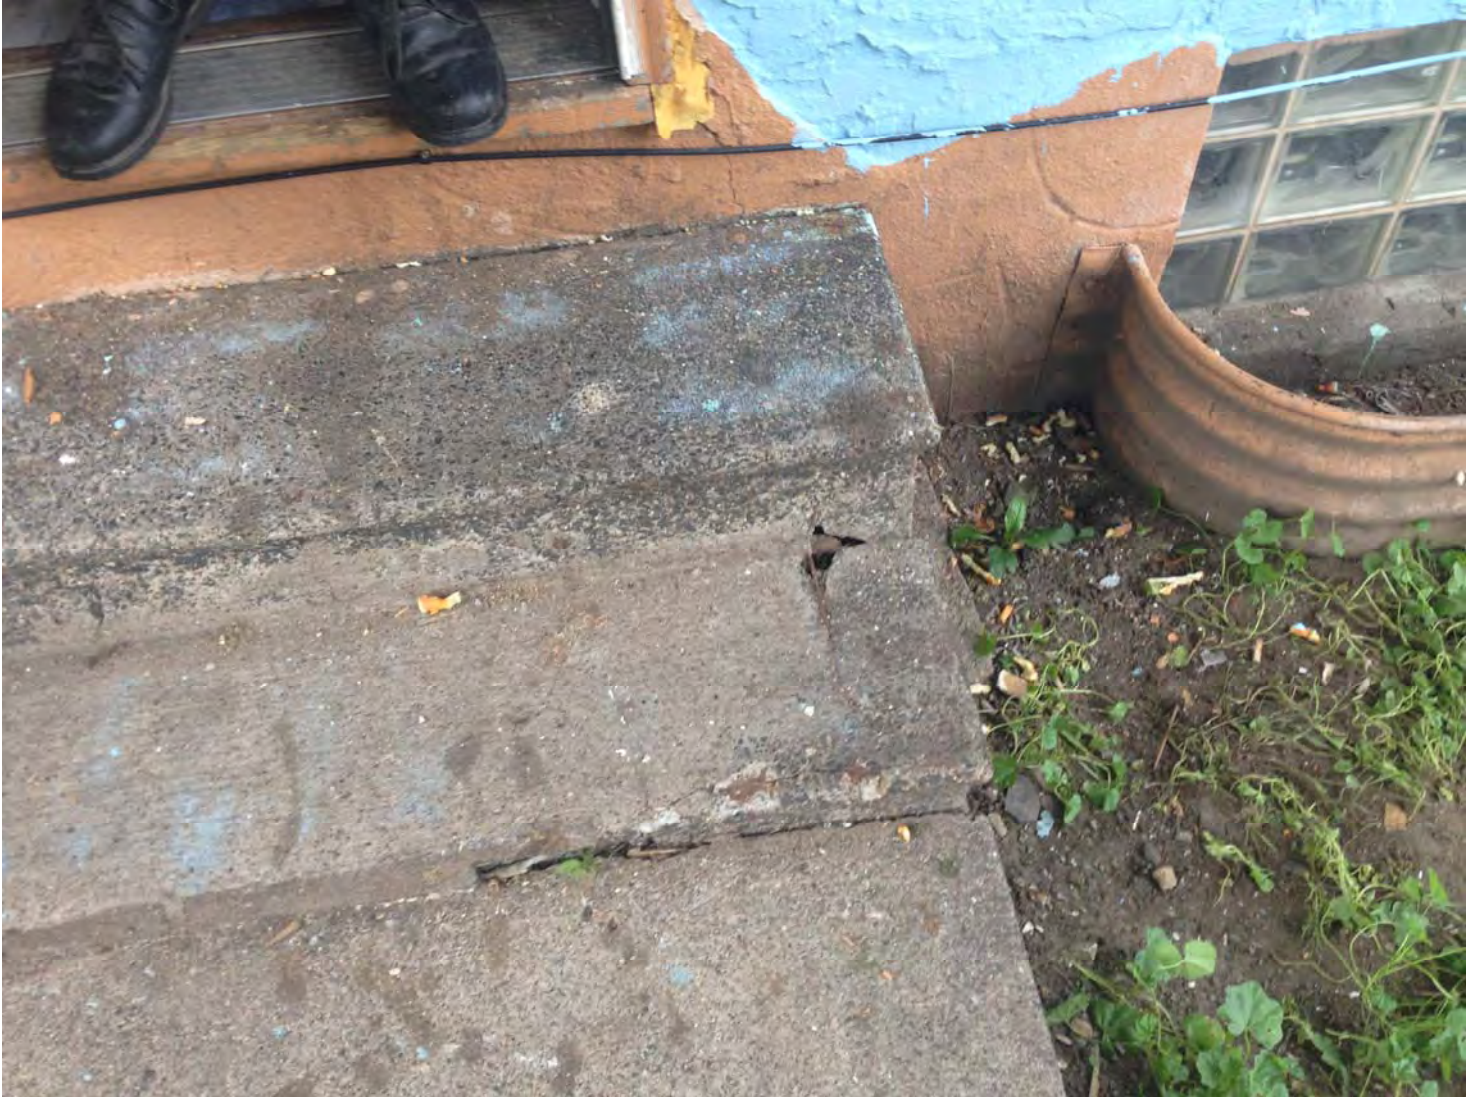
Deteriorated front steps, exposed rebar

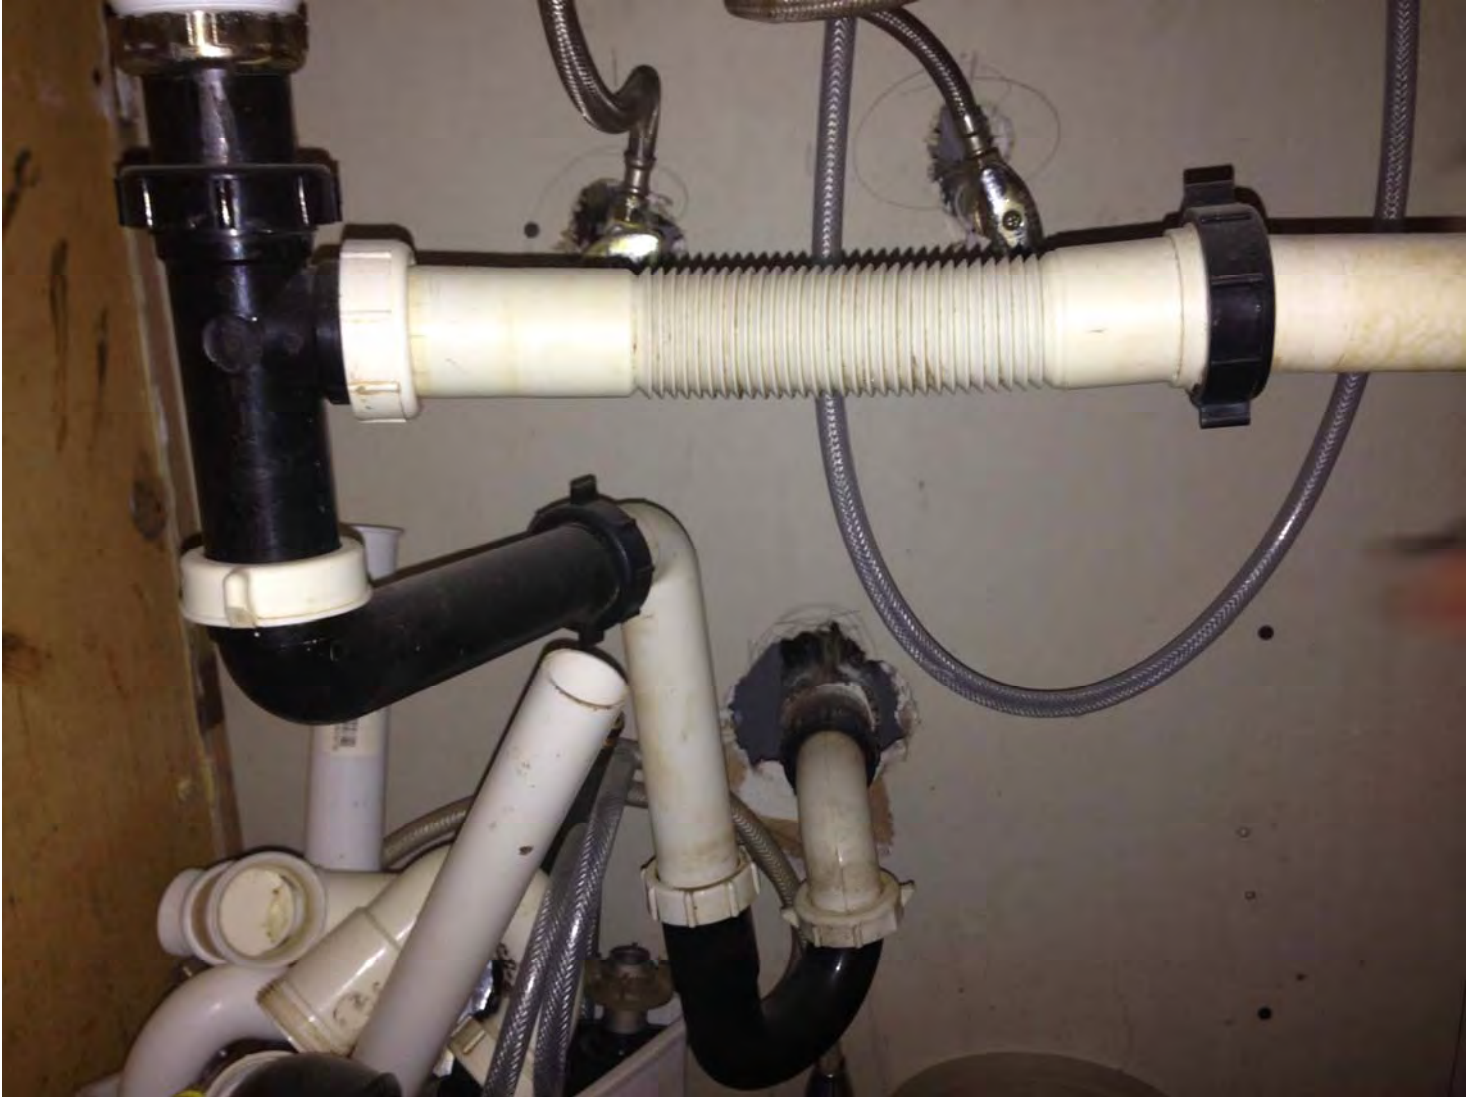
Plumbing improperly installed and incorrect materials installed without permit

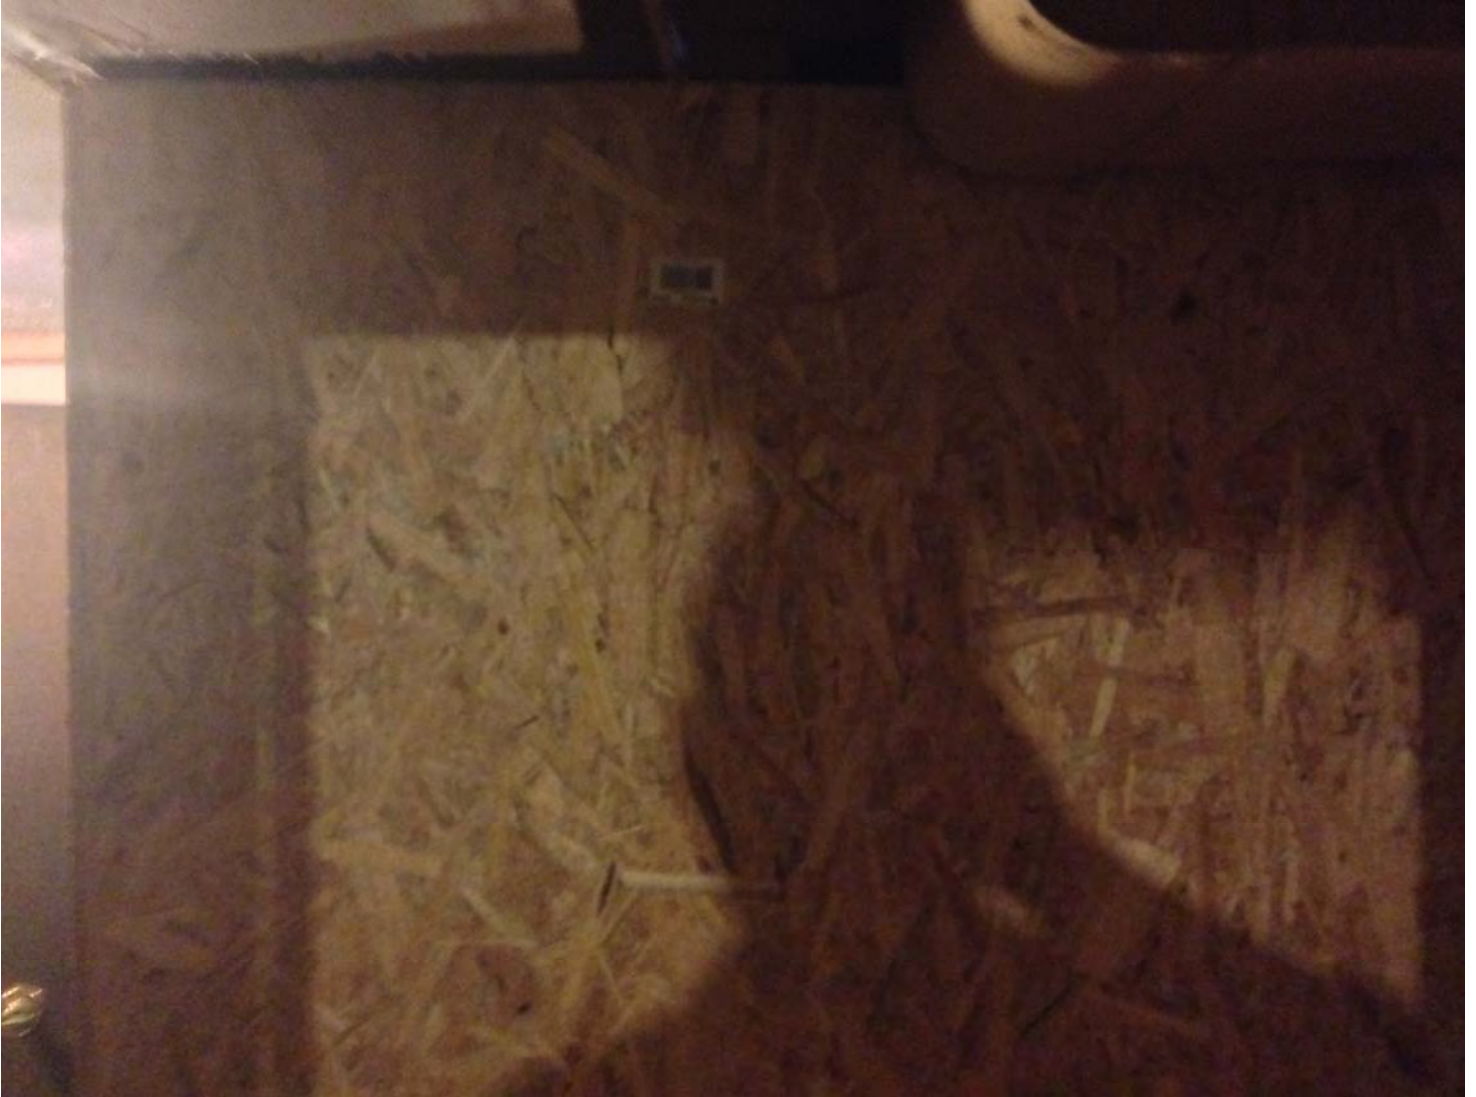
¼ Newly installed since last inspection OSB used to enclose unapproved basement bathroom.
