Dear Councilman Tolbert:

We would like to clarify and reiterate our reasons for submitting a petition regarding the alley between 408 and 412 South Lexington Parkway. We are petitioning for a <u>redesign and the rebuilding</u> of this alley. We don't believe that <u>repairs and patches</u> will solve the problems outlined above. I have already tried using asphalt mix and crushed limestone to fill holes. That approach is expensive for me and does not fix problems 2 through 5 described below.

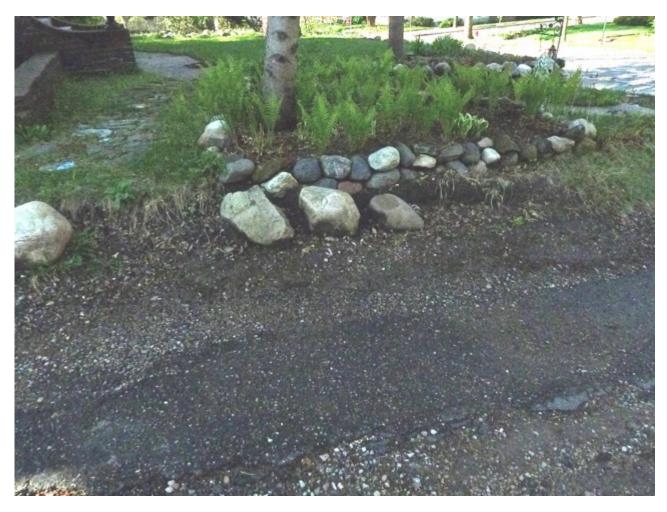
- Neighbors to the south have placed boulders in the right-of-way, further reducing the width of the roadbed. Some of them can be seen in Photo 1 and in the upper right corner of Photo 2.

Photo 1. Boulders in Right-of-Way on South Side.

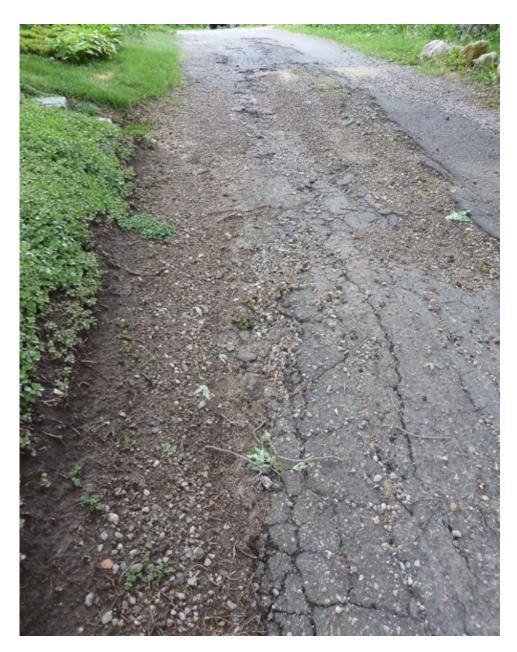
- The alley hill is crowned and has no curbs. Runoff flows to the unpaved sides of the hill, eroding my property adjacent to the alley. See photo 2.
- The upper end (i.e., the east end) is relatively flat and drainage is inadequate. See photo 3.
- Runoff at the east end flows to the south east across the adjacent property on Palace Ave. The runoff is not in sheets, but rather concentrated causing the potential for erosion.

Photo 2. Erosion – North Side (May 2012)

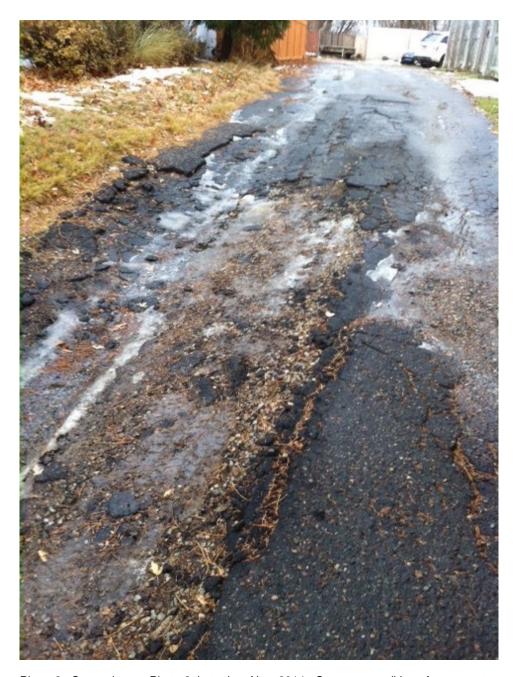
Photo 3. Same view as Photo 2, but taken Nov. 2014. Compare condition of pavement.

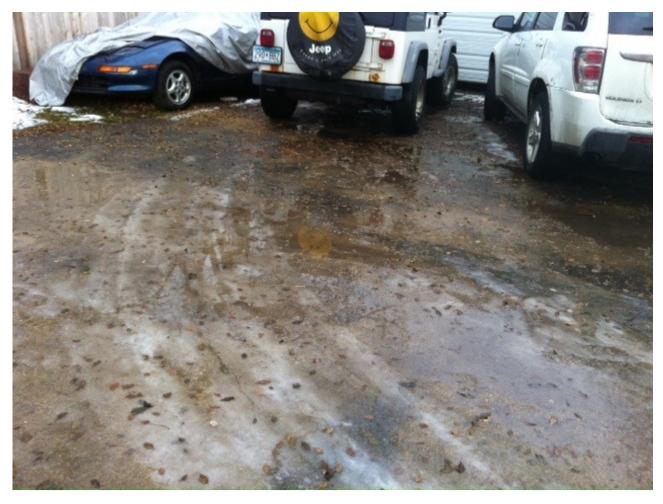
Photo 4. Ice and standing water – East end (Nov. 2014)

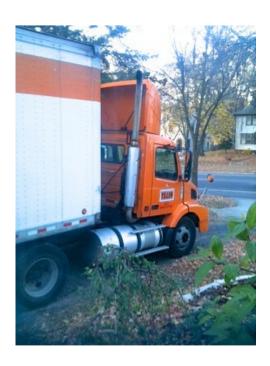
Photo 5.

Furthermore, the neighbors to the south have an ongoing construction project which results in large vehicles using the alley. In the past these vehicles have clearly broken up the pavement. See Photos 5 through 8. Also, the neighbors have an unused swimming pool which they have informed me that they intend to remove. This will entail trucks with fill material as well as the removal of the concrete in the pool. The alley needs to be built to current design standards to support such traffic.
