Dear Councilman Tolbert:

We would like to clarify and reiterate our reasons for submitting a petition regarding the alley between 408 and 412 South Lexington Parkway. We are petitioning for a <u>redesign and the</u> <u>rebuilding</u> of this alley. We don't believe that <u>repairs and patches</u> will solve the problems outlined above. I have already tried using asphalt mix and crushed limestone to fill holes. That approach is expensive for me and does not fix problems 2 through 5 described below.

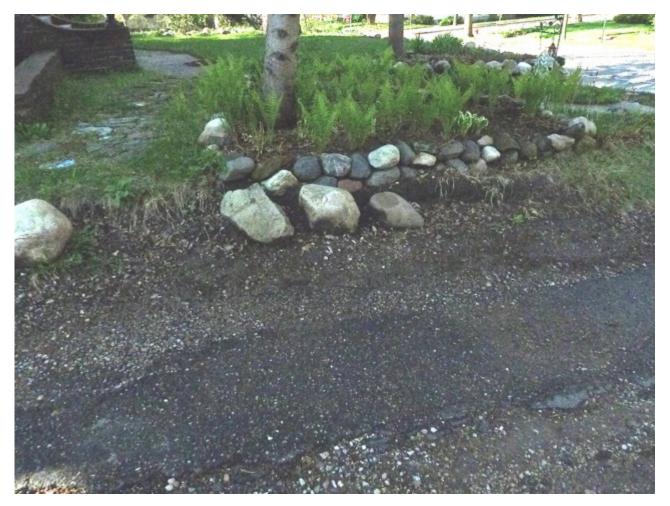
- Neighbors to the south have placed boulders in the right-of-way, further reducing the width of the roadbed. Some of them can be seen in Photo 1 and in the upper right corner of Photo 2.

Photo 1. Boulders in Right-of-Way on South Side.

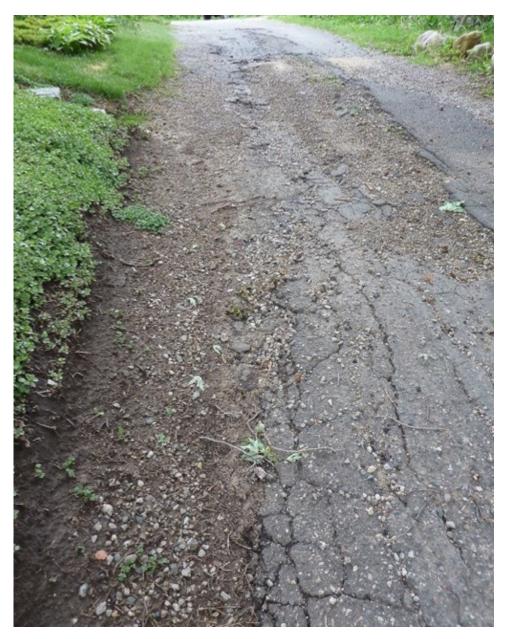
- 5. The inadequate **drainage** creates problems.
 - The alley hill is crowned and has no curbs. Runoff flows to the unpaved sides of the hill, eroding my property adjacent to the alley. See photo 2.
 - The upper end (i.e., the east end) is relatively flat and drainage is inadequate. See photo 3.
 - Runoff at the east end flows to the south east across the adjacent property on Palace Ave. The runoff is not in sheets, but rather concentrated causing the potential for erosion.

Photo 2. Erosion - North Side (May 2012)

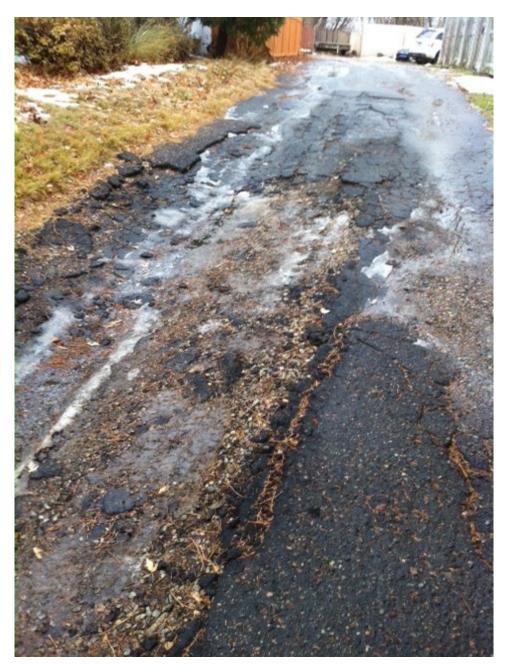
Photo 3. Same view as Photo 2, but taken Nov. 2014. Compare condition of pavement.

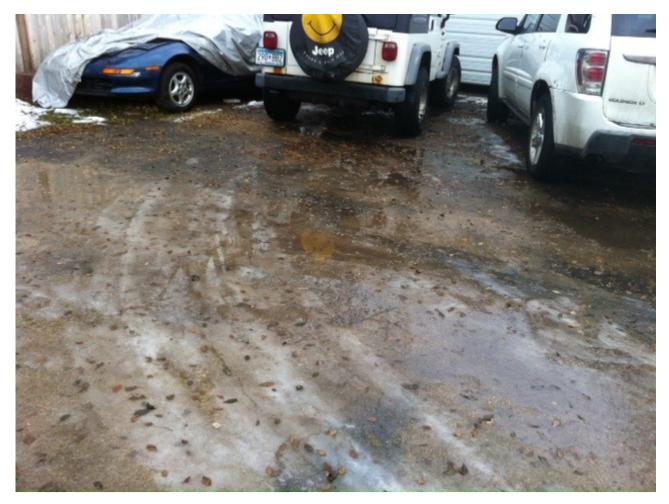
Photo 4. Ice and standing water - East end (Nov. 2014)

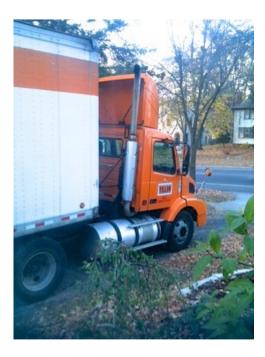
Photo 5.

Furthermore, the neighbors to the south have an ongoing construction project which results in large vehicles using the alley. In the past these vehicles have clearly broken up the pavement. See Photos 5 through 8. Also, the neighbors have an unused swimming pool which they have informed me that they intend to remove. This will entail trucks with fill material as well as the removal of the concrete in the pool. The alley needs to be built to current design standards to support such traffic.
