Subject: Foundation Requirements
688 East 6th Street, St. Paul MN 55106
Ulteig Project No. 10.00796

The purpose of this letter is to report the findings of a structural engineering assessment of the existing foundations located at the residence at the above address.

688 East 6th Street New Footings Plan

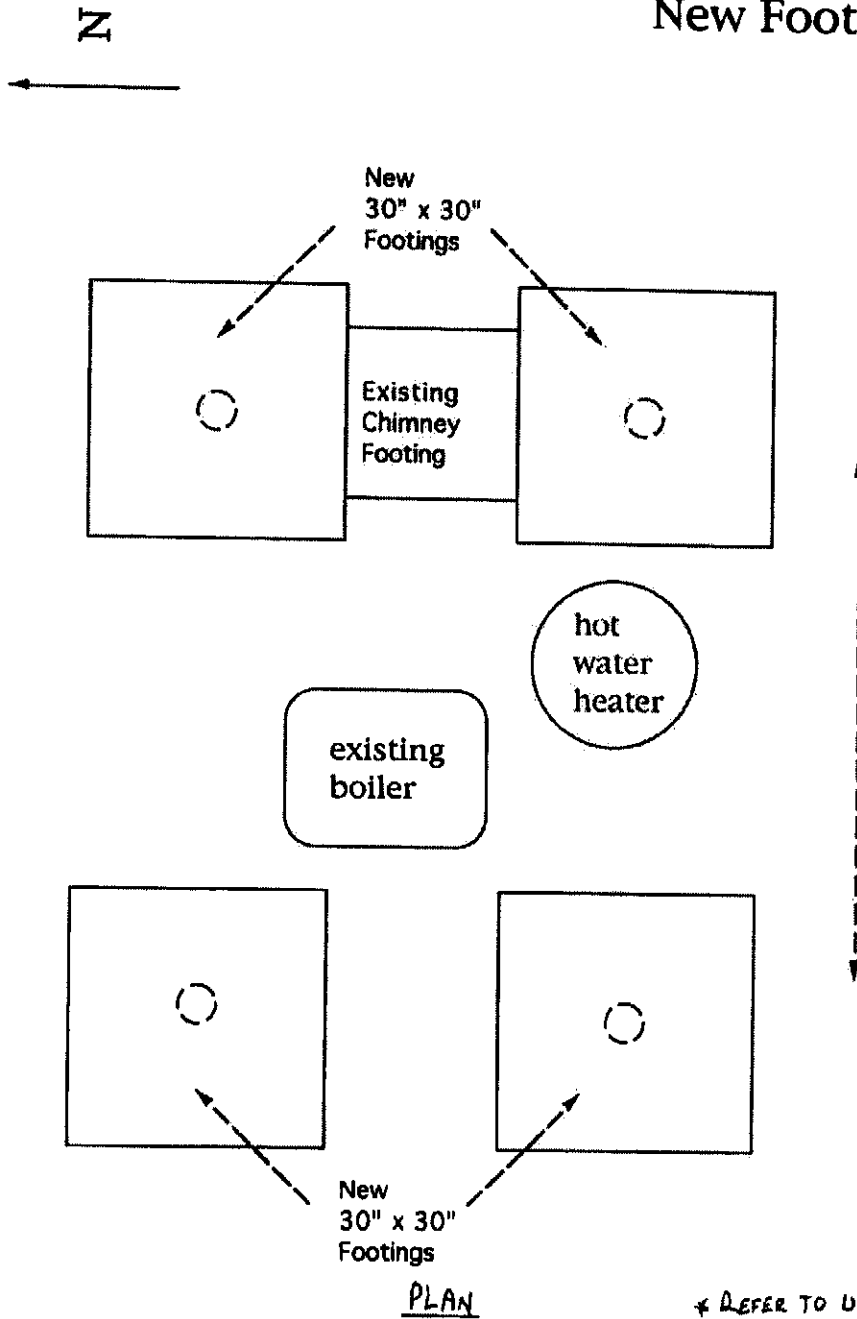
- d. The existing middle beam was a sawn 8" deep x 6" wide beam. This beam was interrupted at the chimney 11'-0" in each direction and supported on each side of the chimney with a 3" temporary steel column. The steel columns were supported on a flat sawn section of lumber laid on the concrete slab-on-grade. Though the second floor framing was not visible, it is assumed that the framing is similar and this beam is supporting both floors.

- e. An additional 6"x6" sawn beam spanning approximately 6'-0" was installed in the front right side of the basement and supported by temporary steel columns. The steel columns bear on sawn 6"x6" wood blocks on the slab-on-grade. The supports were most likely installed to remove sag of the floor above.

- b. The existing temporary steel columns should be replaced with 3" diameter permanent columns that have adequate top and bottom plates and positive mechanical fastening.

- c. The new permanent steel columns should be supported on a new 30"x30"x8" deep concrete foundation beneath the slab with (3)#4 reinforcing bars placed in each direction.

NOTES: Each footing to be 30"x30"x.8' deep, with three # 4 rebar evenly spaced in the N/S and E/S directions, for a total of six rebar per footing. Existing posts are to be replaced with permanent structurally code approved steel posts. A new plinth block is needed under the next post south of the existing chimney.
