**Date:** June 12, 2015  
**File #:** 13 - 252825  
**Folder Name:** 1052 ROSS AVE  
**PIN:** 282922340015

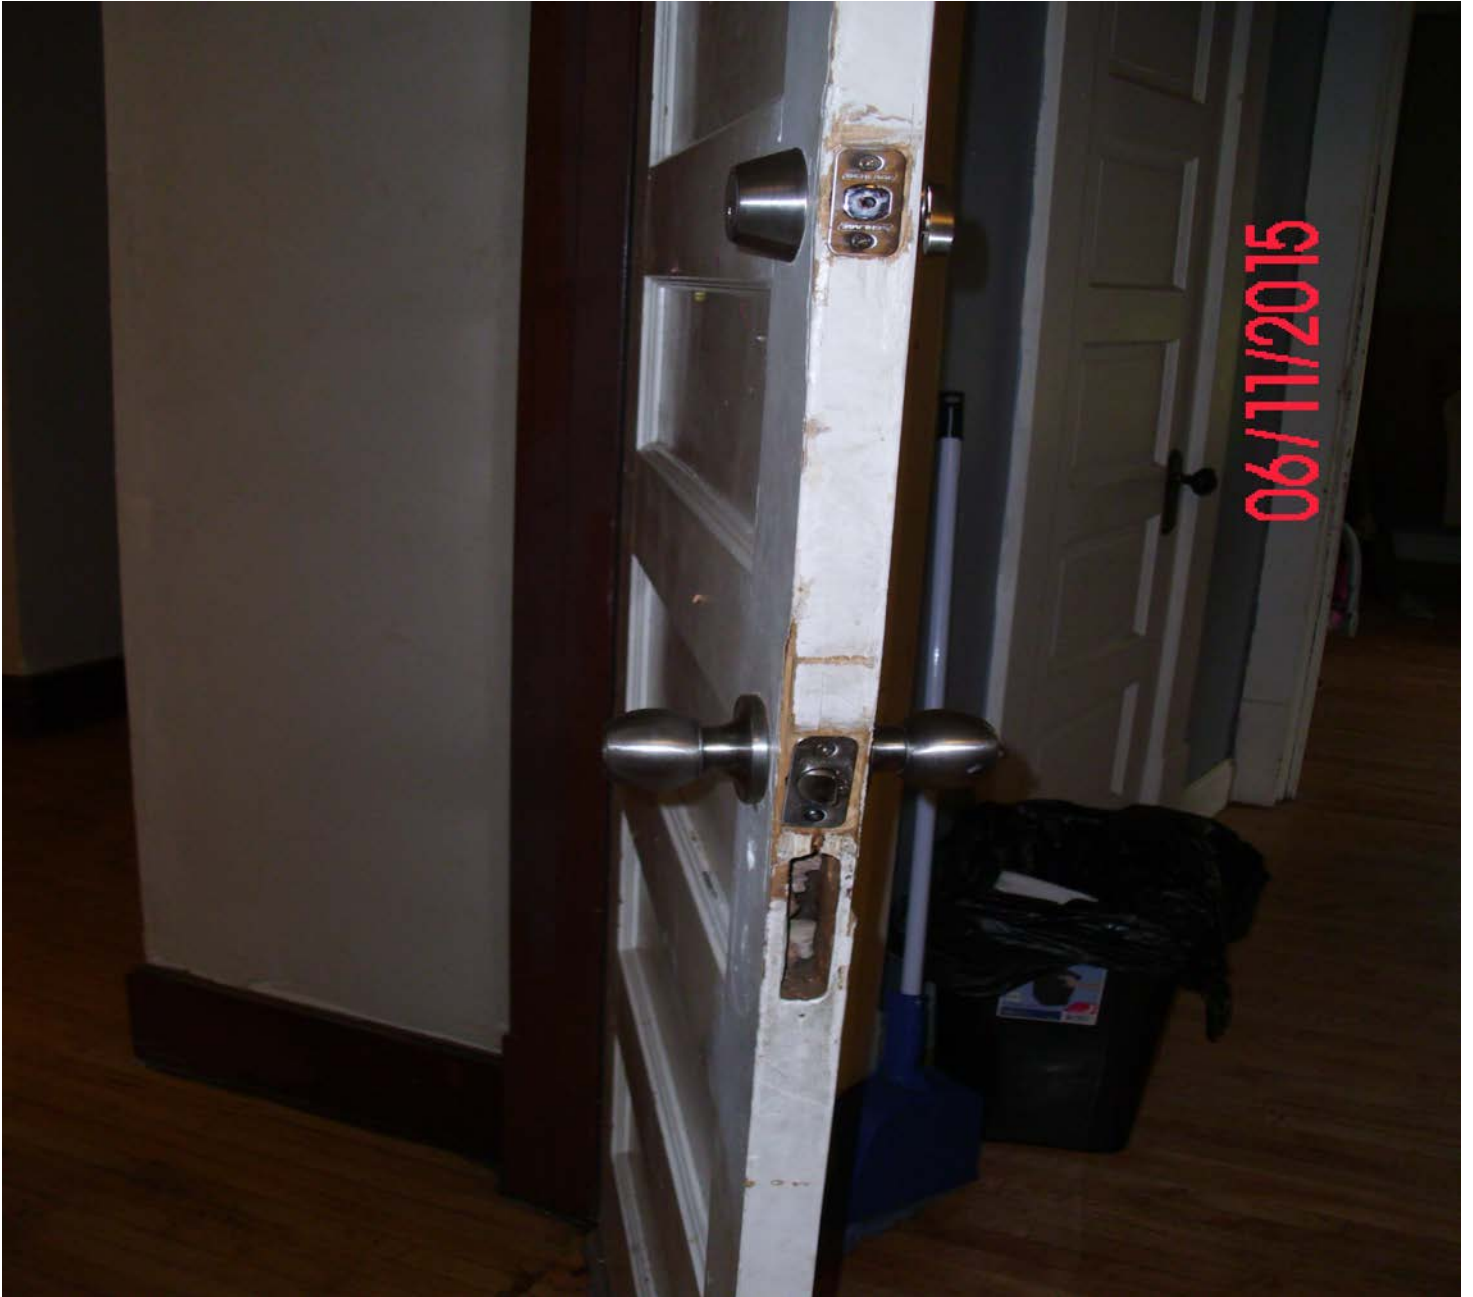
**Continuation of first picture**

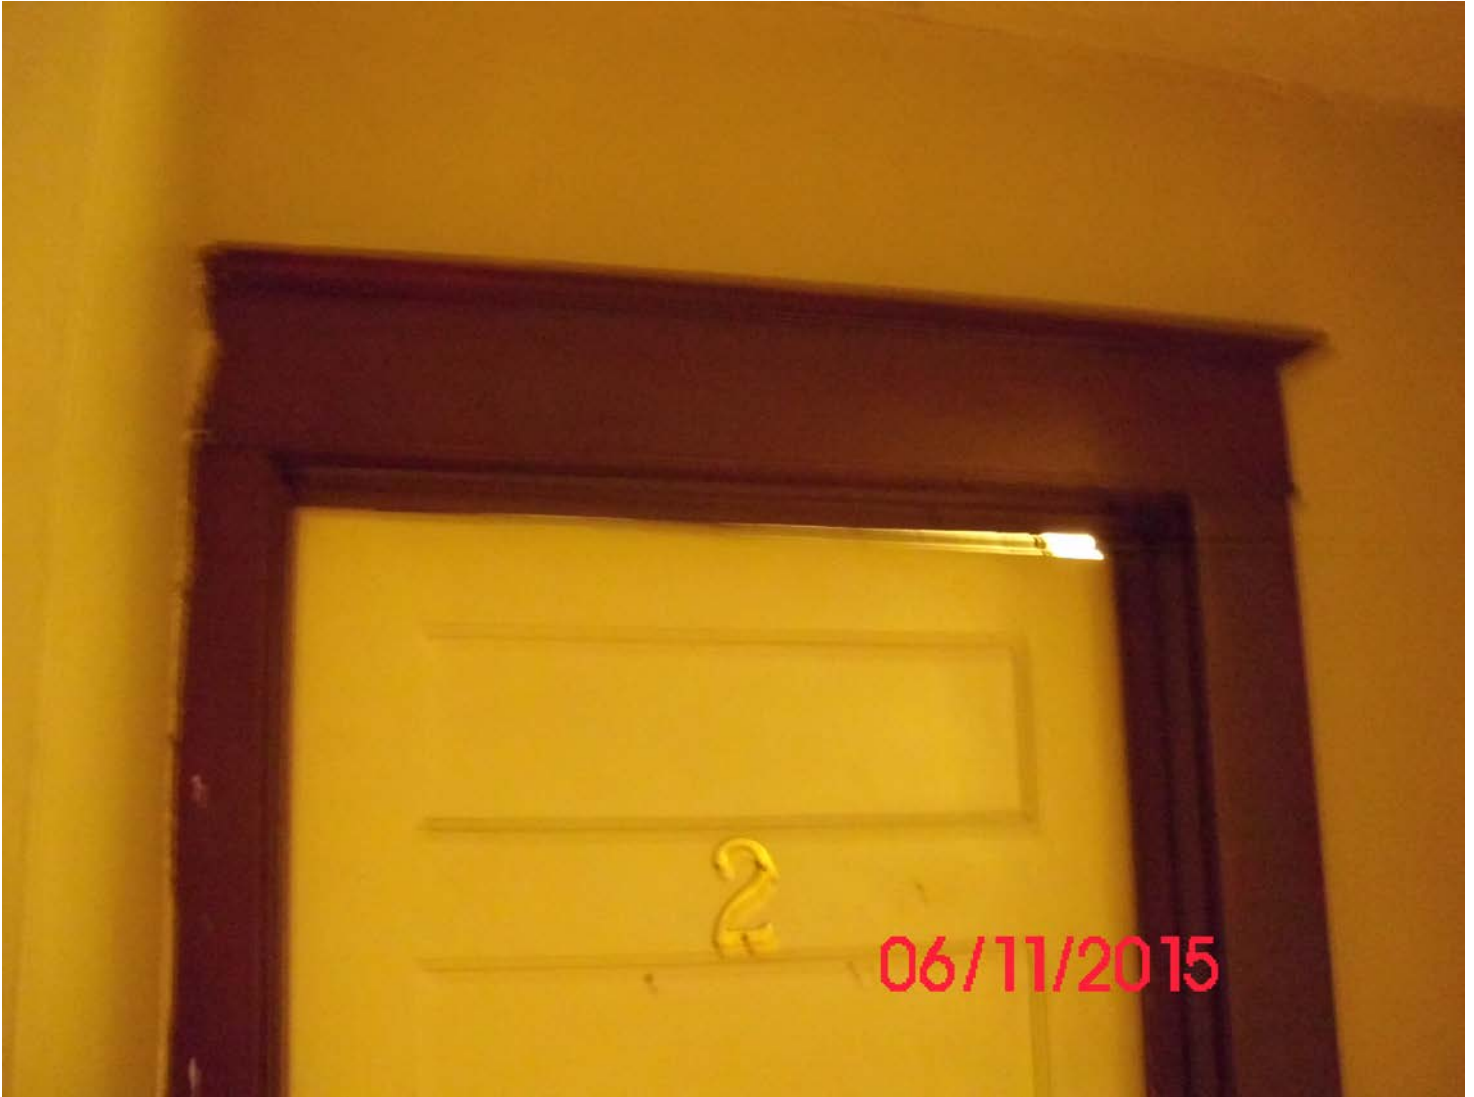
**Entry door does not fit in frame.**
