Re: Alley Slab Reinforcement at 209 E. 4th St. St. Paul. MN

At your request, I traveled to 209 E. 4th St. in St. Paul on Thursday, 5/28/15 to observe rusted steel beams supporting the alley slab on the north side of the building.

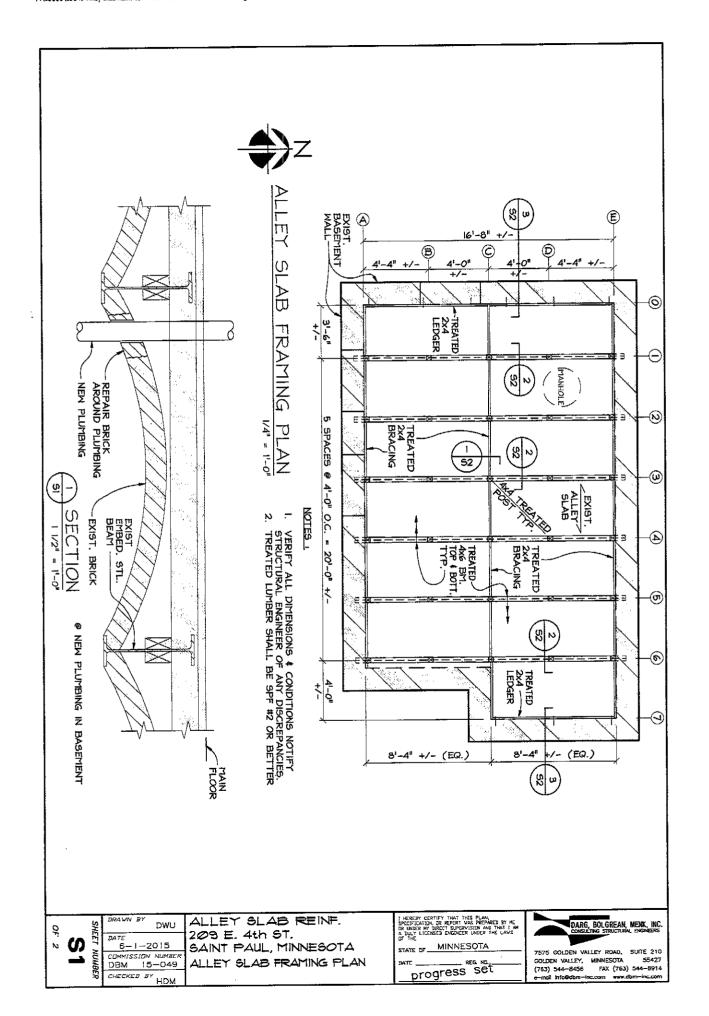
The steel beams supporting the alley slab have considerable rust that has resulted in lost section and capacity. Two options were discussed; removal and replacement or temporary shoring. After some discussion, it was agreed to provide temporary shoring with green treated timbers as per the attached sheets S1 & S2. We understand that a permanent solution will be implemented within the next 12 months.

In the interim and until the temporary shoring is in place, we recommend that temporary barriers or a fence be located such that vehicles are not permitted on this section of alley slab.
