HERITAGE PRESERVATION COMMISSION DESIGN REVIEW APPLICATION

Demolition of 700 4th Street East

14 September 2015

Project No.: 15538.00
Re: Structural Condition Review of the building at 700 4th St. E.

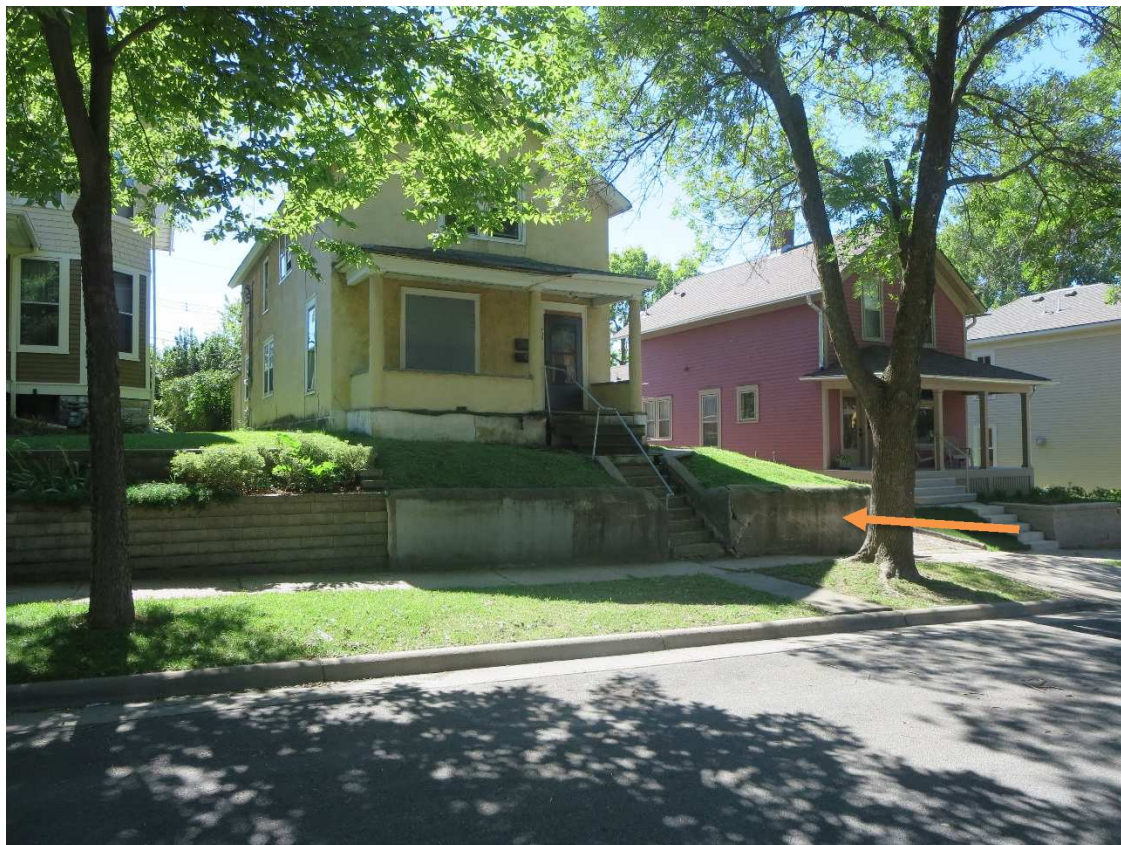
Picture 1 – Front Retaining Wall

The retaining wall at the front of the house is cracking and needs to be replaced. Picture 1 shows an overall view of the front retaining wall. Picture 2 shows the portion of the retaining wall that is showing the most cracking. A portion of the retaining wall has tipped. As the retaining wall continues along the southern side of the building its deflection increases. Picture 3 shows the wall, as seen from 4th street. There are also cracks that appear to go through the wall. Picture 4 shows one such crack.

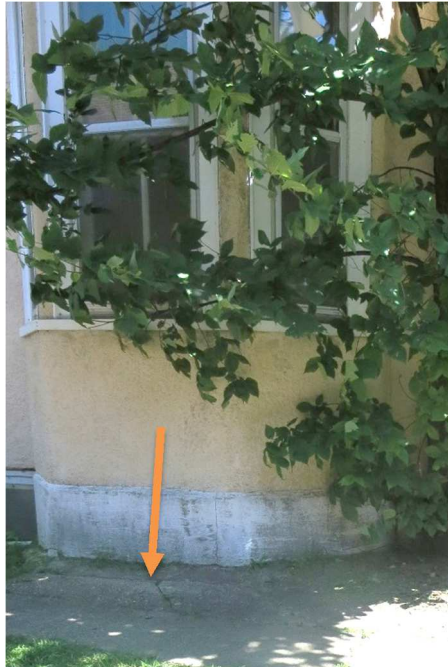
Picture 5 – Bay at South Wall

The bay along the south wall of the house appears to have settled. Picture 5 shows the bay and a crack that has occurred next to it. There is a tree that is growing just east of the bay. Its trunk is adjacent to the foundation wall. The tree is likely one cause of the settlement of the bay and could be the cause of other problems in the house. Picture 6 shows the base of the tree and the foundation wall. The background of Picture 4 shows the bay along with the tree as well.

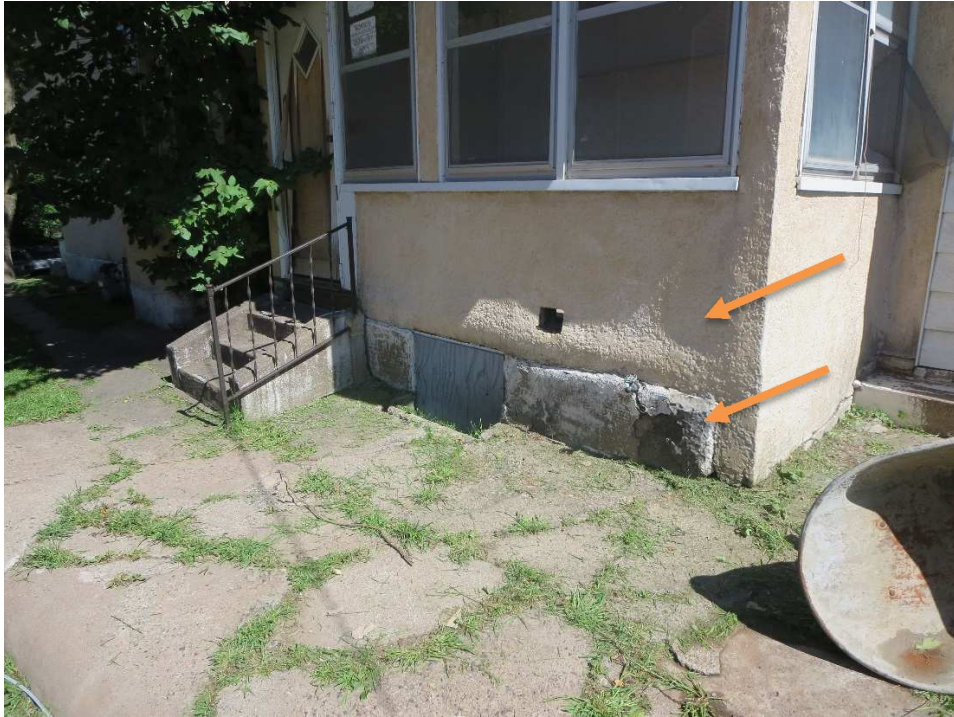
Picture 7 – Water Damage at Southern Foundation Wall

There is some water damage to the house. The eastern section of the south foundation wall showed signs of damage and rot. Picture 7 shows some of the rot that has occurred as well as spalling of the finish material along the foundation and bulging of the stucco on the wall. Water damage effects were found in the floor of the second story of the house. Picture 8 shows some of the damage. It is likely that there is damage that allows water to leak. The roof was observed from the outside to be sagging slightly (not pictured). It is likely that there is some damage to the roof, which is causing water to enter the house.
