HERITAGE PRESERVATION COMMISSION DESIGN REVIEW APPLICATION

RE: 767 4th Street East Request for Demolition

Project No.: 15539.00
Re: Structural Condition Review of the building at 767 4th St. E.

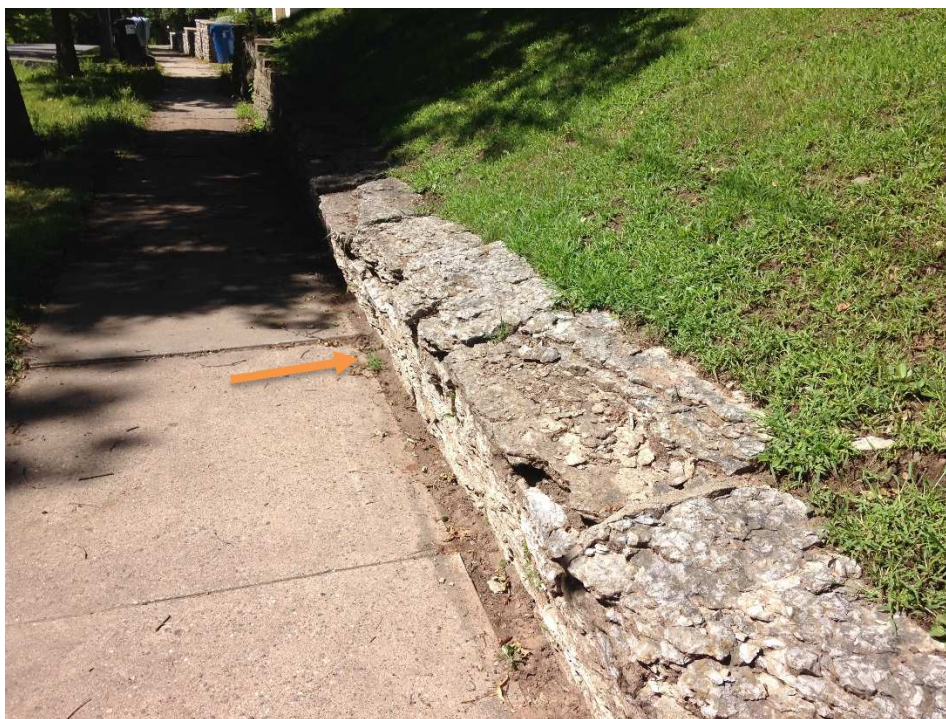
The retaining walls around the house are tipping and need to be replaced. The retaining wall at the front of the house is shown in Picture 1. The retaining wall on the eastern side of the house, between the house and the driveway of the adjacent property, is also in poor condition. Picture 2 is taken along the wall, from the street and shows the top of the wall as it has deflected. There is a tree that is growing between the retaining wall at the driveway and the wall at the stairs. The tree is likely a main cause of the current condition of the walls. Picture 3 gives a different perspective on the wall. The deflection of the wall can be seen farther back and the tree is more easily visible.

Picture 1 – Front Retaining Wall

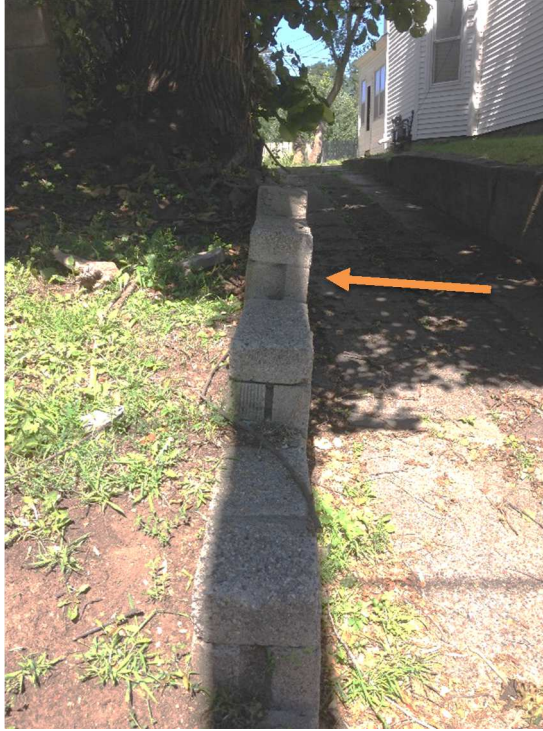
Picture 2 – East Retaining Wall

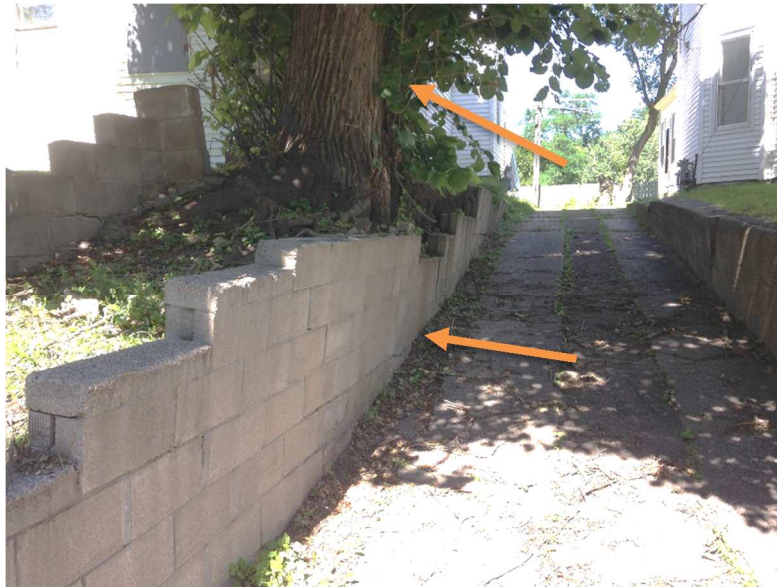
Picture 3 – East Retaining Wall with Tree

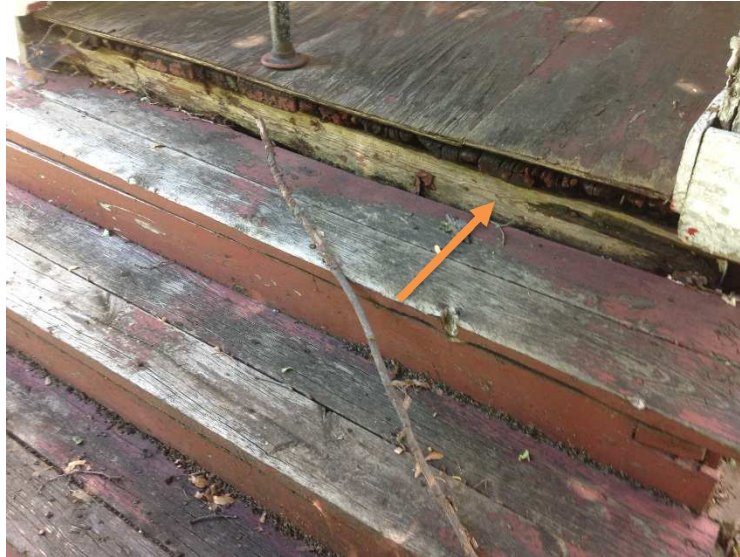
The front porch has deteriorated. Rot of the deck can be seen in Picture 4 and damage to the column can be seen in Picture 5. The porch slopes away from the building at an unusual angle. Picture 5 also shows the slope of the porch. It is likely that there is more damage to the porch that is unseen.

Picture 4 – Front Porch Deterioration

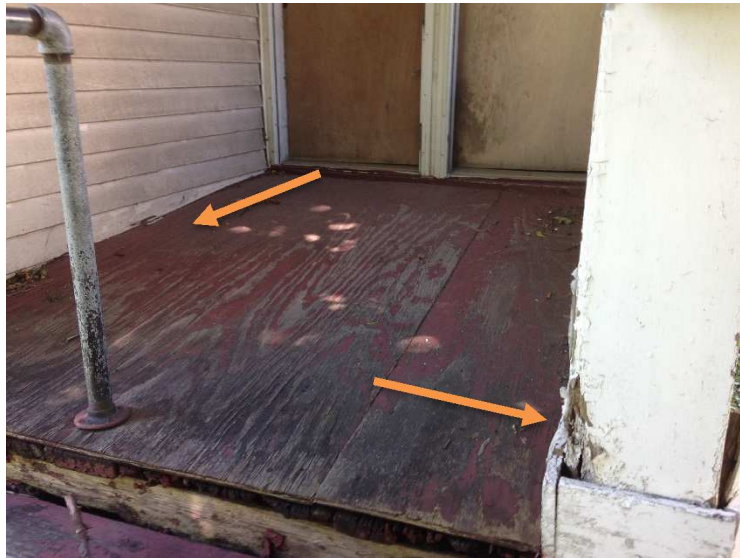
Picture 5 – Front Porch Deterioration and Slope

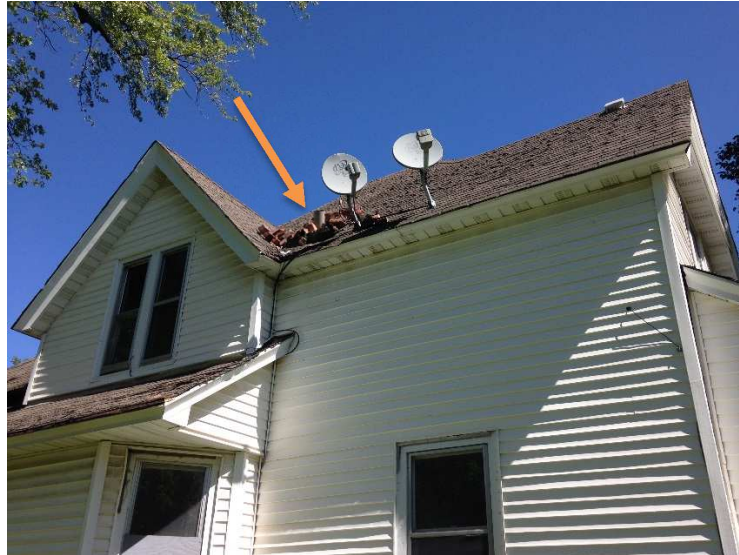
The chimney that extends above the southern roof of the house has been demolished. There is brick debris on the roof of the building and around the property. Picture 6 shows the existing chimney extending above the roof and the rubble scattered around it. Picture 7 gives a close up view of the damage.

Picture 6 – Demolished Chimney

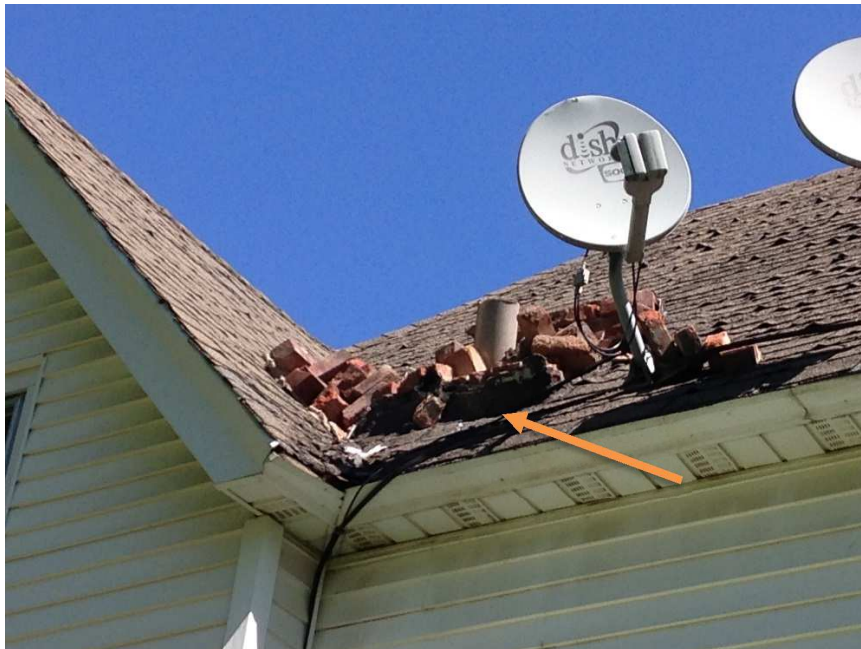
Picture 7 – Demolished Chimney

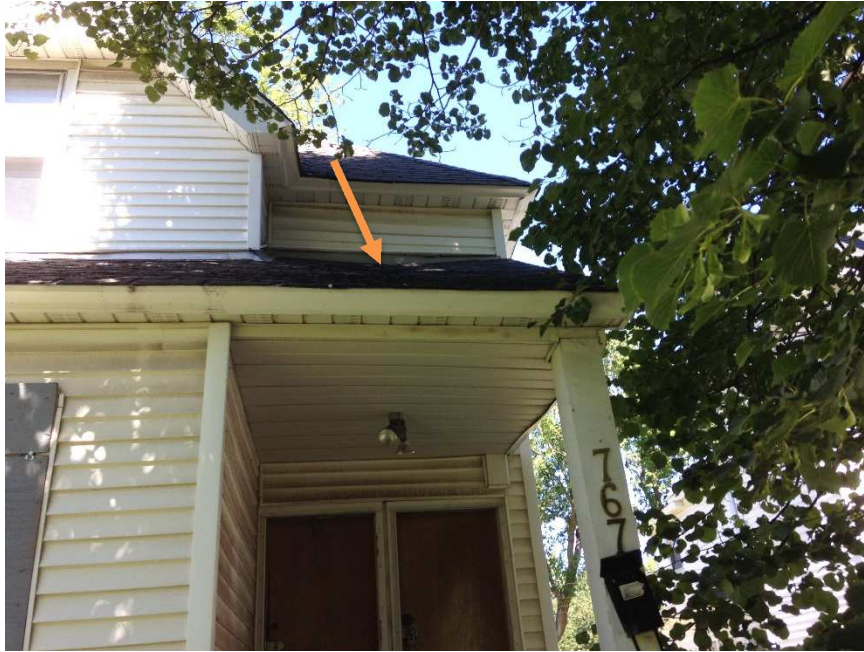
The roofs of the house are in poor condition. Sagging was observed on the roof above the front porch and on the roof at the western side of the house. Picture 8 shows the front porch and Picture 9 shows the west roof. Rot and deterioration were observed as well. The back roof shows signs of rot as well. Picture 10 shows some of the damage to the building. Picture 11 shows the roof as seen from the inside. There are obvious holes through the roof and water damage. Many of the house's shingles are damaged or are missing as well. It is likely that there are multiple places in all of the house's roofs that are damaged and are allowing water in.

Picture 8 – Roof Sag at the Front Porch

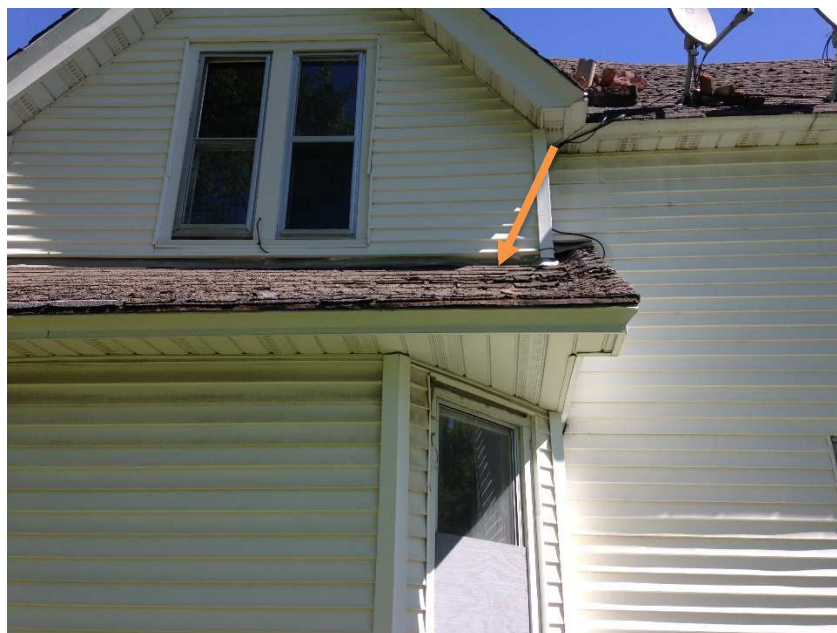
Picture 9 – Roof Sag on the West Side

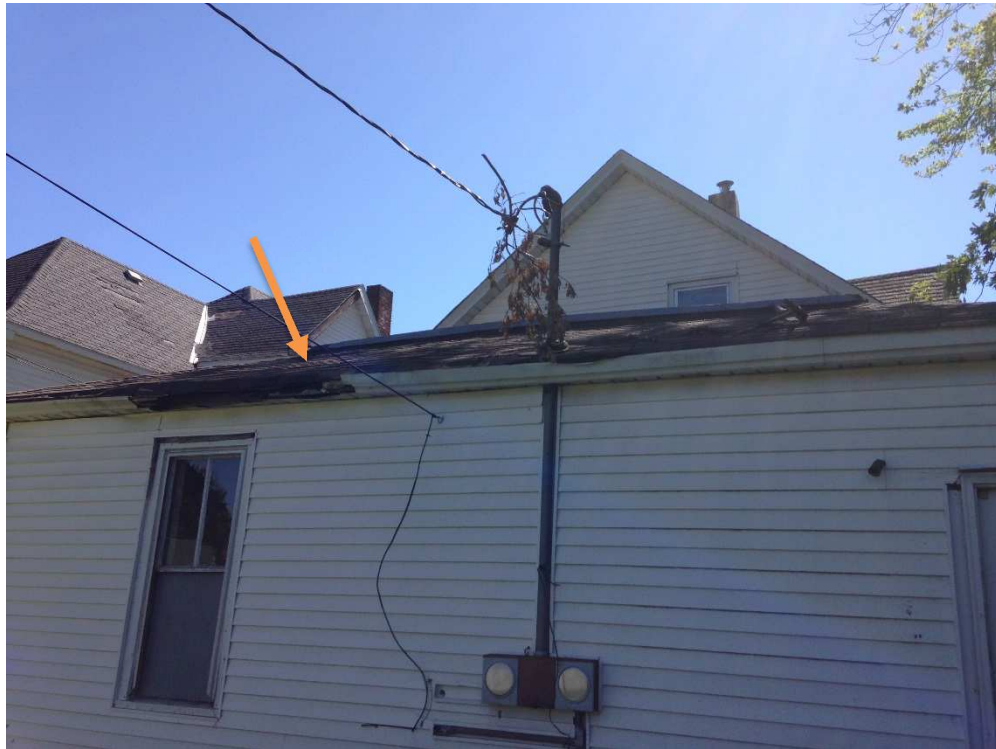
Picture 10 – Rot At Back Roof

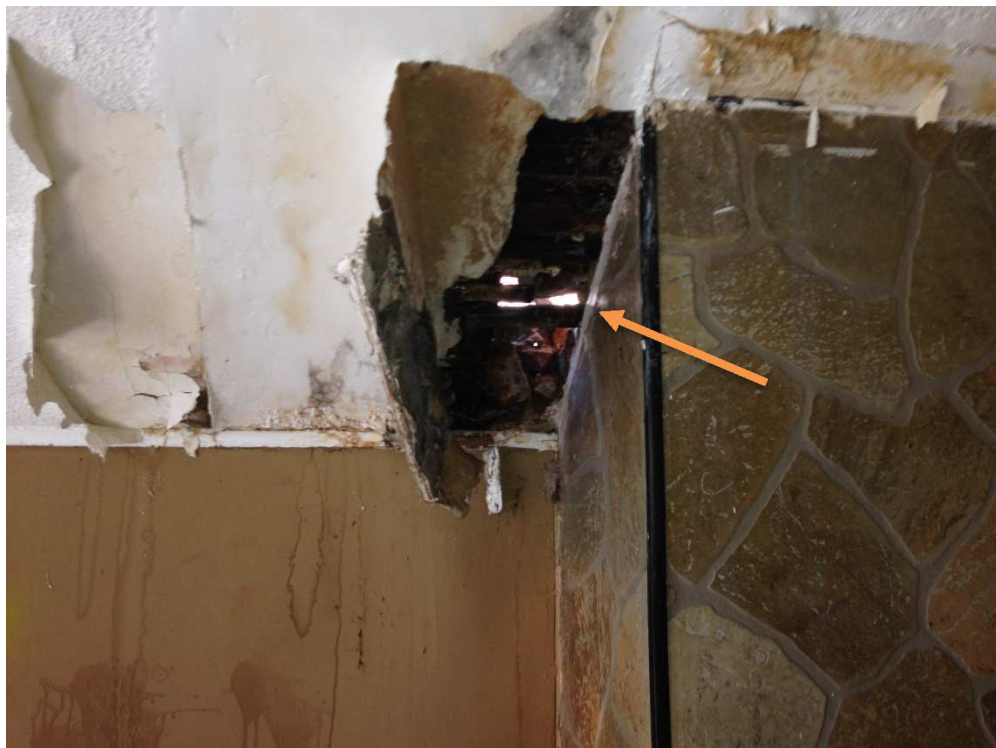
Picture 11 – Rot Through Roof

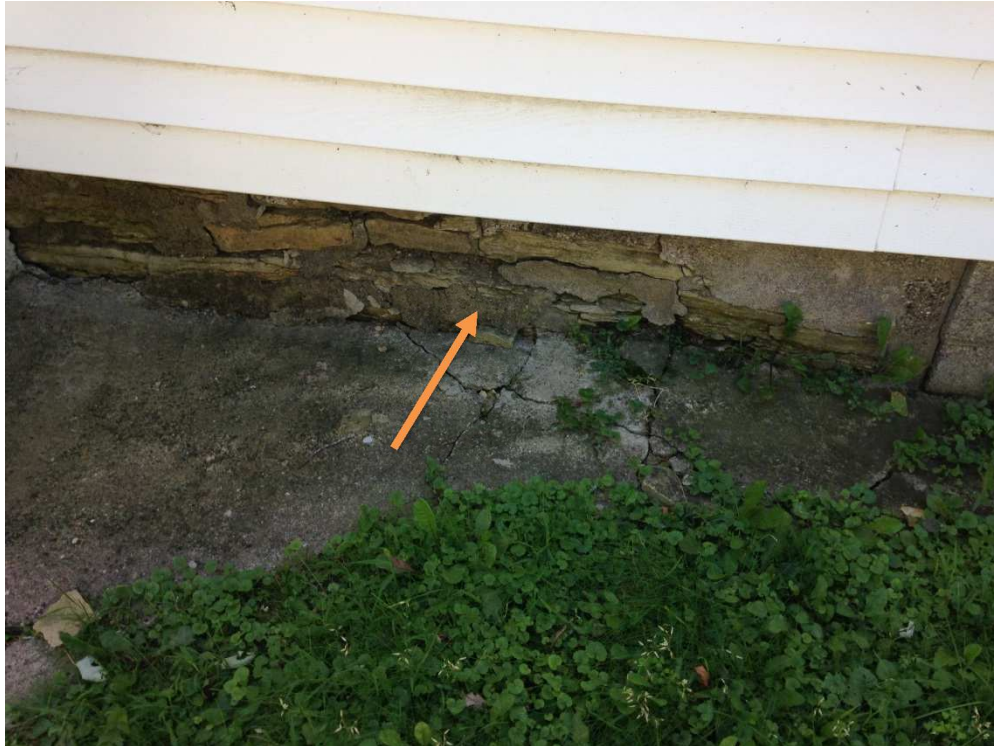
The foundation walls, as observed from outside the house, are also in poor condition. The original limestone foundation walls are deteriorating. Debris from the deterioration of the walls can be found all along the house. Picture 12 shows one such instance. In it, the wall has broken away and has exposed some of the wall's interior. Picture 13 shows a separate instance. More debris and broken foundation wall can be seen. The foundation of the addition on the north side of the house appears to have been installed without mortar between the units. Mortar typically helps a foundation resist loads and keep water out. Picture 14 shows some of the masonry units and the lack of mortar between them.

Picture 12 – Foundation Deterioration

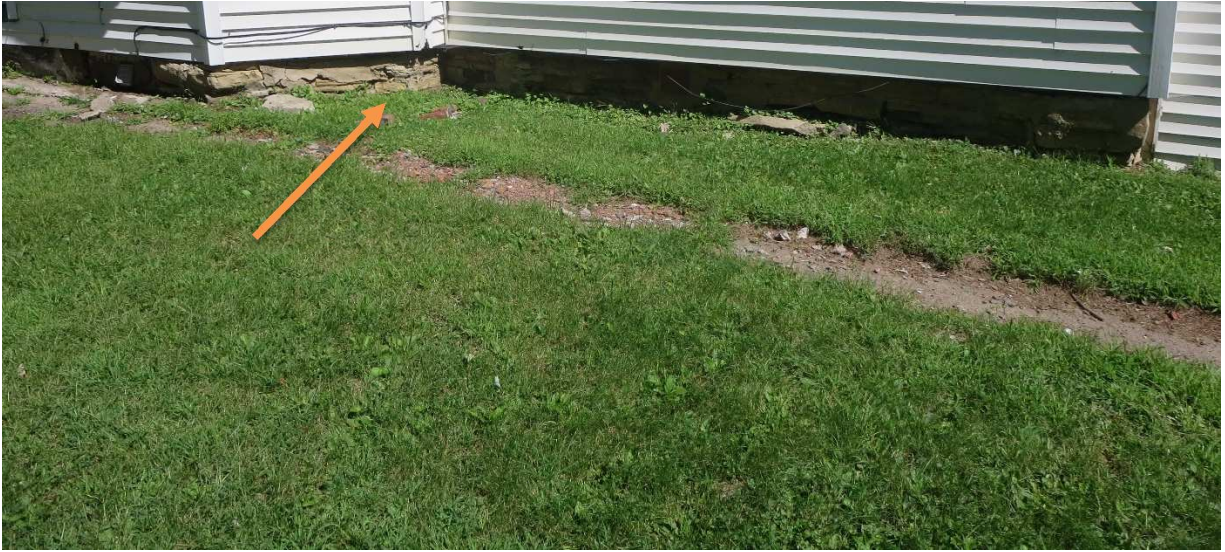
Picture 13 – Foundation Deterioration

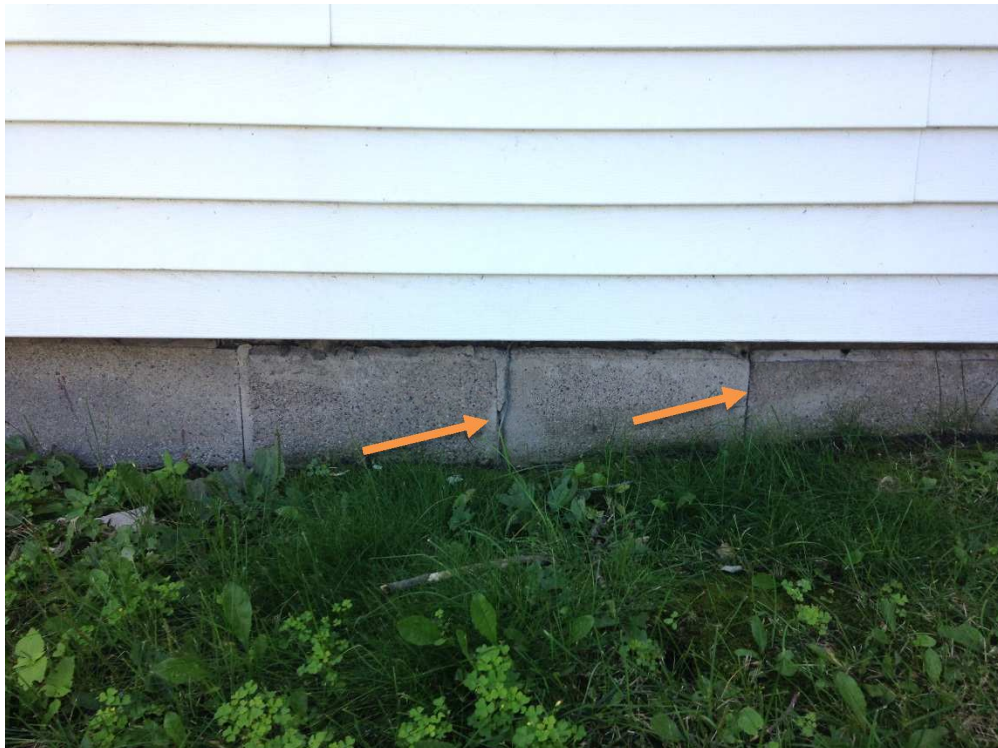
Picture 14 – No Mortar Between CMU Units

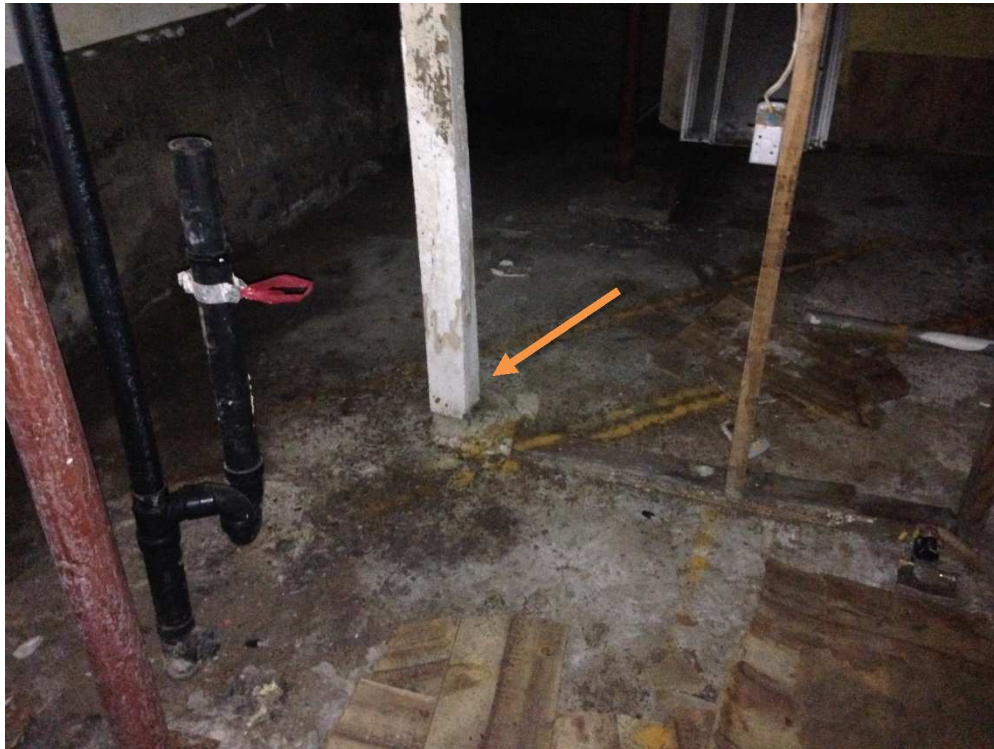
In the basement we observed a column that had shifted off of its footing. The column as well as the footing both need to be replaced. Picture 15 shows the base of the column as well as the footing.

Picture 15 – Basement Column and Footing

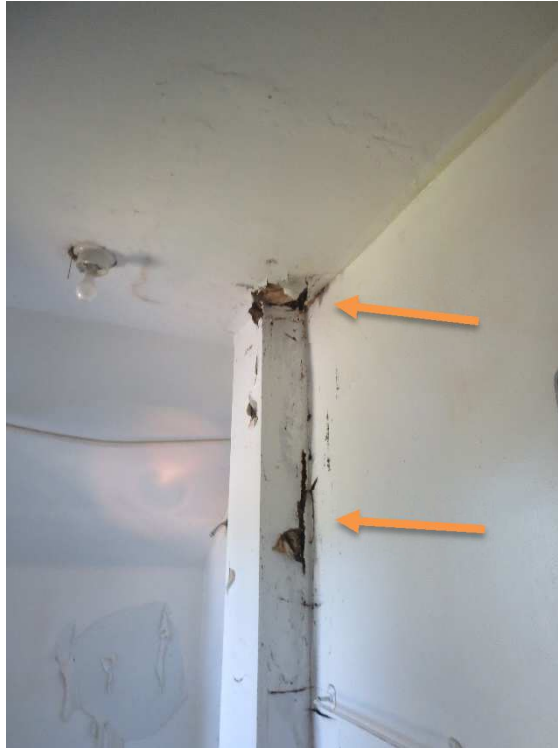
Water damage was found throughout the house. As noted above, there are likely holes in the roof which is allowing water to enter the house. It is also likely that the damage inside the house allows for the water to get to each room and each level. Picture 16 shows water damage that has been done to a column within the house. The finish has deteriorated and it is likely that the column itself has been affected by the water. Picture 17 shows a ceiling within the house that has been damaged. Picture 18 shows mold that is in the basement which covers the foundation walls. The mold that is in the basement is extensive and is damaging the framing.

Picture 16 – Water Damage to Column

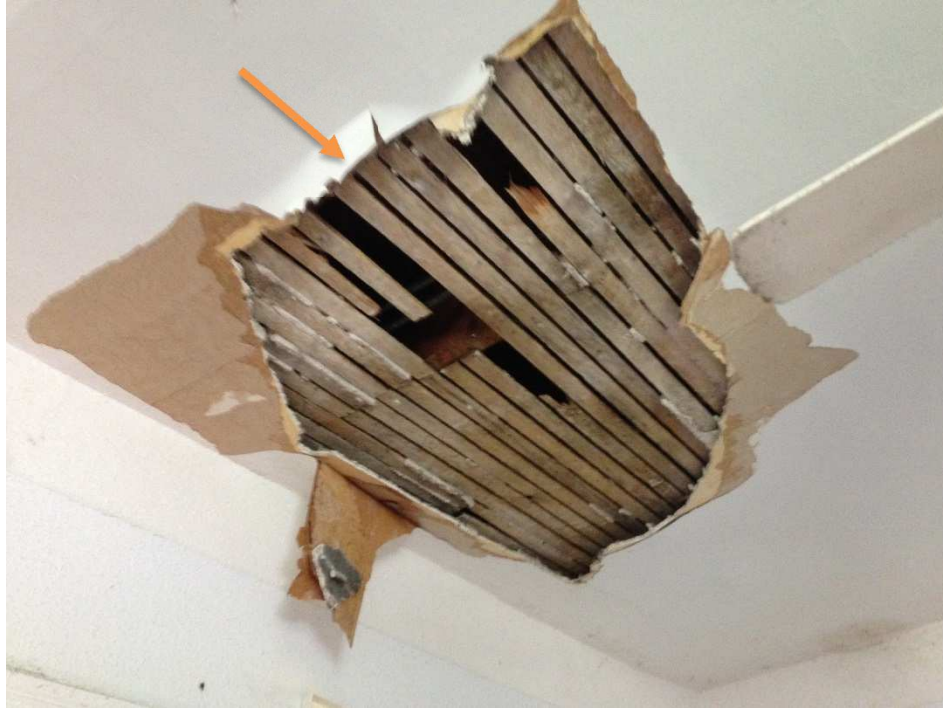
Picture 17 –Damage to Ceiling

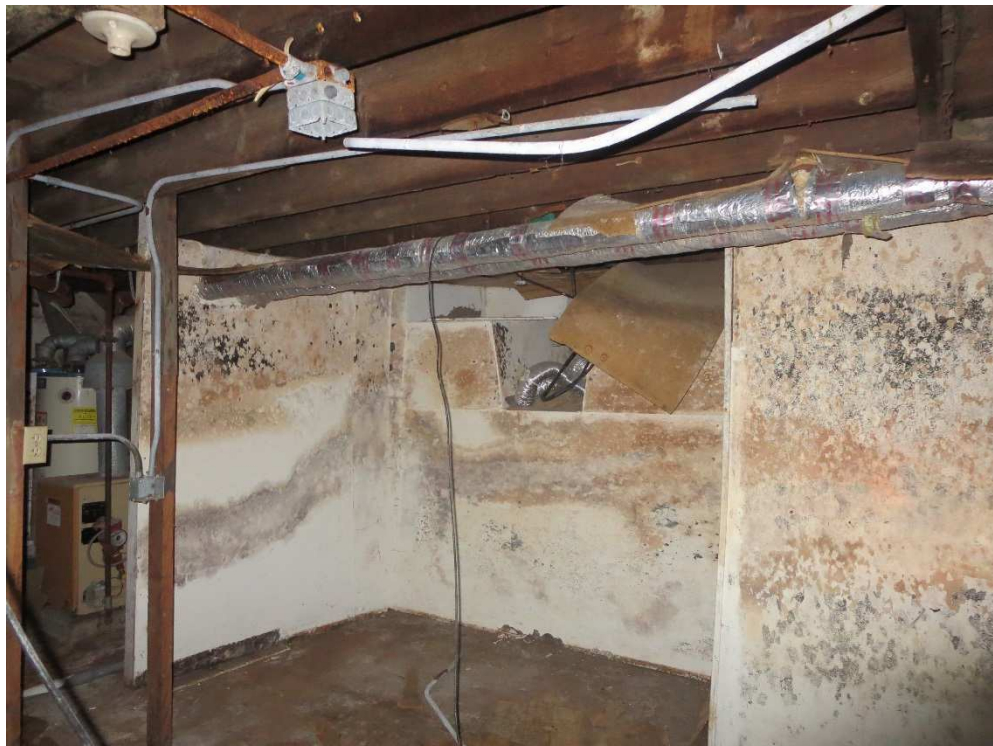
Picture 18 – Mold in Basement
