Saint Paul Heritage Preservation Commission
 Department of Planning and Economic Development
 25 Fourth Street West, Suite 1400
 Saint Paul, MN 55102
 Phone: (651) 266-9078
 ApplyHPC@stpaul.gov

HERITAGE PRESERVATION COMMISSION DESIGN REVIEW APPLICATION

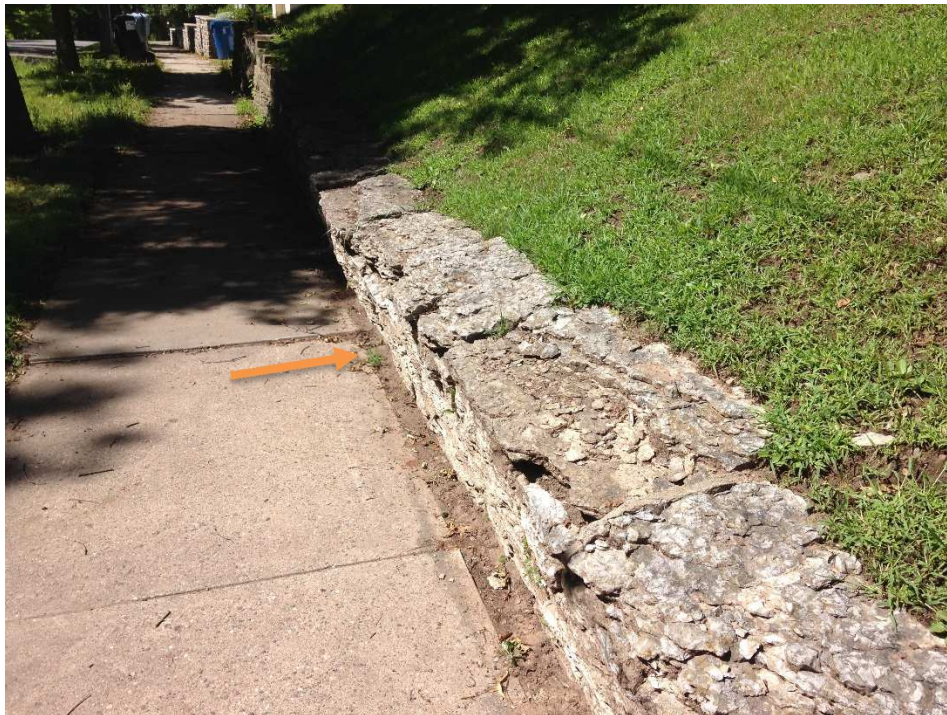
Picture 1 – Front Retaining Wall

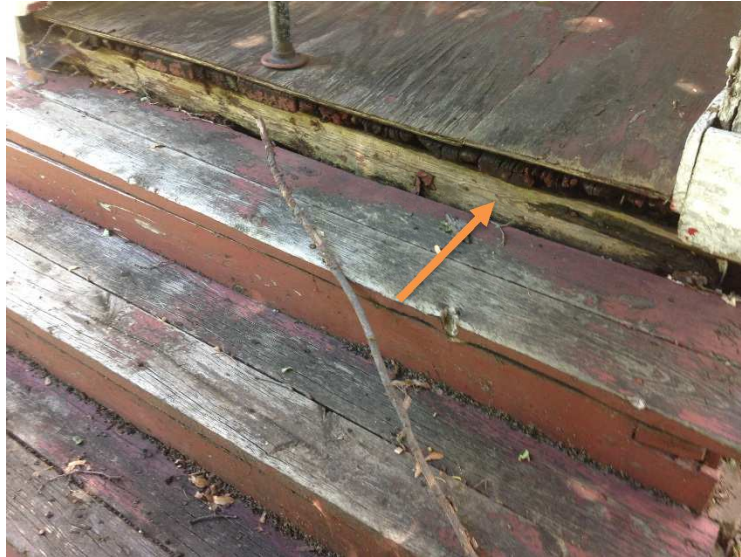
Picture 4 – Front Porch Deterioration

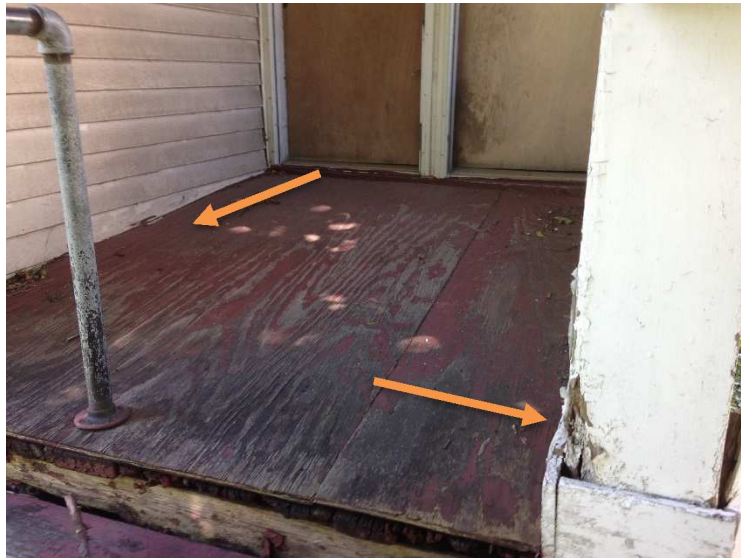
Picture 5 – Front Porch Deterioration and Slope

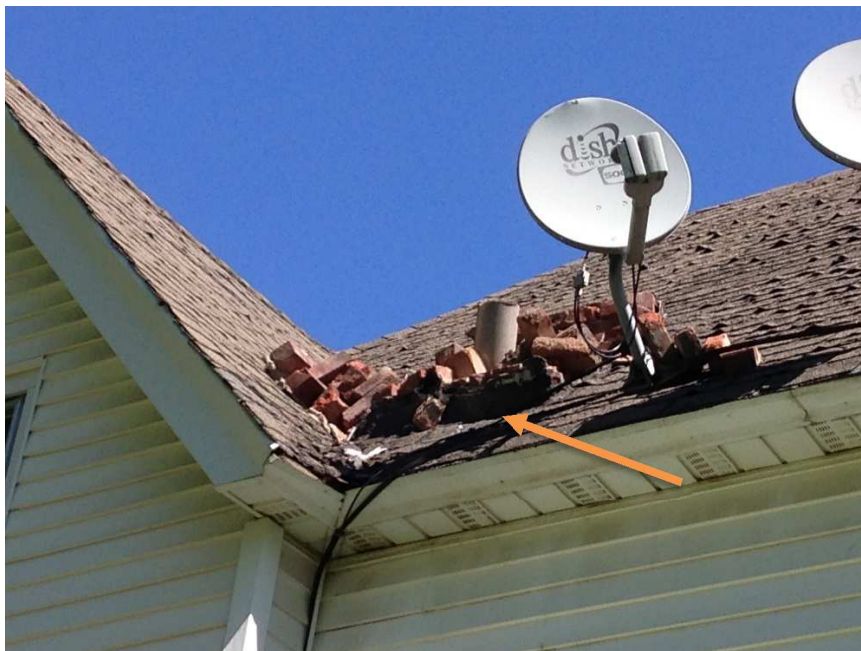
Picture 7 – Demolished Chimney

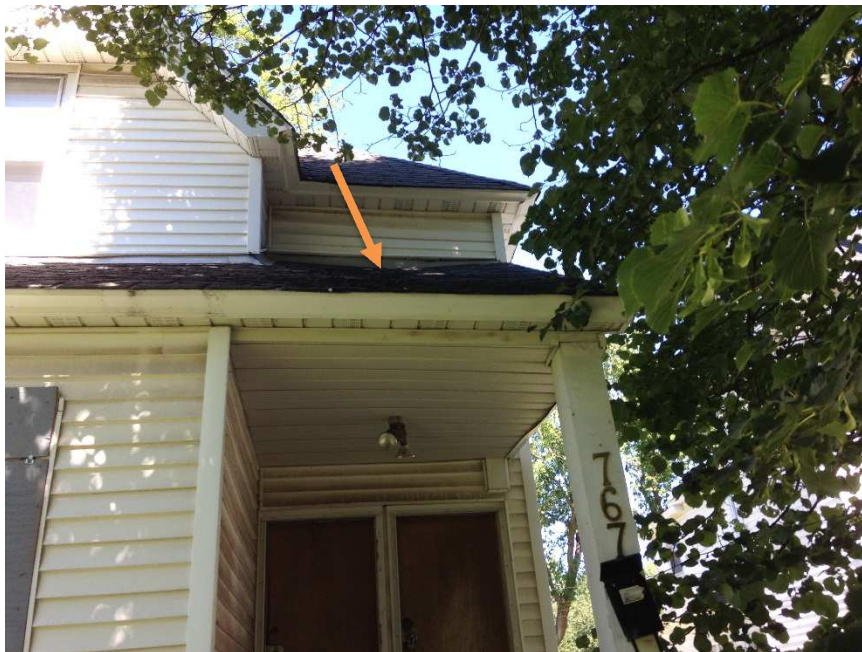
Picture 8 – Roof Sag at the Front Porch

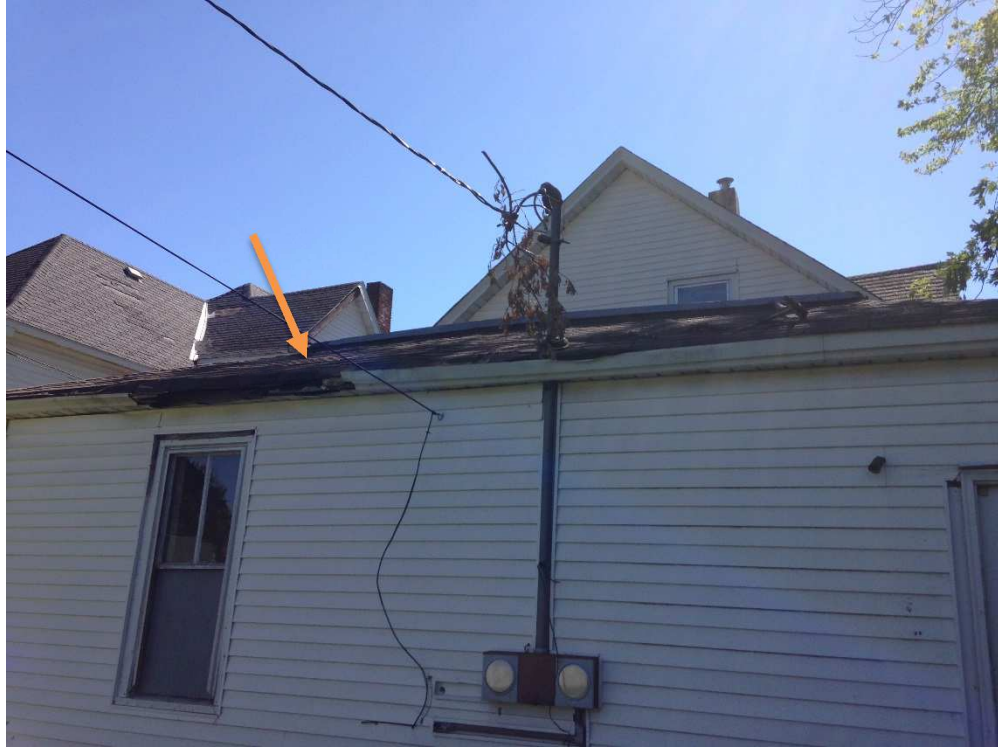
Picture 10 – Rot At Back Roof

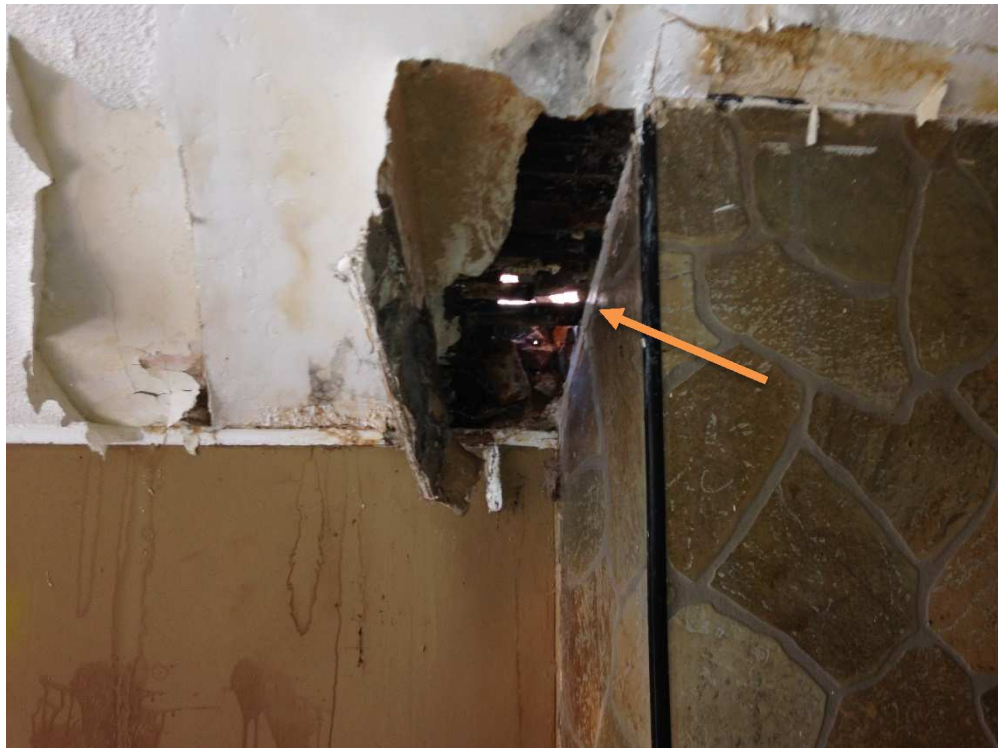
Picture 11 – Rot Through Roof

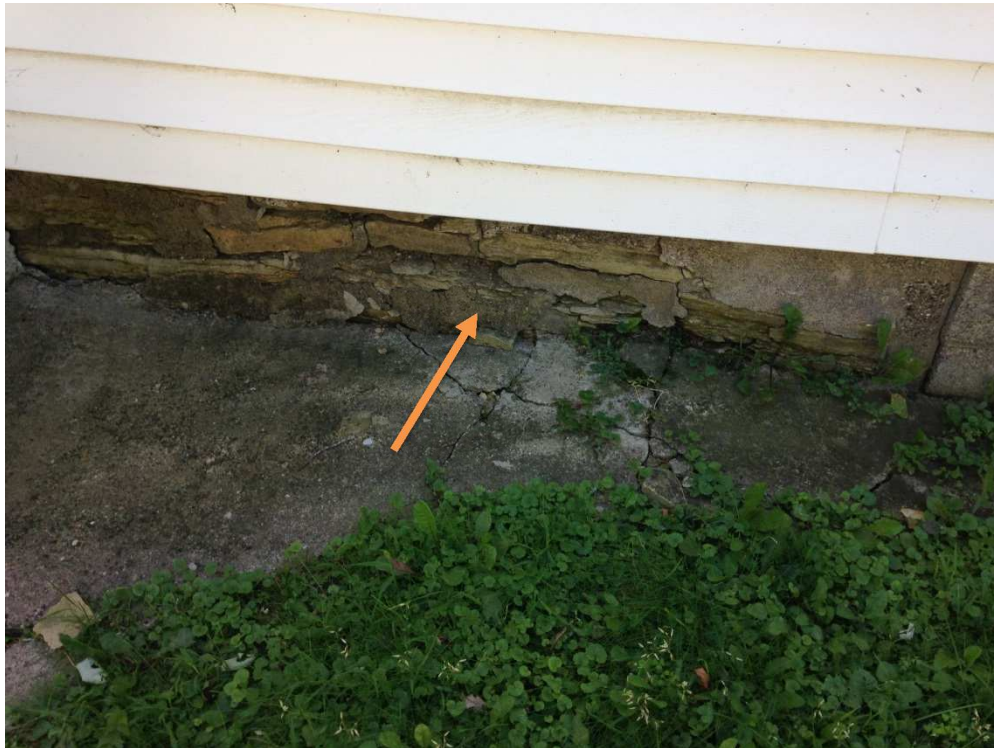
Picture 12 – Foundation Deterioration

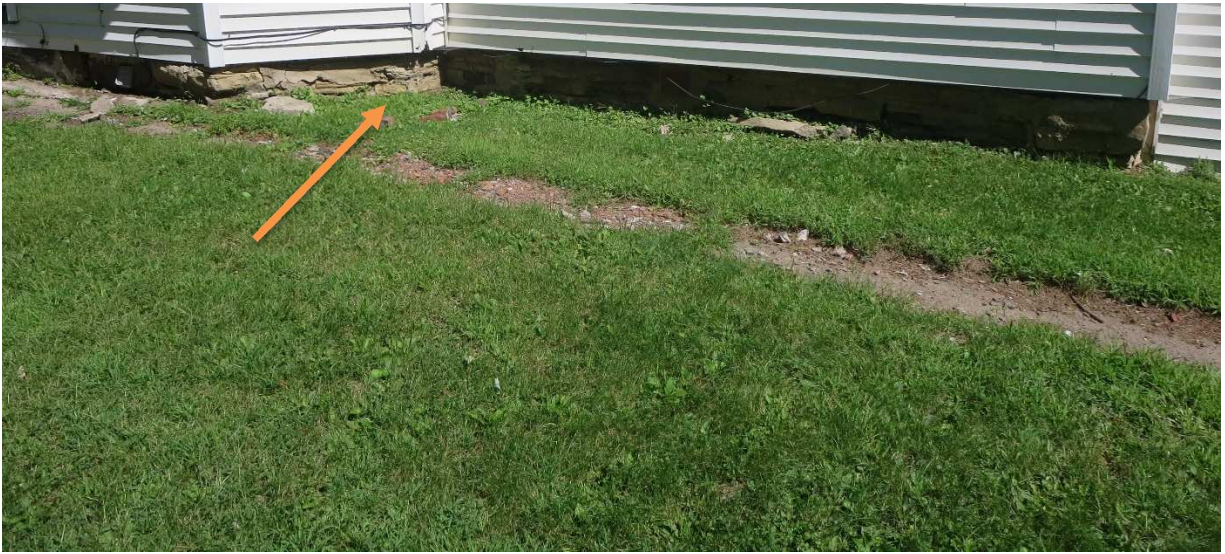
Picture 13 – Foundation Deterioration

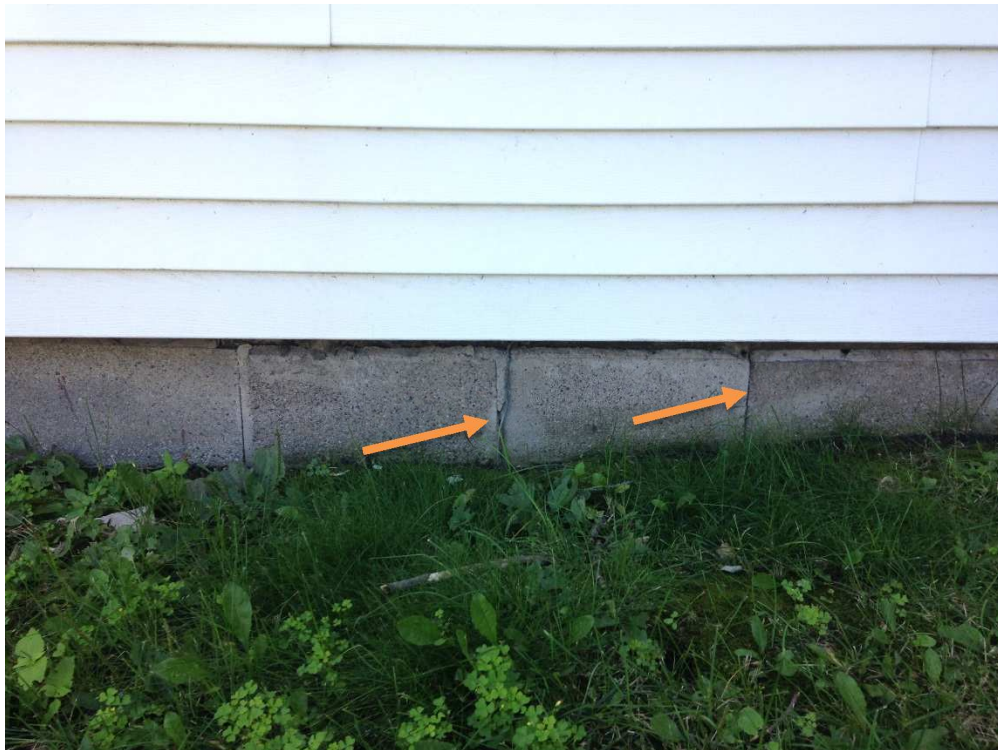
Picture 14 – No Mortar Between CMU Units

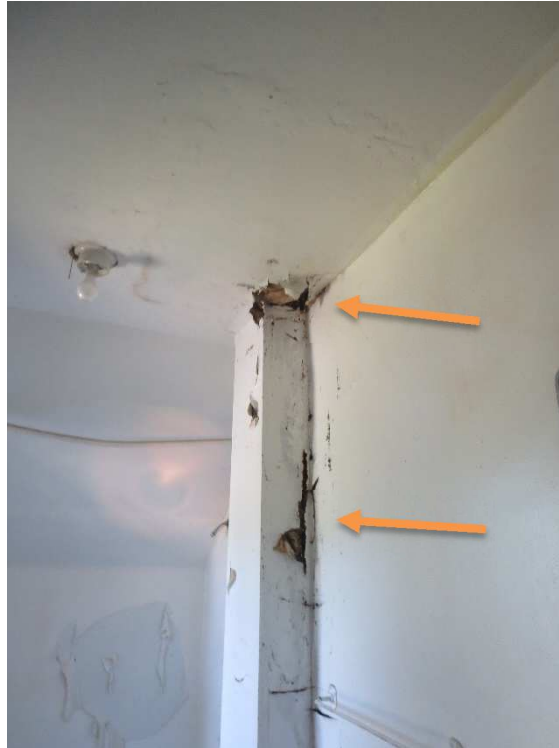
Picture 16 – Water Damage to Column

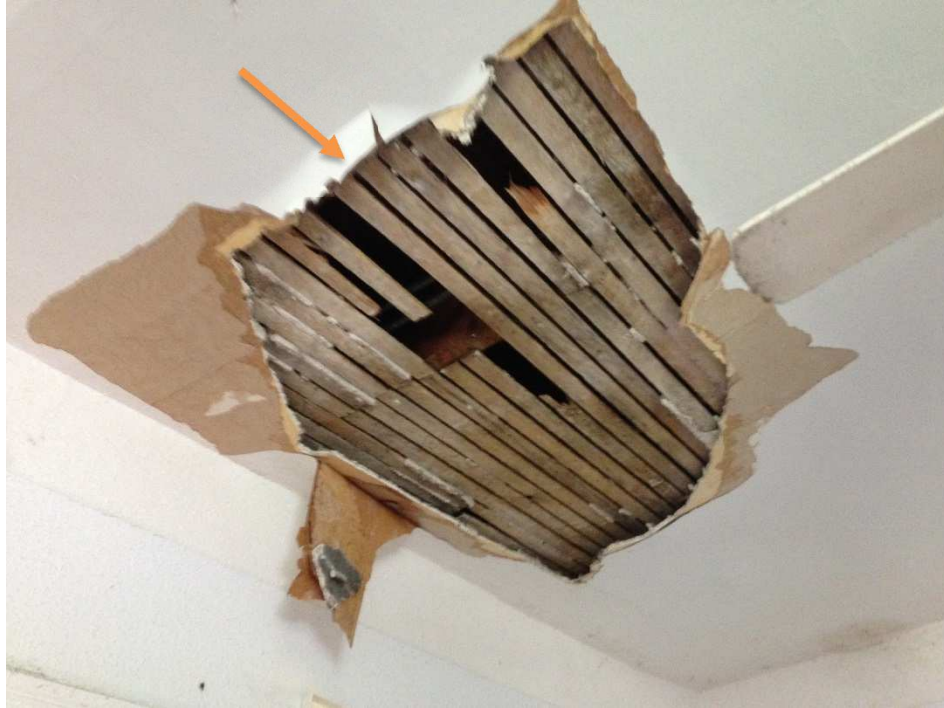
Picture 17 –Damage to Ceiling

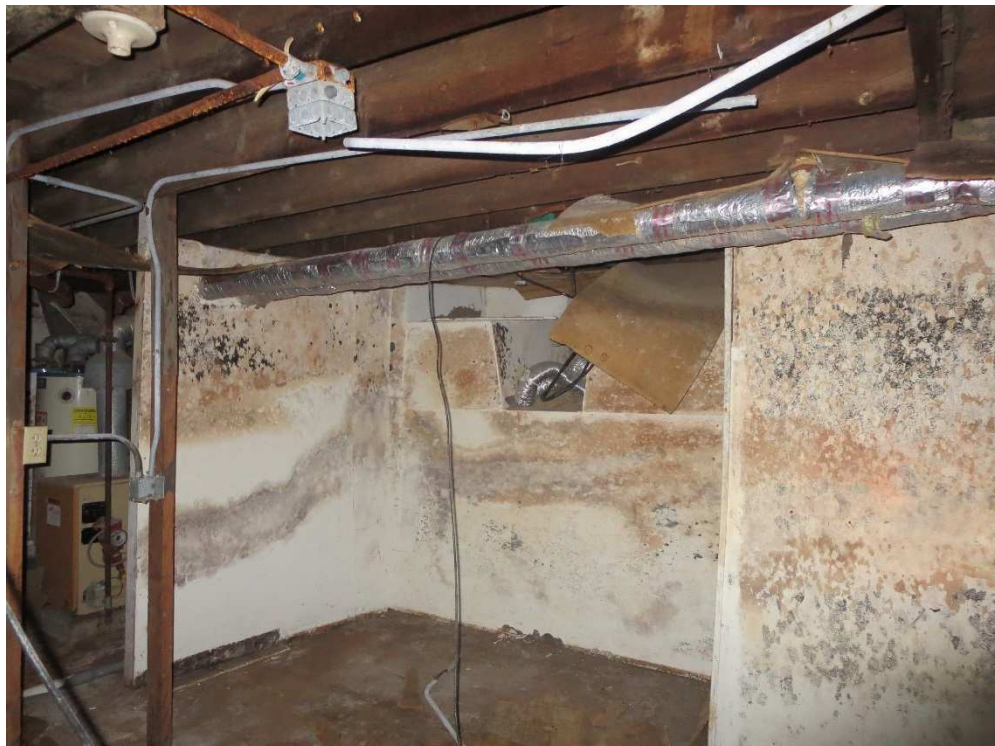
Picture 18 – Mold in Basement
