Summary Report of the Structural Assessment Fridley Pumping Station

April 2016

Assessment performed by: GEI Consultants Inc.

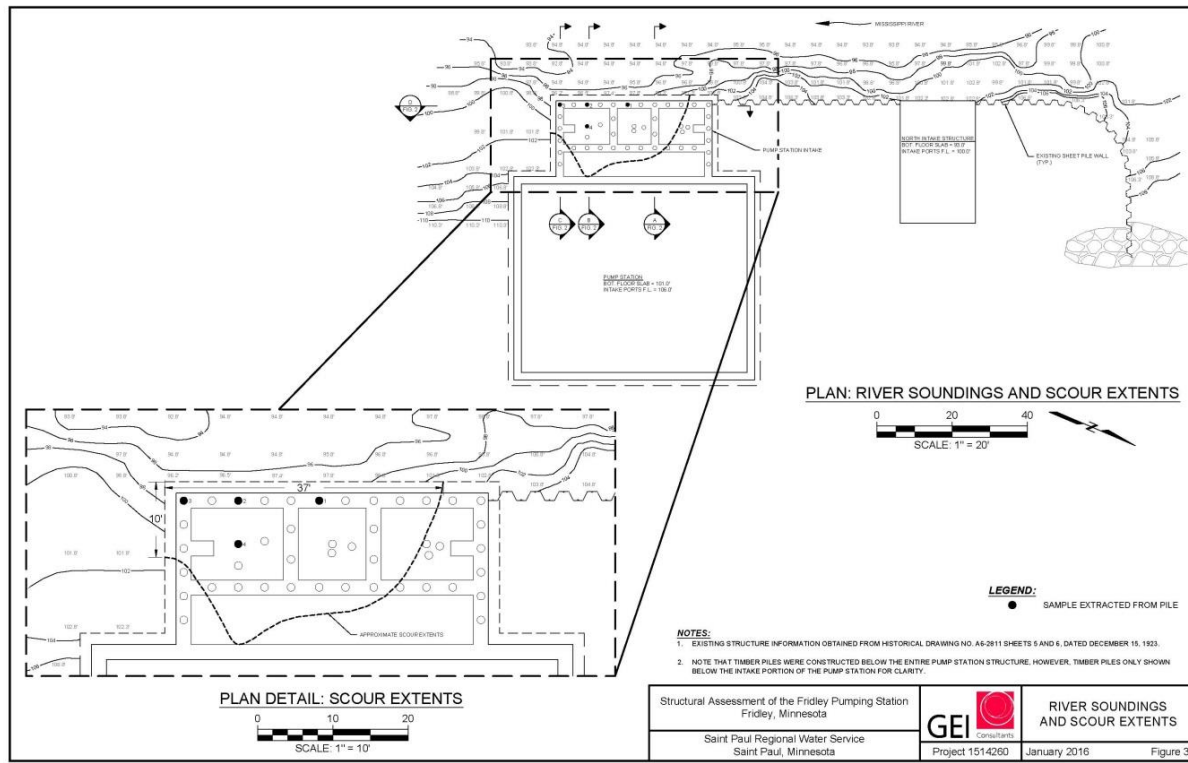
Figure 1: Extents of Scouring

- A review of the historical river soundings and scour extents show that the current limit of scour around the timber piles under the Pump Station has not noticeably increased since the early 1960s. The structure has functioned since that time without notable structural distress.

- Several options are presented to address the scour under the Pump Station, ranging from Do-Nothing, to forming and placing cementitious fill under the building.
