# Summary Report of the Structural Assessment Fridley Pumping Station

April 2016

Assessment performed by: GEI Consultants Inc.

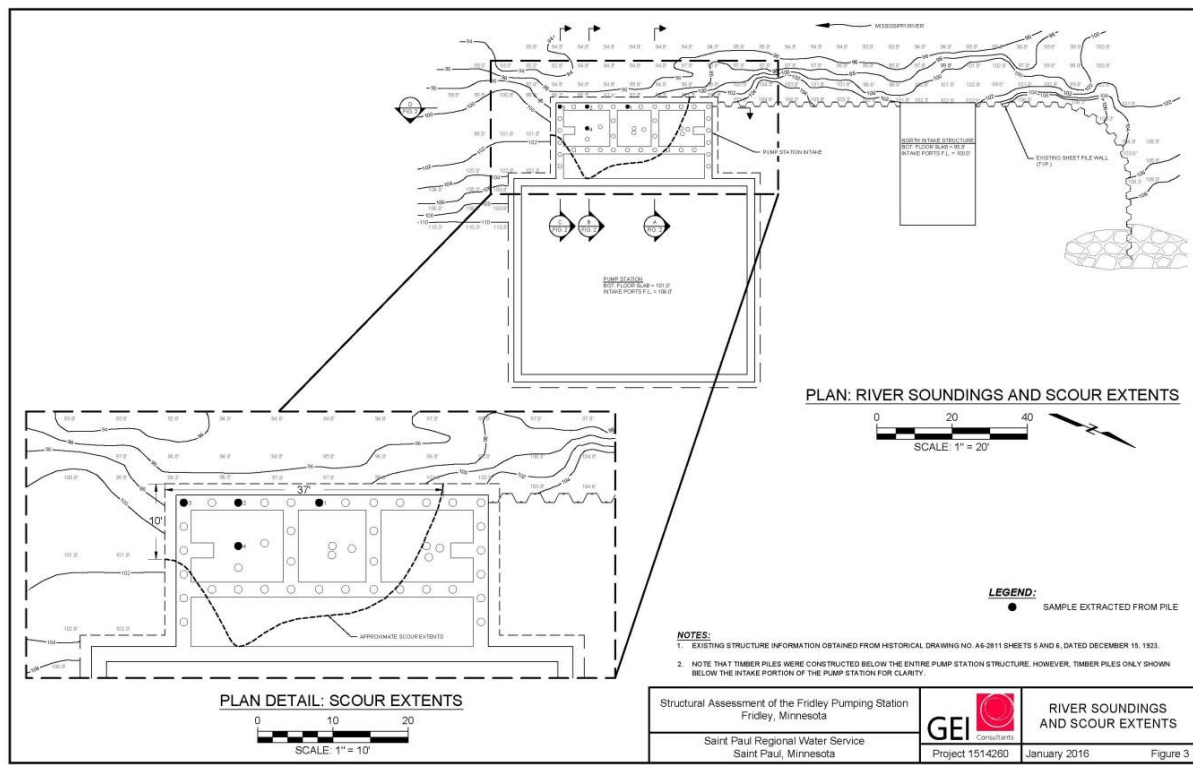
Figure 1: Extents of Scouring

- A review of the historical river soundings and scour extents show that the current limit of scour around the timber piles under the Pump Station has not noticeably increased since the early 1960s. The structure has functioned since that time without notable structural distress.

- Several options are presented to address the scour under the Pump Station, ranging from Do-Nothing, to forming and placing cementitious fill under the building.
