**Mattson
Macdonald
Young**
structural
engineers

February 10, 2016

RE: Foundation Assessment
956 Geranium Ave E
St. Paul, Minnesota

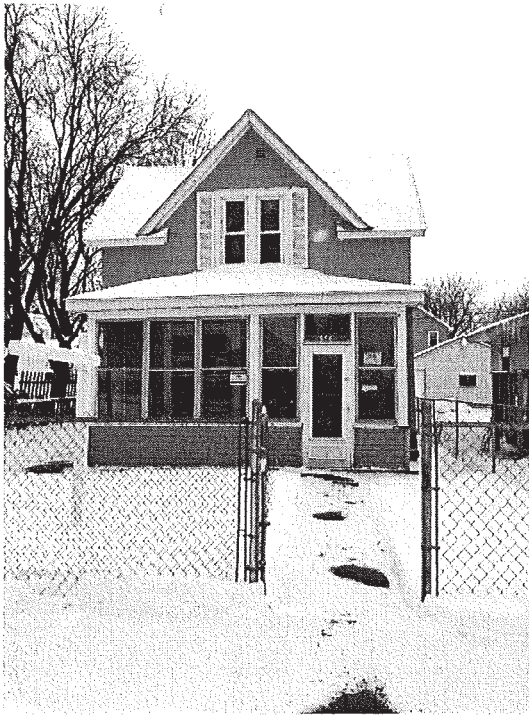
Photo 1 – North Elevation of 956 Geranium Ave

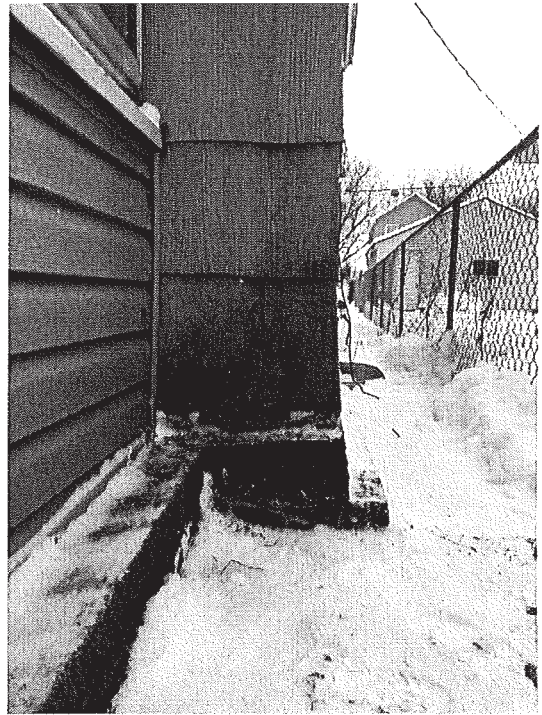
Along the perimeter of the house, a poured concrete ledge was visible, projecting out from the face of the exterior wall (see Photo 2). This ledge is a source of standing water which has been allowed to enter the rim joist and main floor framing members. The water intrusion appears to have resulted in damage/rot throughout the perimeter of the house (see Photo 3).

Photo 2 – Poured Concrete Ledge at Perimeter

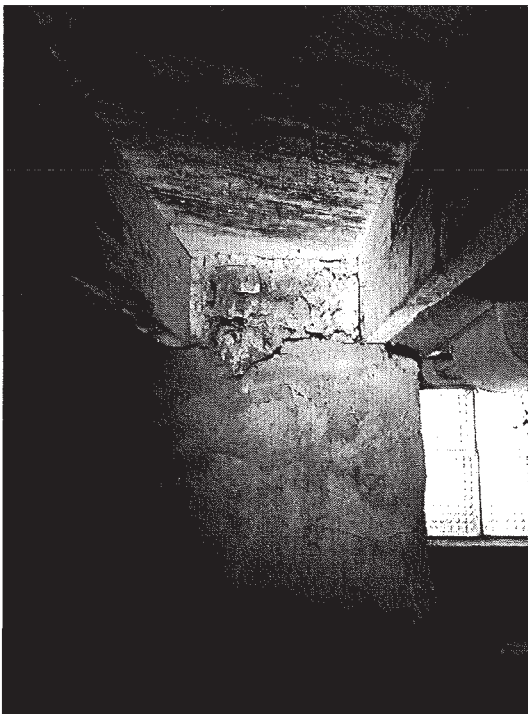
Photo 3 – Damaged/Rotted Wood Floor Joists

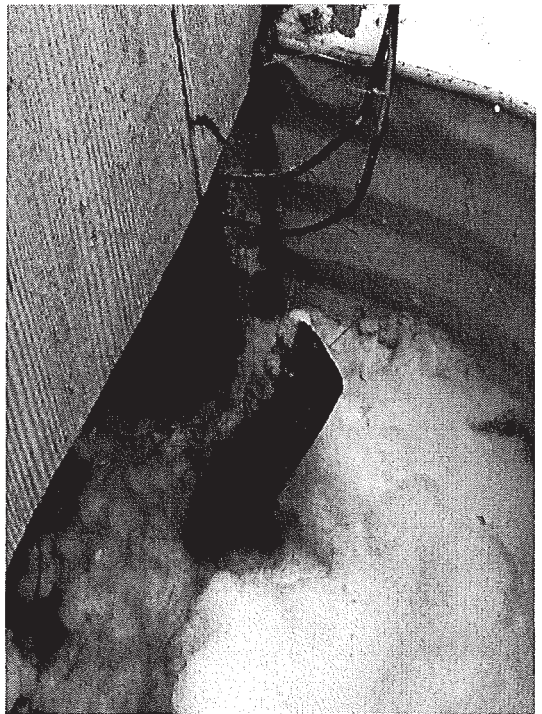
Other areas were noted as locations where water has been allowed to penetrate the foundation system. Poorly constructed window wells (see Photo 4), window sills located near exterior grade level (see Photo 5), and an exterior stair providing access to the lower level (see Photos 6 & 7) have all contributed to the moisture problem. In addition, the lower level stair structure did not appear to have adequate frost coverage at the foundation, so heave/settlement due to frost effects have also been an issue.

Photo 4 – Window Well with High Interior Grade Level

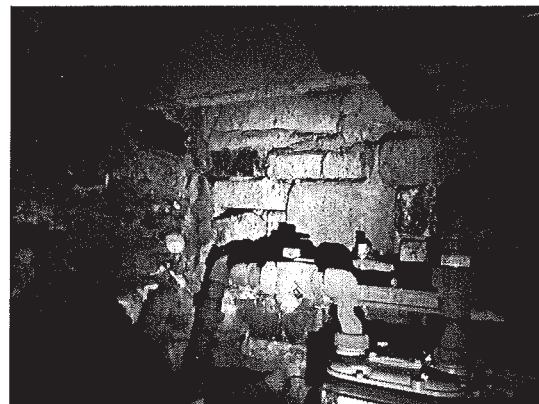
The majority of the existing stone foundation walls had been covered in a concrete/stucco parge coat, so identifying particular areas of deterioration was difficult. However, in locations where applying a finish was difficult, there are numerous signs of deterioration and settlement (see Photos 8 & 9).

Photo 8 – Cracked, Settling Stone/Brick Foundation Wall

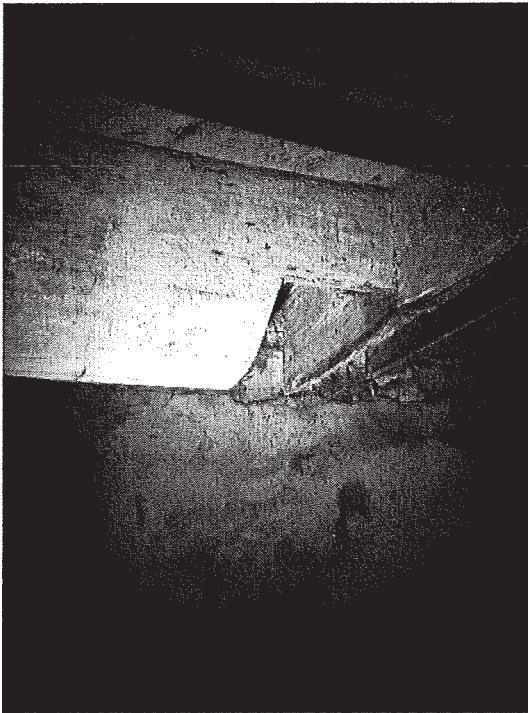
The main floor framing consisted of 2 x 8 floor joists, spaced at 16" o.c. In most areas, the joists were inadequately supported (no joist hangers, insufficient bearing length). Many of the headers over openings were undersized and in many cases, the joists were heavily notched or drilled (see Photos 10, 11 & 12), decreasing their load carrying capacity.

Photo 11 – Notched Floor Joist without Joist Hanger
