HERITAGE PRESERVATION COMMISSION DESIGN REVIEW APPLICATION

RE: 737 Plum Avenue Request for Demolition

Project No.: 15537.00
Re: Structural Condition Review of the building at 737 Plum St.

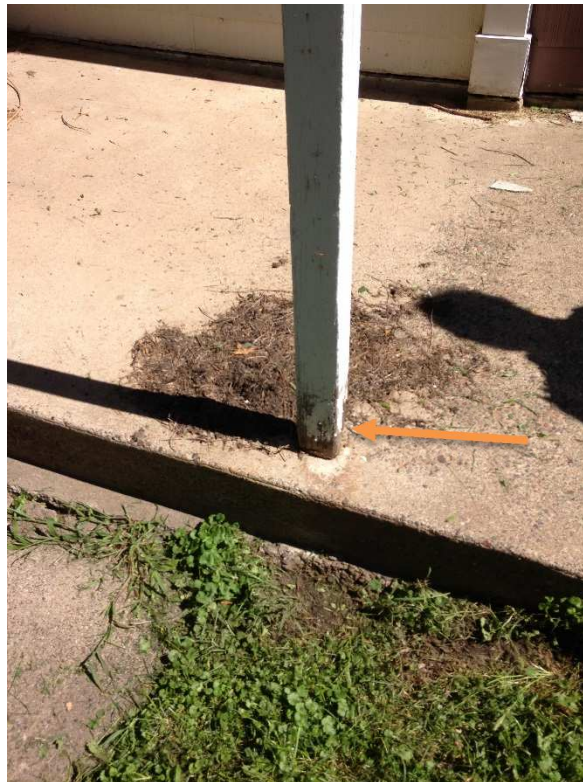
Picture 1 – Front Porch Post

The post at the front porch is loose. When a gentle force was applied to the post's base, it displaced one to two inches. Picture 1 shows the base of the post after the displacement occurred. The light patch on the concrete is the original location of the post. The easy displacement implies that it is no longer supporting any load. An awning is above the porch and was probably originally designed to be supported by the post. Picture 2 shows the front porch, including the top of the post and the awning.

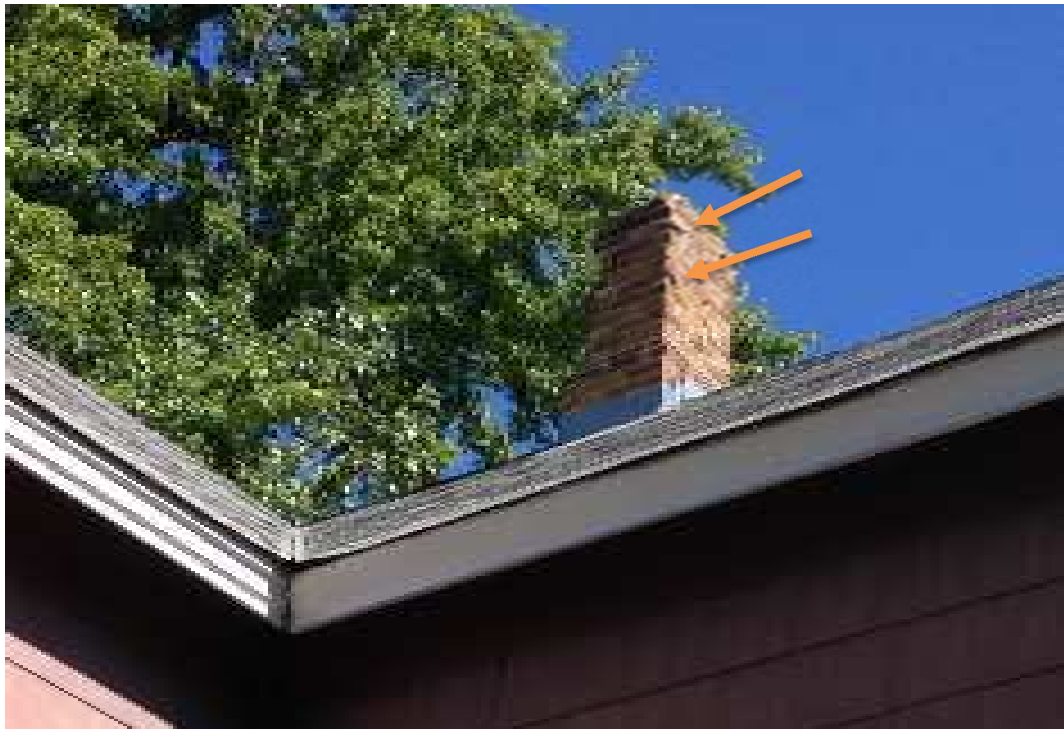
Picture 3 – Chimney in Center of House

The chimney above the main portion of the house may need to be repaired. Some of the bricks have been damaged and are missing pieces. Picture 3 shows the chimney as seen from the ground below, including a couple of the damaged pieces. We were unable to observe the top of the chimney more closely.

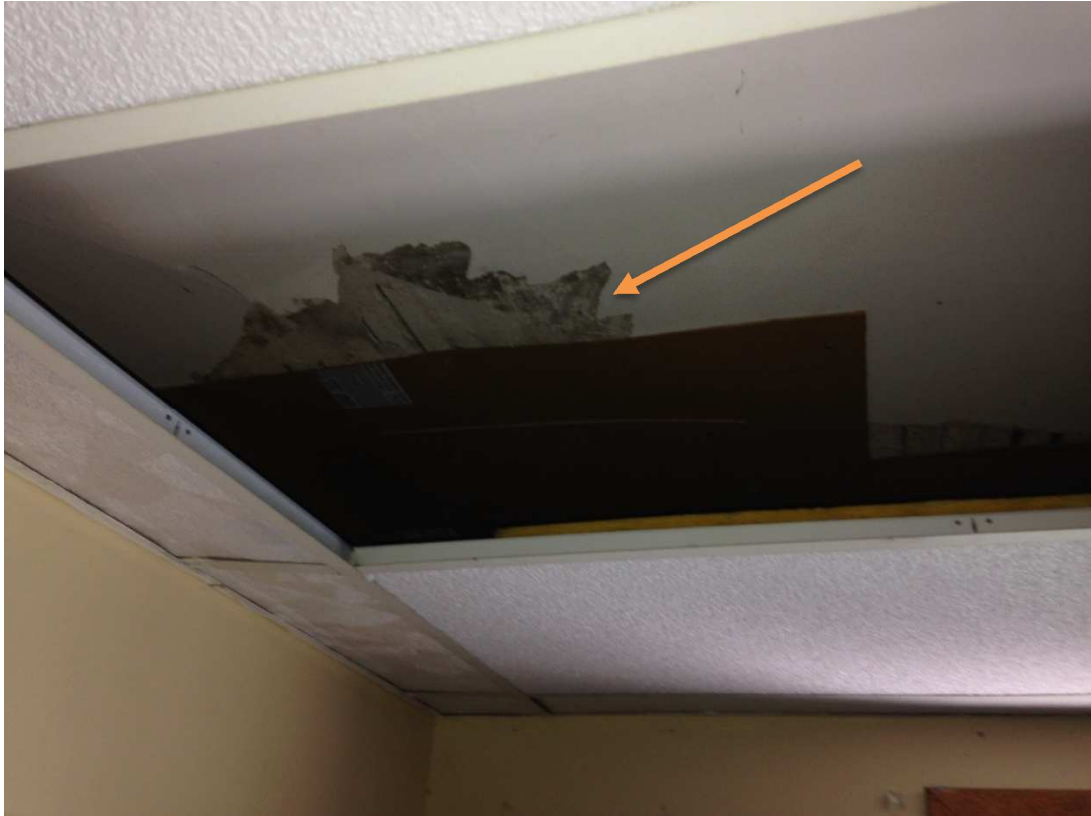
Picture 4 – Water Damage to 2nd Floor Ceiling

Water damage was observed in the ceiling of the 2nd floor. It is likely that the roof is damaged and allows water to get into the house. We were unable to review the roof to observe its condition. It is also likely that the water damage is more extensive than the one area that we were able to observe. There was a smell of mold present during our walkthrough suggesting that water damage and mold growth is prevalent throughout the house. Picture 4 shows the area of the 2nd floor that we were able to observe that has water damage.

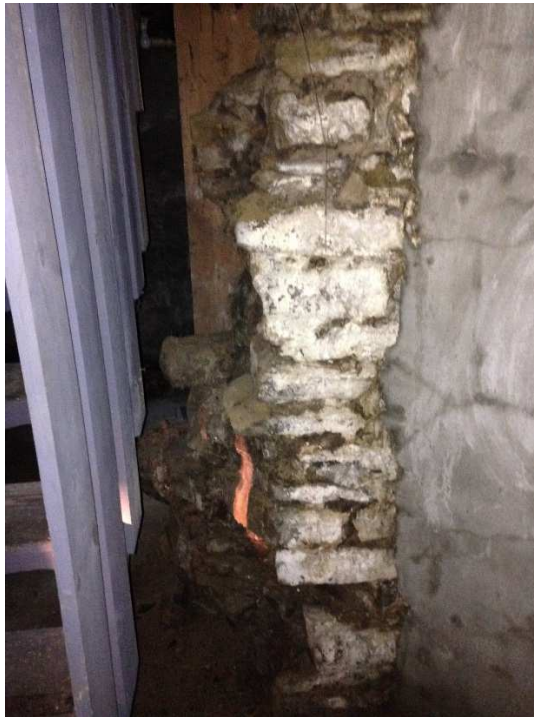
Picture 6 – Interior Foundation Walls

The interior foundation walls are different at different locations. This is likely due to the house being constructed in separate additions. The foundation walls appeared to be functional. Picture 6 shows the interior limestone foundation wall with a brick foundation wall behind it. Picture 7 shows a different foundation wall in the basement. It is relatively free of cracks and seems to be in good condition.

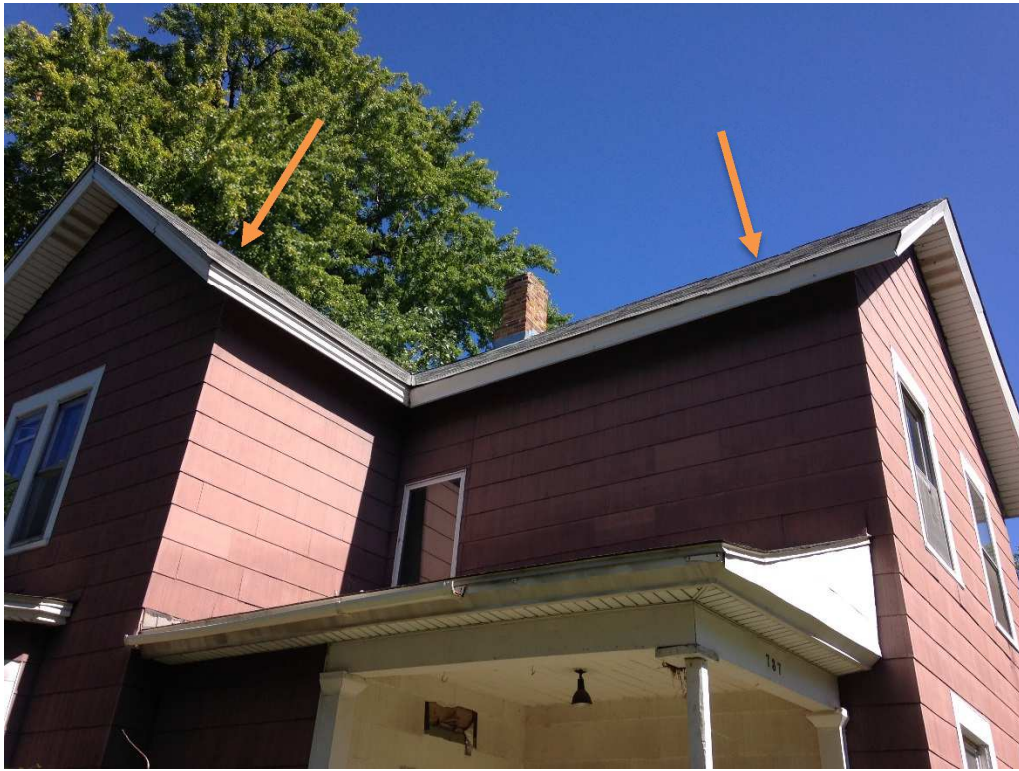
Picture 8 – House Roofs

The roof and exterior walls, as observed from the outside, appeared to be in good condition. The roof was flat and there were no obvious problems. The exterior walls appeared to be plumb. Picture 8 shows two such roofs and Picture 9 shows one such wall.
