HERITAGE PRESERVATION COMMISSION DESIGN REVIEW APPLICATION

RE: 737 Plum Avenue Request for Demolition

Project No.: 15537.00
Re: Structural Condition Review of the building at 737 Plum St.

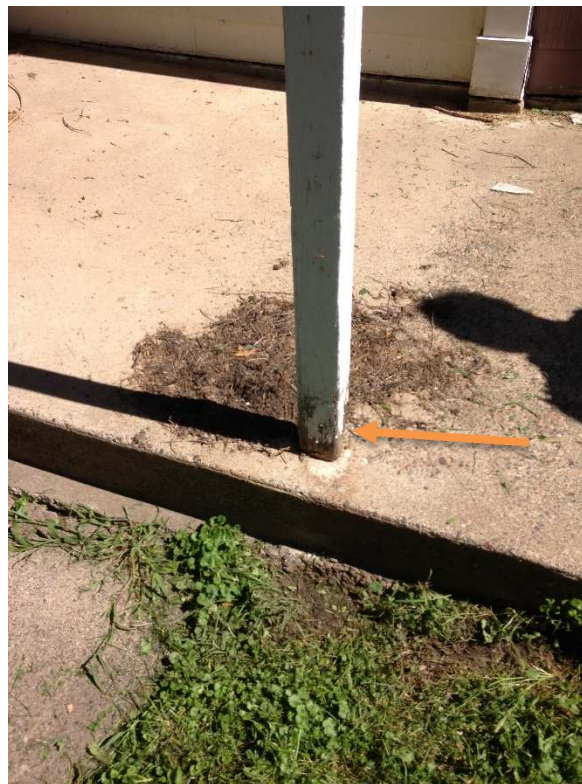
The post at the front porch is loose. When a gentle force was applied to the post's base, it displaced one to two inches. Picture 1 shows the base of the post after the displacement occurred. The light patch on the concrete is the original location of the post. The easy displacement implies that it is no longer supporting any load. An awning is above the porch and was probably originally designed to be supported by the post. Picture 2 shows the front porch, including the top of the post and the awning.

Picture 1 – Front Porch Post

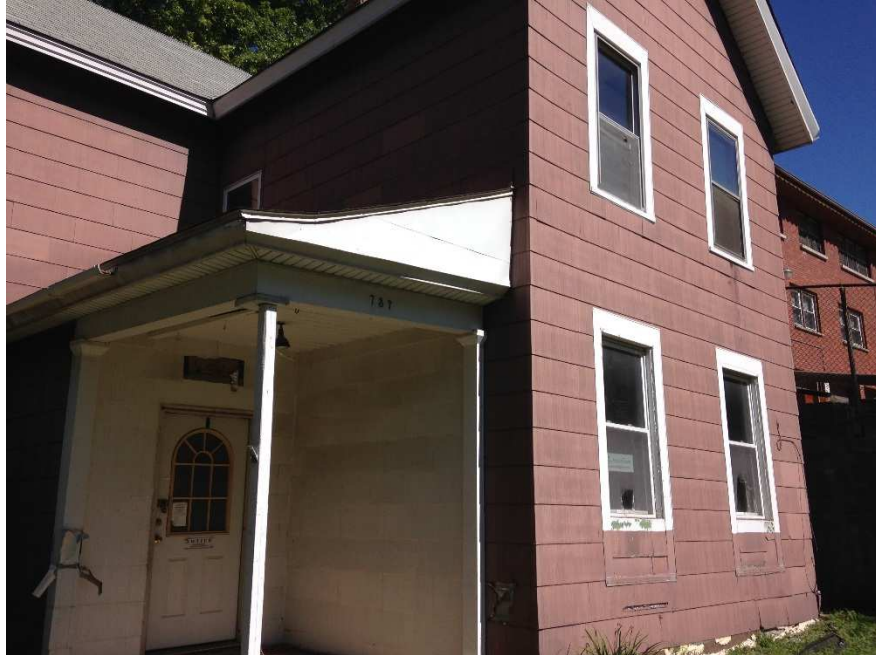
Picture 2 – Front Porch

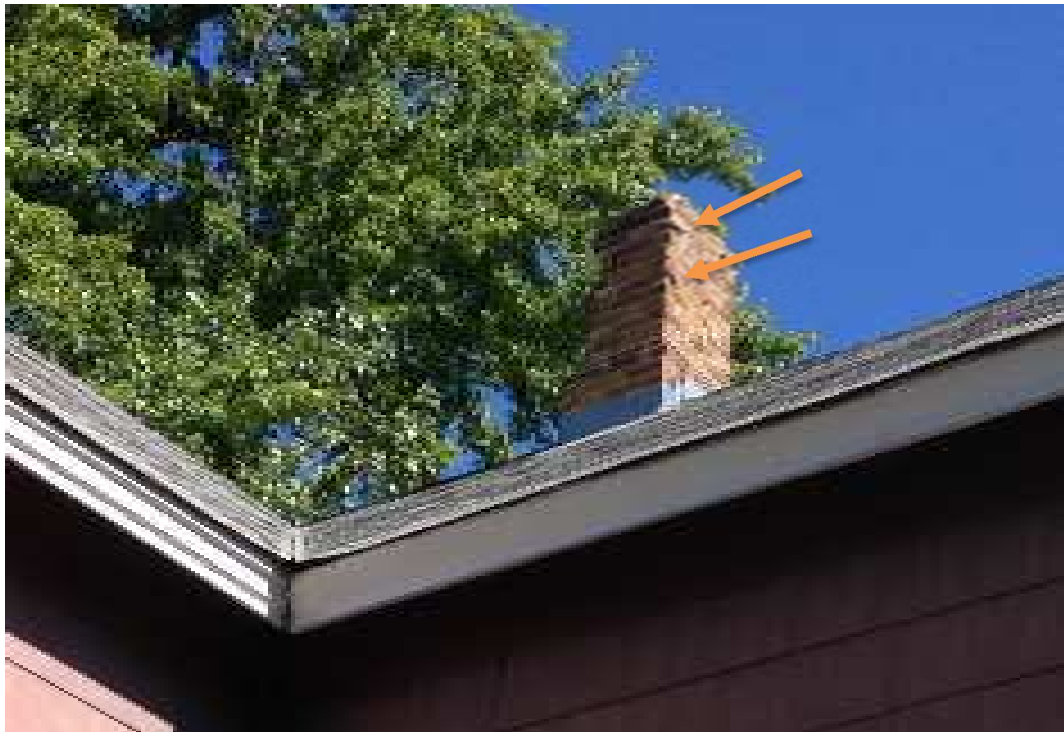
The chimney above the main portion of the house may need to be repaired. Some of the bricks have been damaged and are missing pieces. Picture 3 shows the chimney as seen from the ground below, including a couple of the damaged pieces. We were unable to observe the top of the chimney more closely.

Picture 3 – Chimney in Center of House

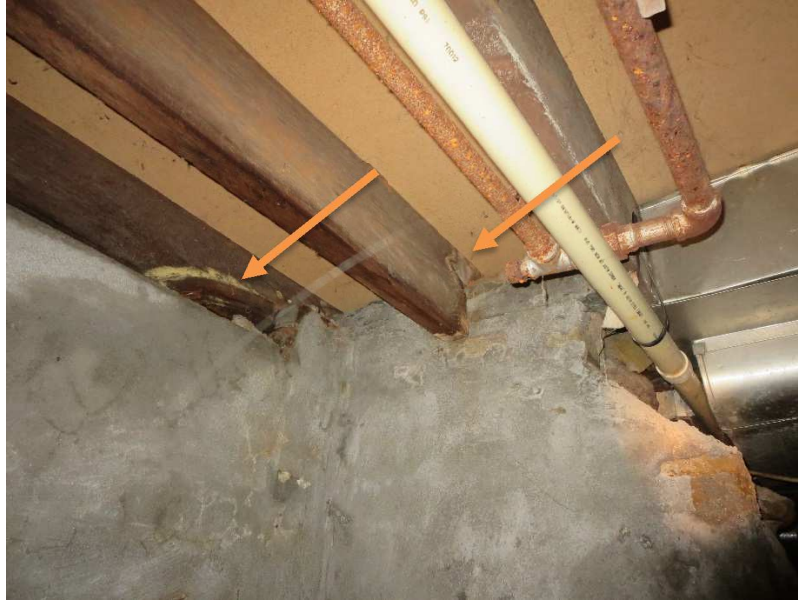
Many of the joists are rotting in the basement. Much of the damage is located where the joists bear on the foundation wall. Picture 5 shows two such joists.

Picture 5 – Joists Bearing on Foundation Wall

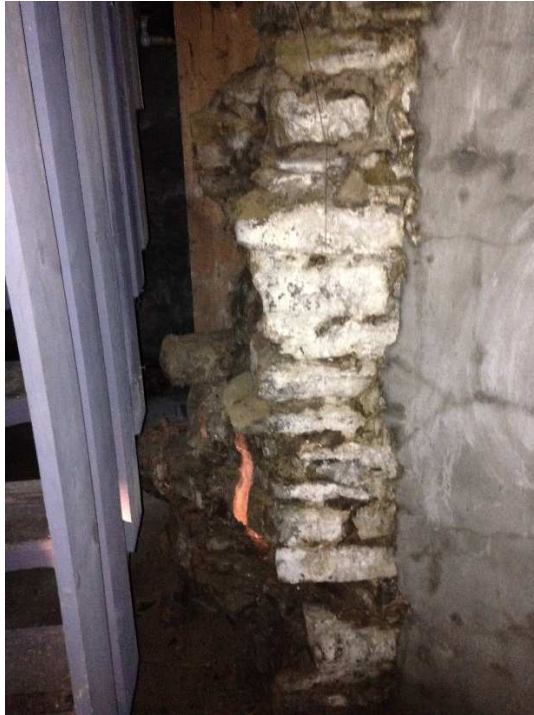
The interior foundation walls are different at different locations. This is likely due to the house being constructed in separate additions. The foundation walls appeared to be functional. Picture 6 shows the interior limestone foundation wall with a brick foundation wall behind it. Picture 7 shows a different foundation wall in the basement. It is relatively free of cracks and seems to be in good condition.

Picture 6 – Interior Foundation Walls

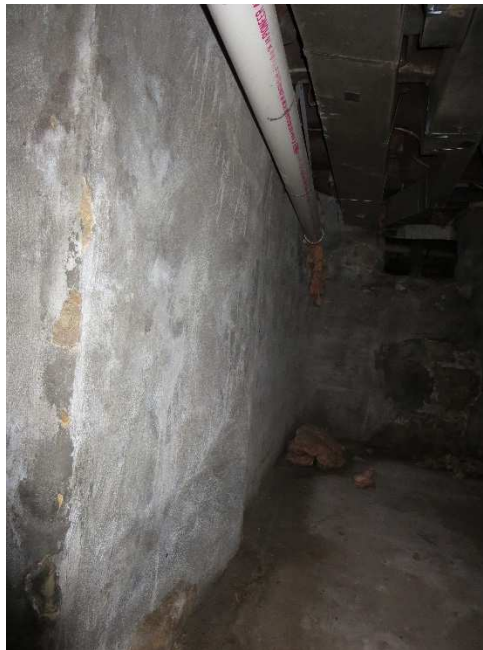
Picture 7 – Interior Foundation Walls

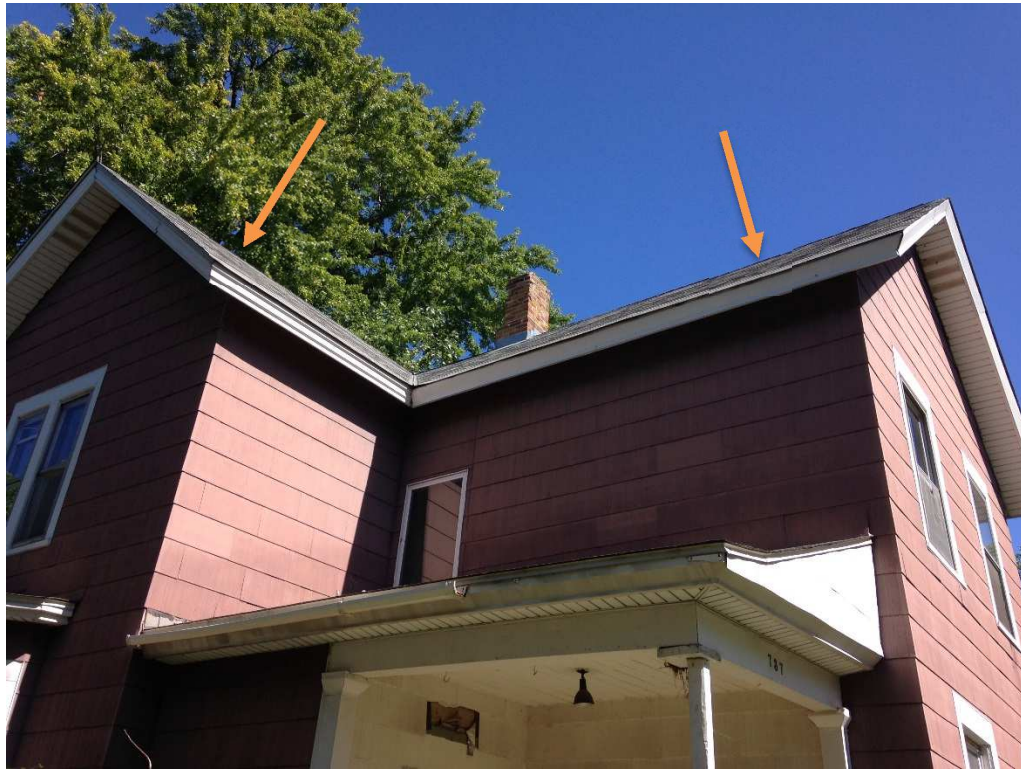
The roof and exterior walls, as observed from the outside, appeared to be in good condition. The roof was flat and there were no obvious problems. The exterior walls appeared to be plumb. Picture 8 shows two such roofs and Picture 9 shows one such wall.

Picture 8 – House Roofs

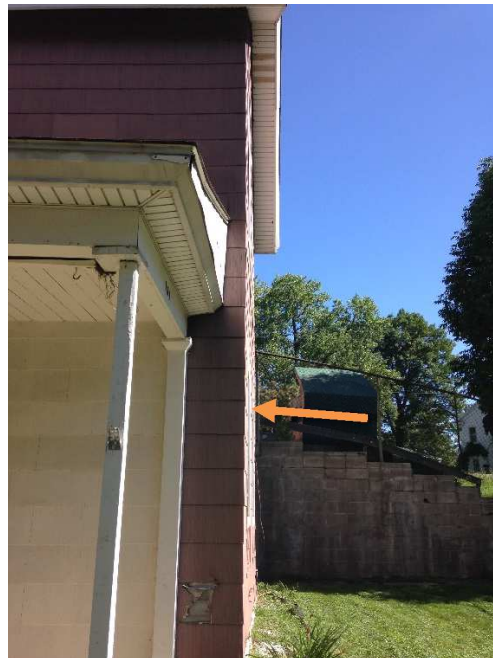
Picture 9 – House Exterior Wall
