737 Plum Street south elevation (above) and southwest elevations (below)

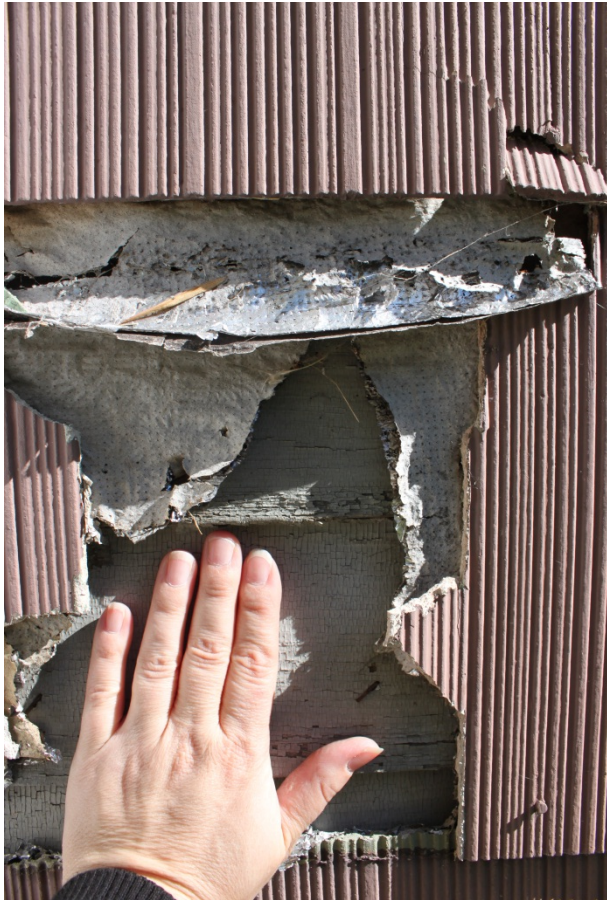
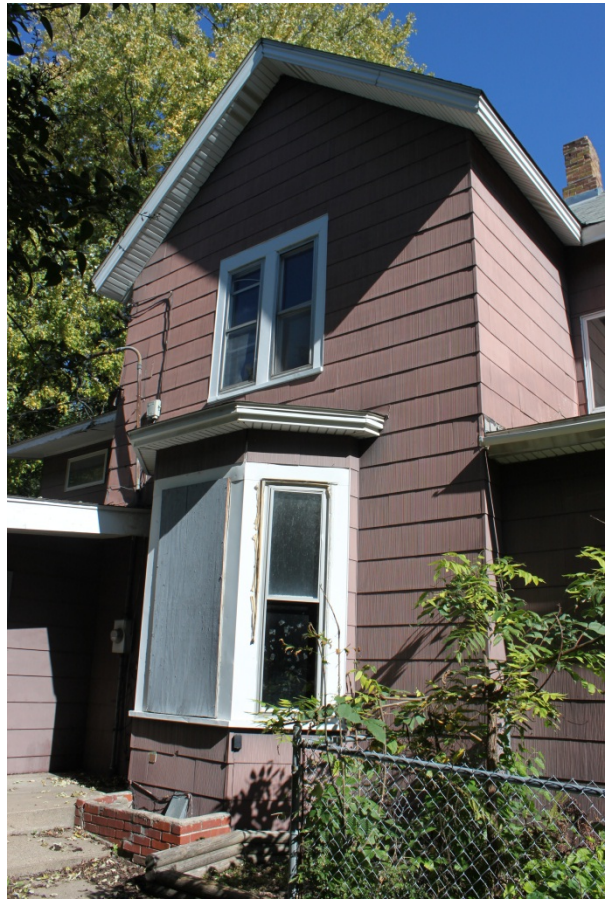
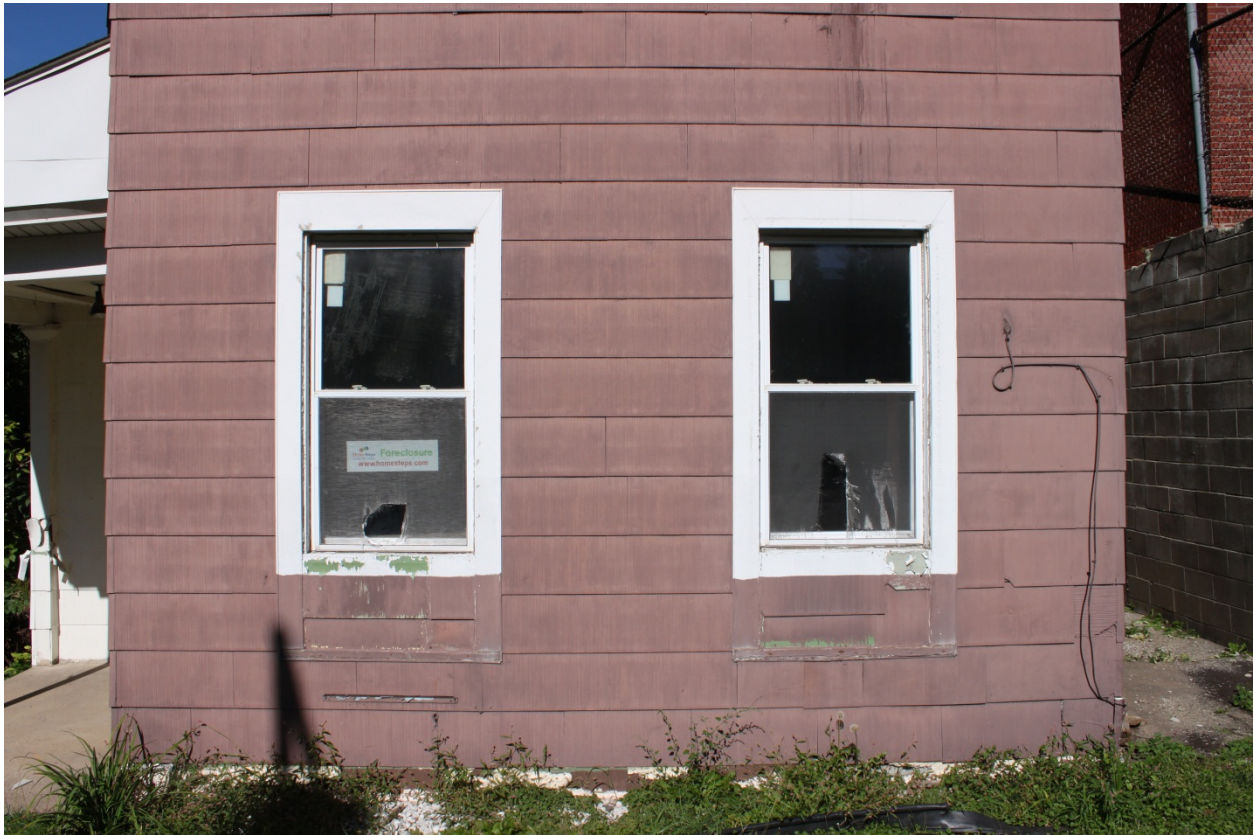
Exposed 4" clapboard beneath cement asbestos shingle (above left), west elevation with projecting bay (above right), and blocked-in windows on south elevation (below)

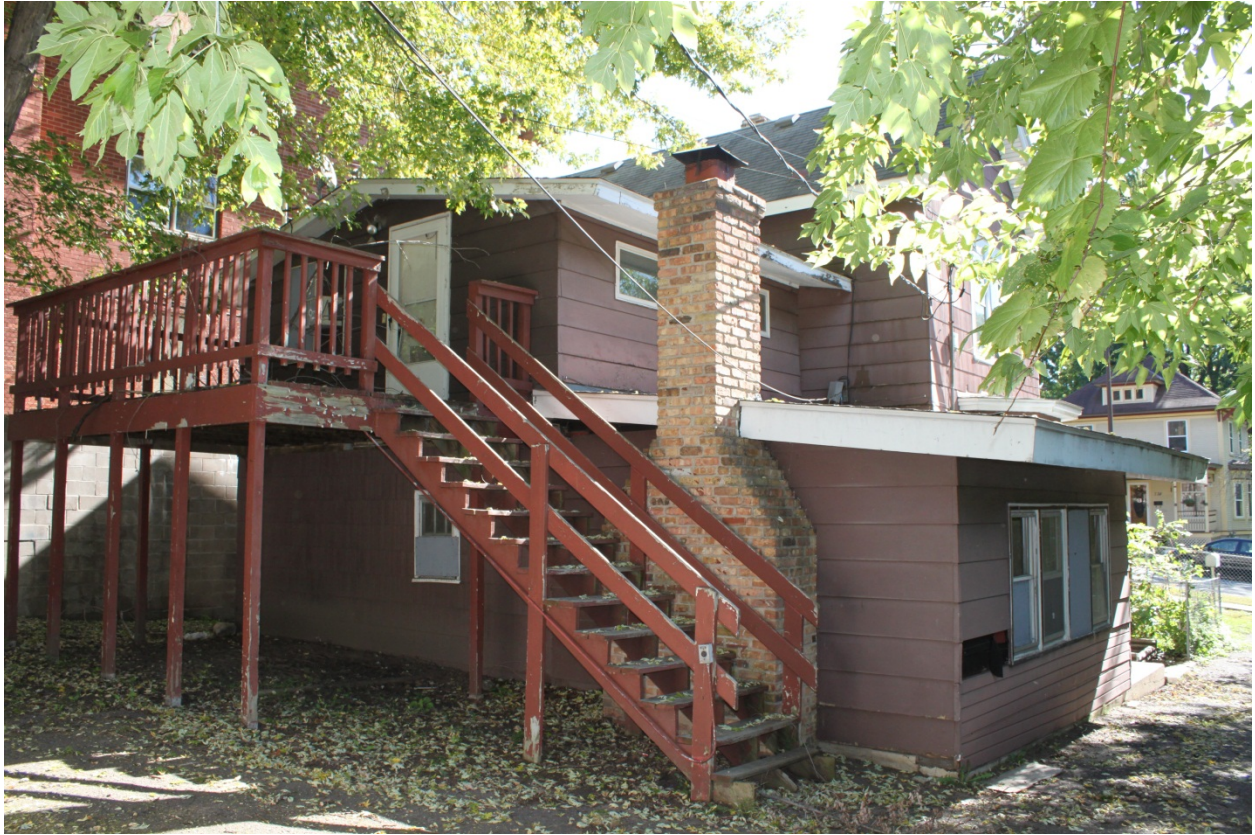
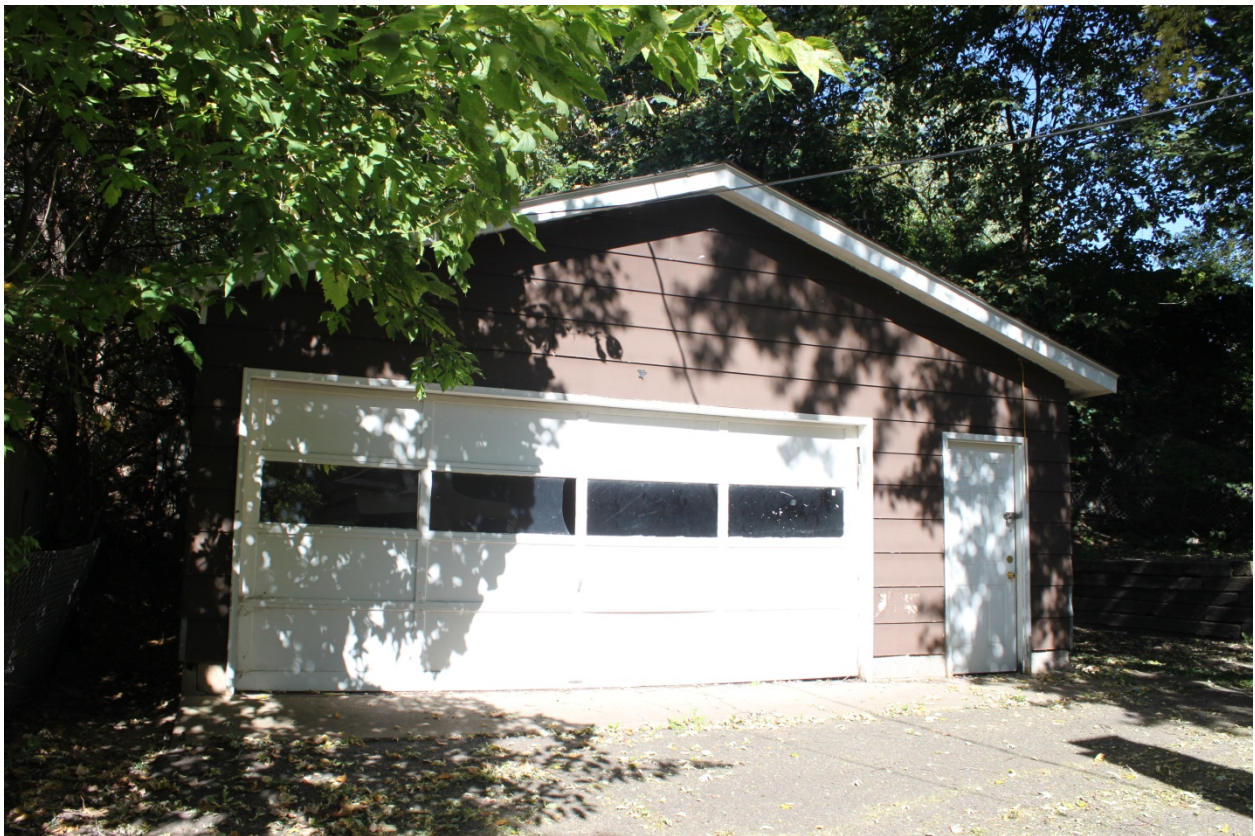
C. 1970 rear addition (above) and garage (below)

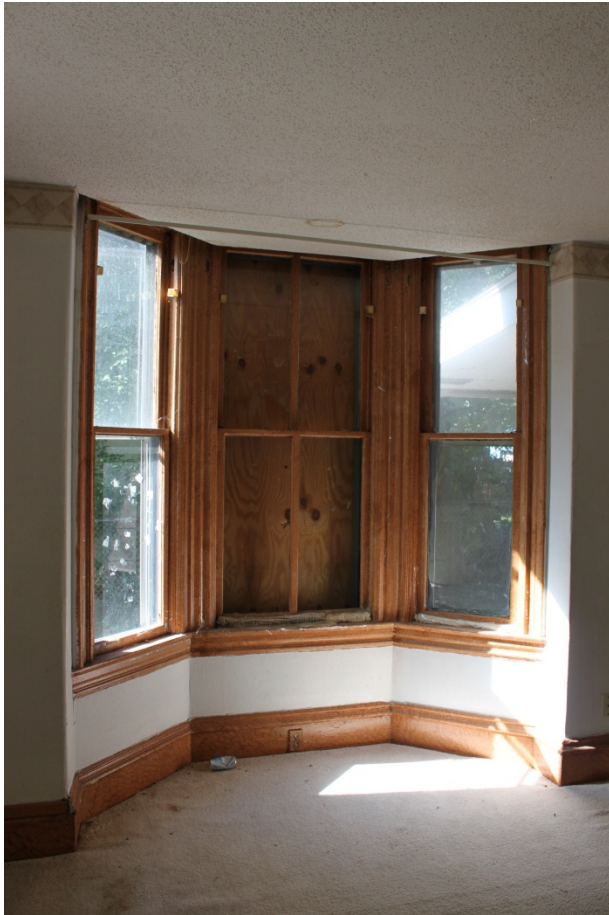
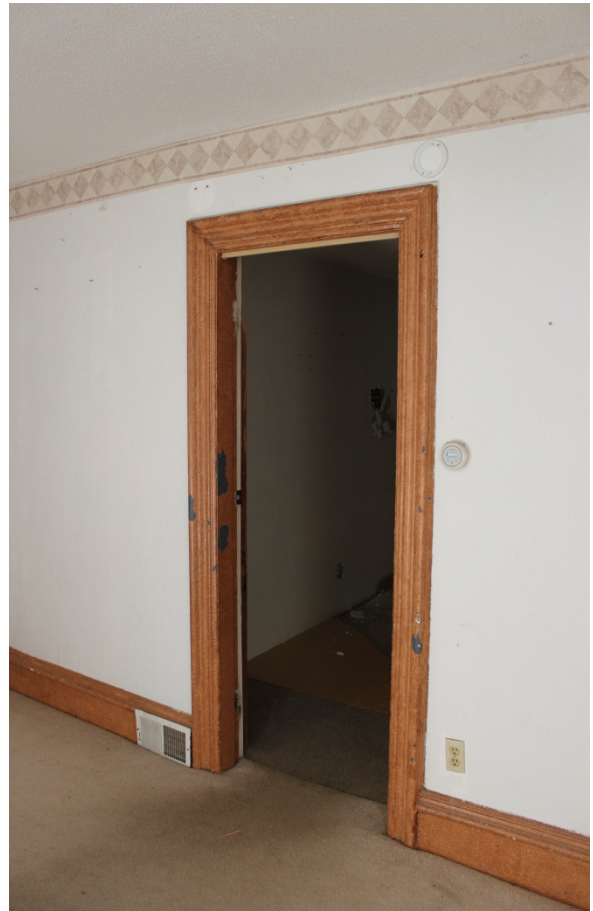
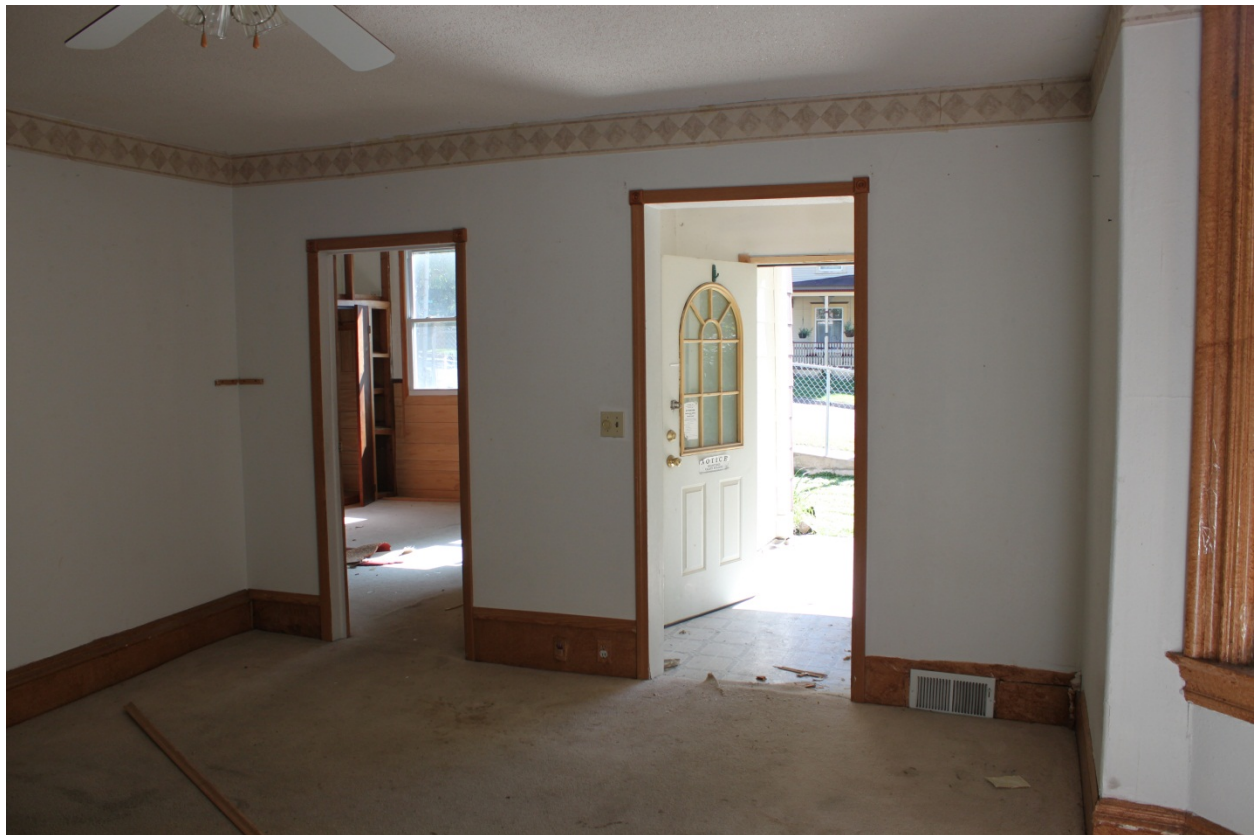
Dining Room west projecting bay window (above left), door trim (above right), and view towards front room (below)

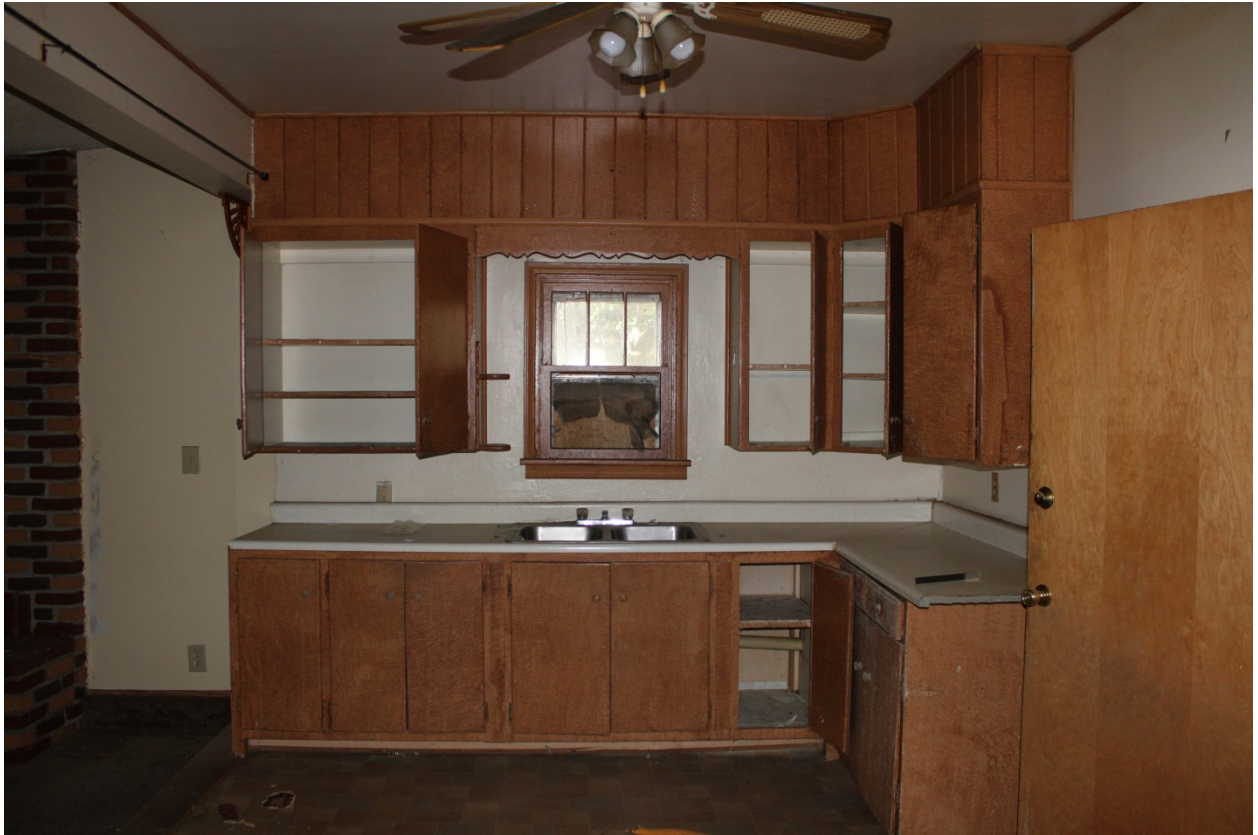
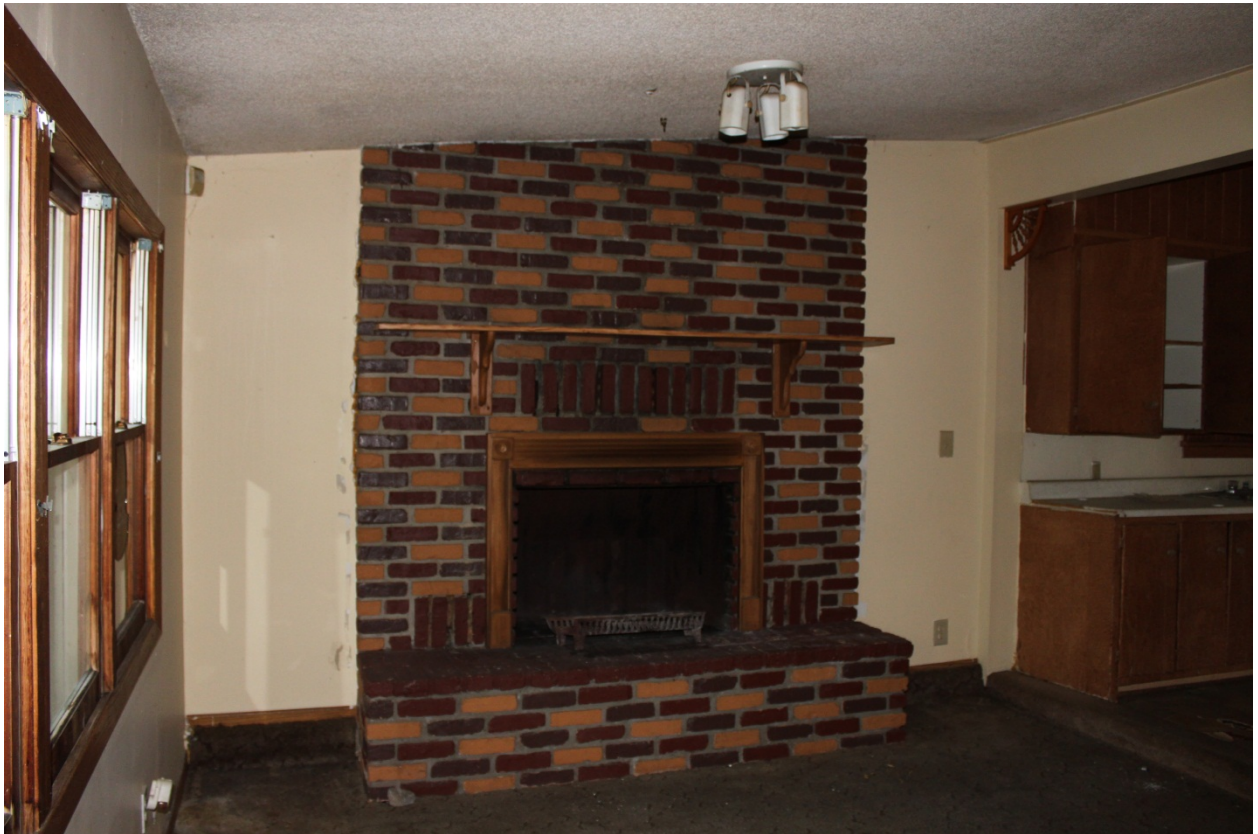
Rear addition kitchen (above) and den (below)

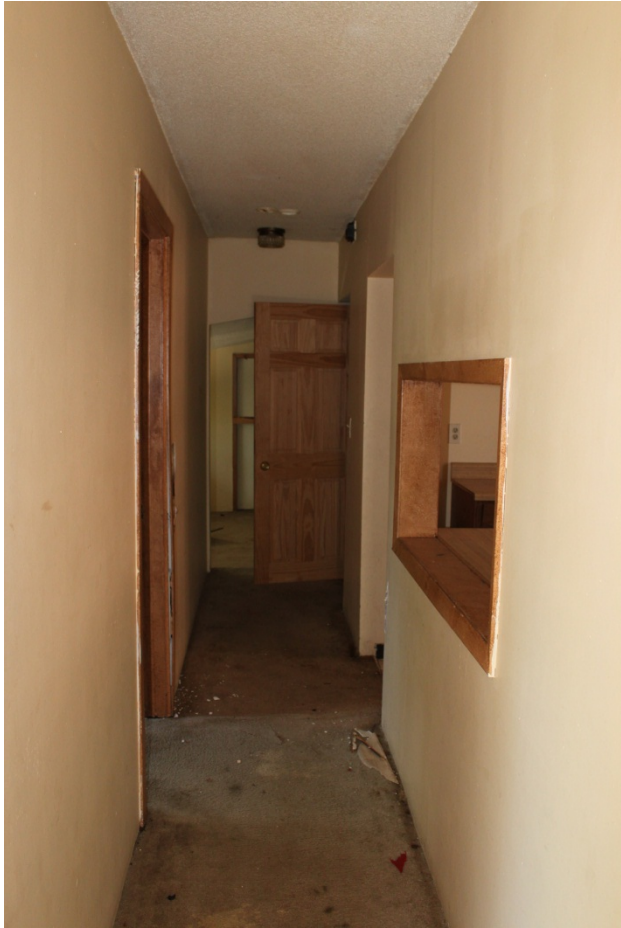
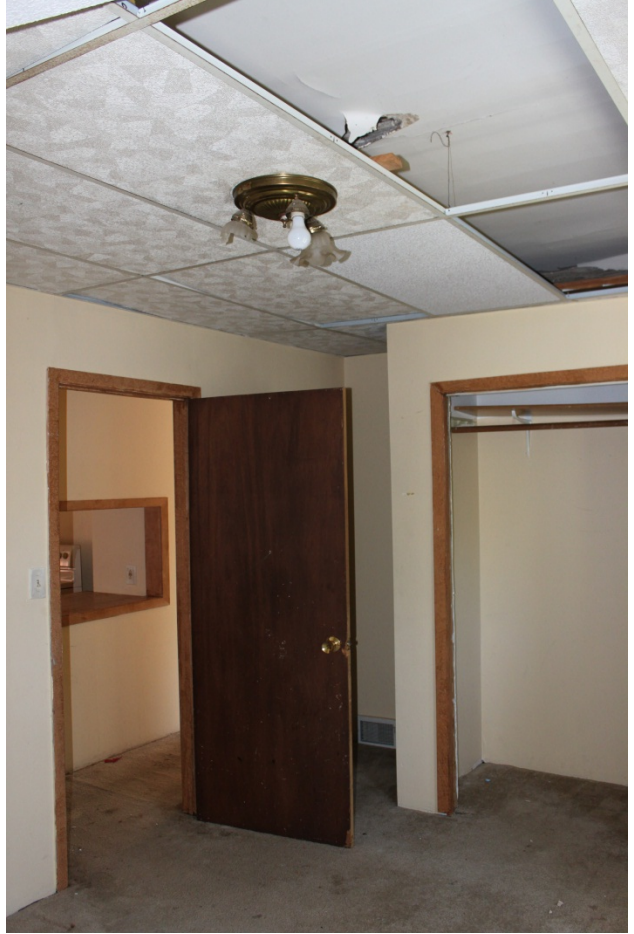
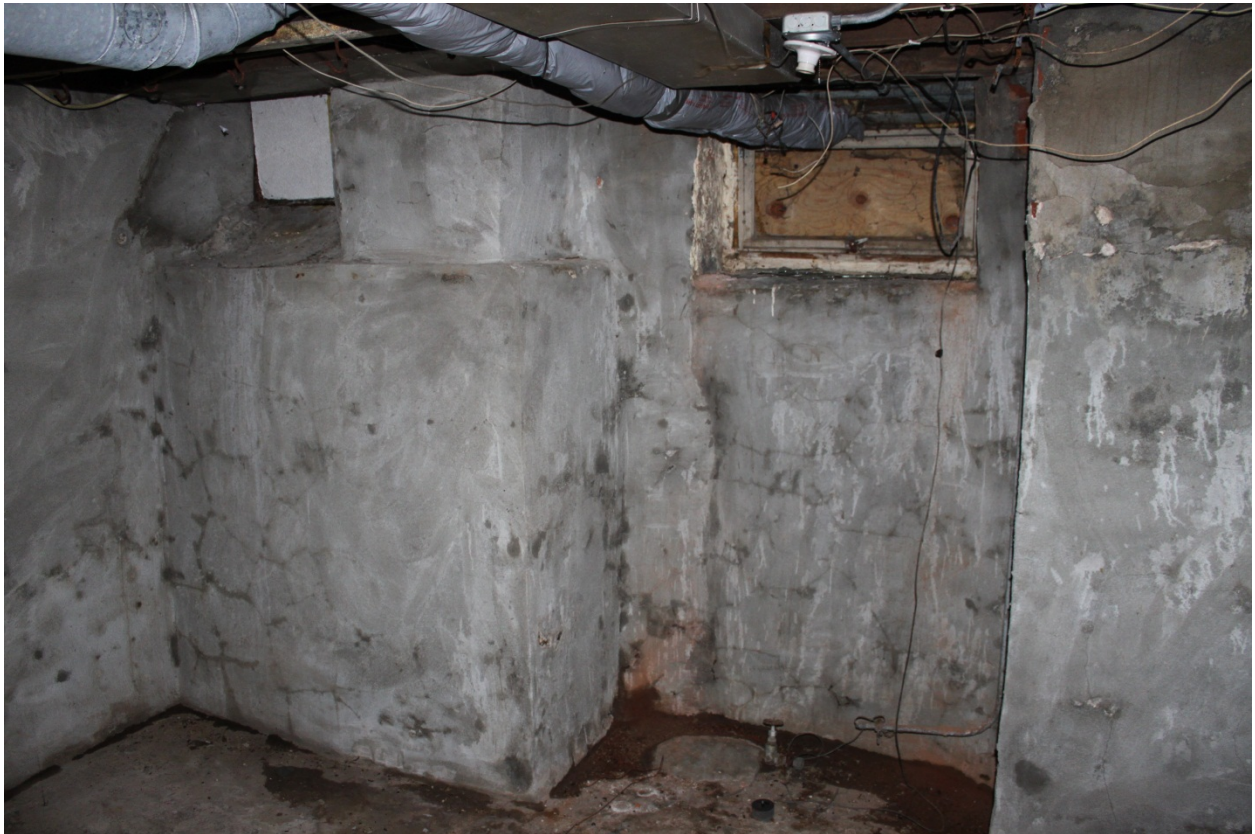
Upstairs hallway (above left), west upstairs bedroom (above right) with dropped ceiling detail, and basement (below)
