**Date:** January 17, 2019  
**File #:** 16 - 032685  
**Folder Name:** 455 GRAND AVE  
**PIN:** 012823310114

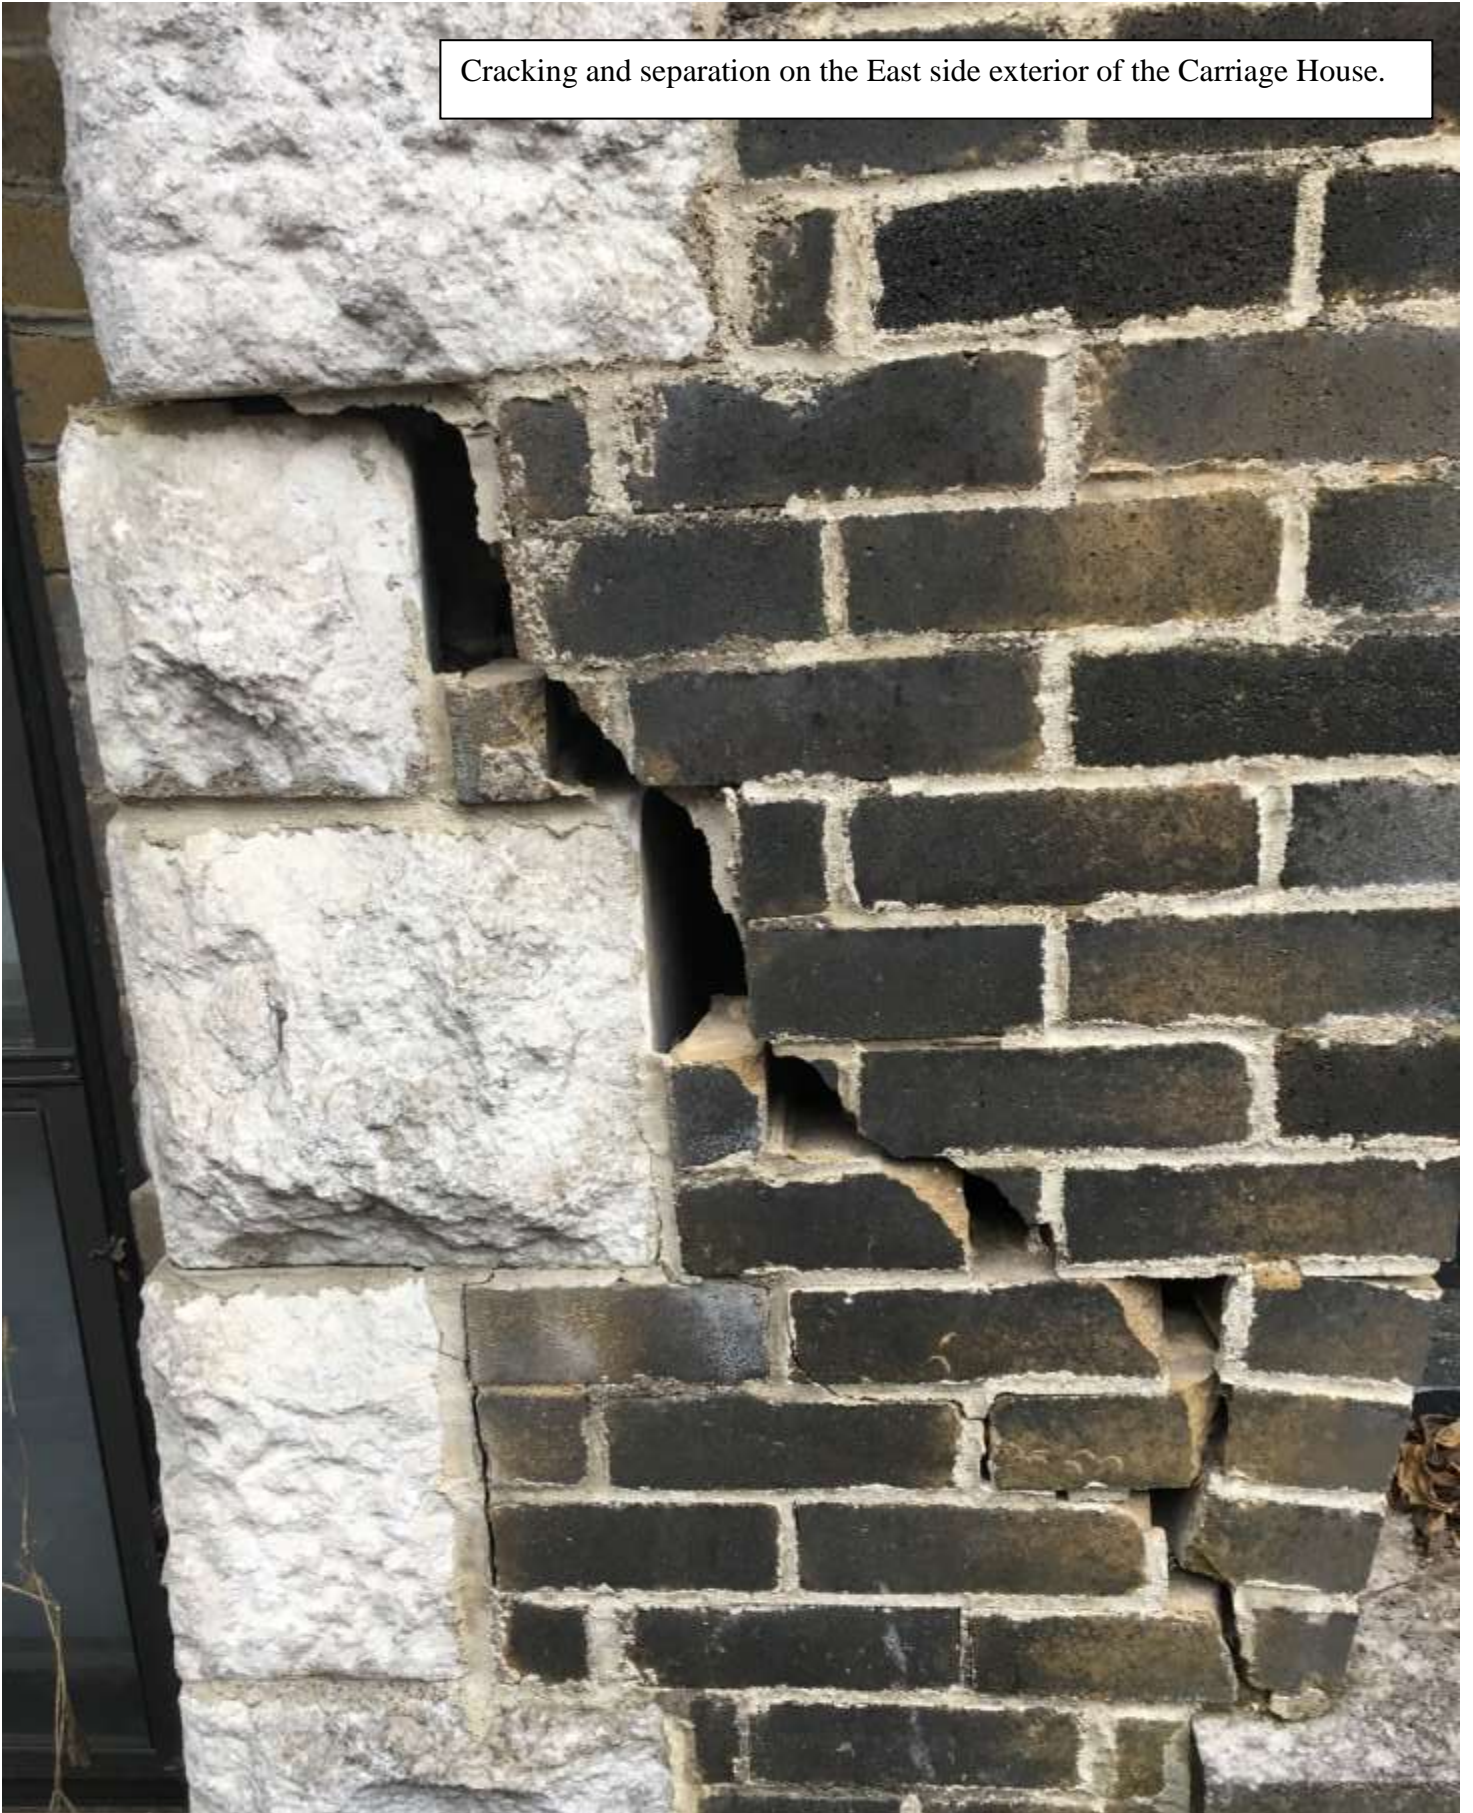
Cracking and separation on the East side exterior of the Carriage House.

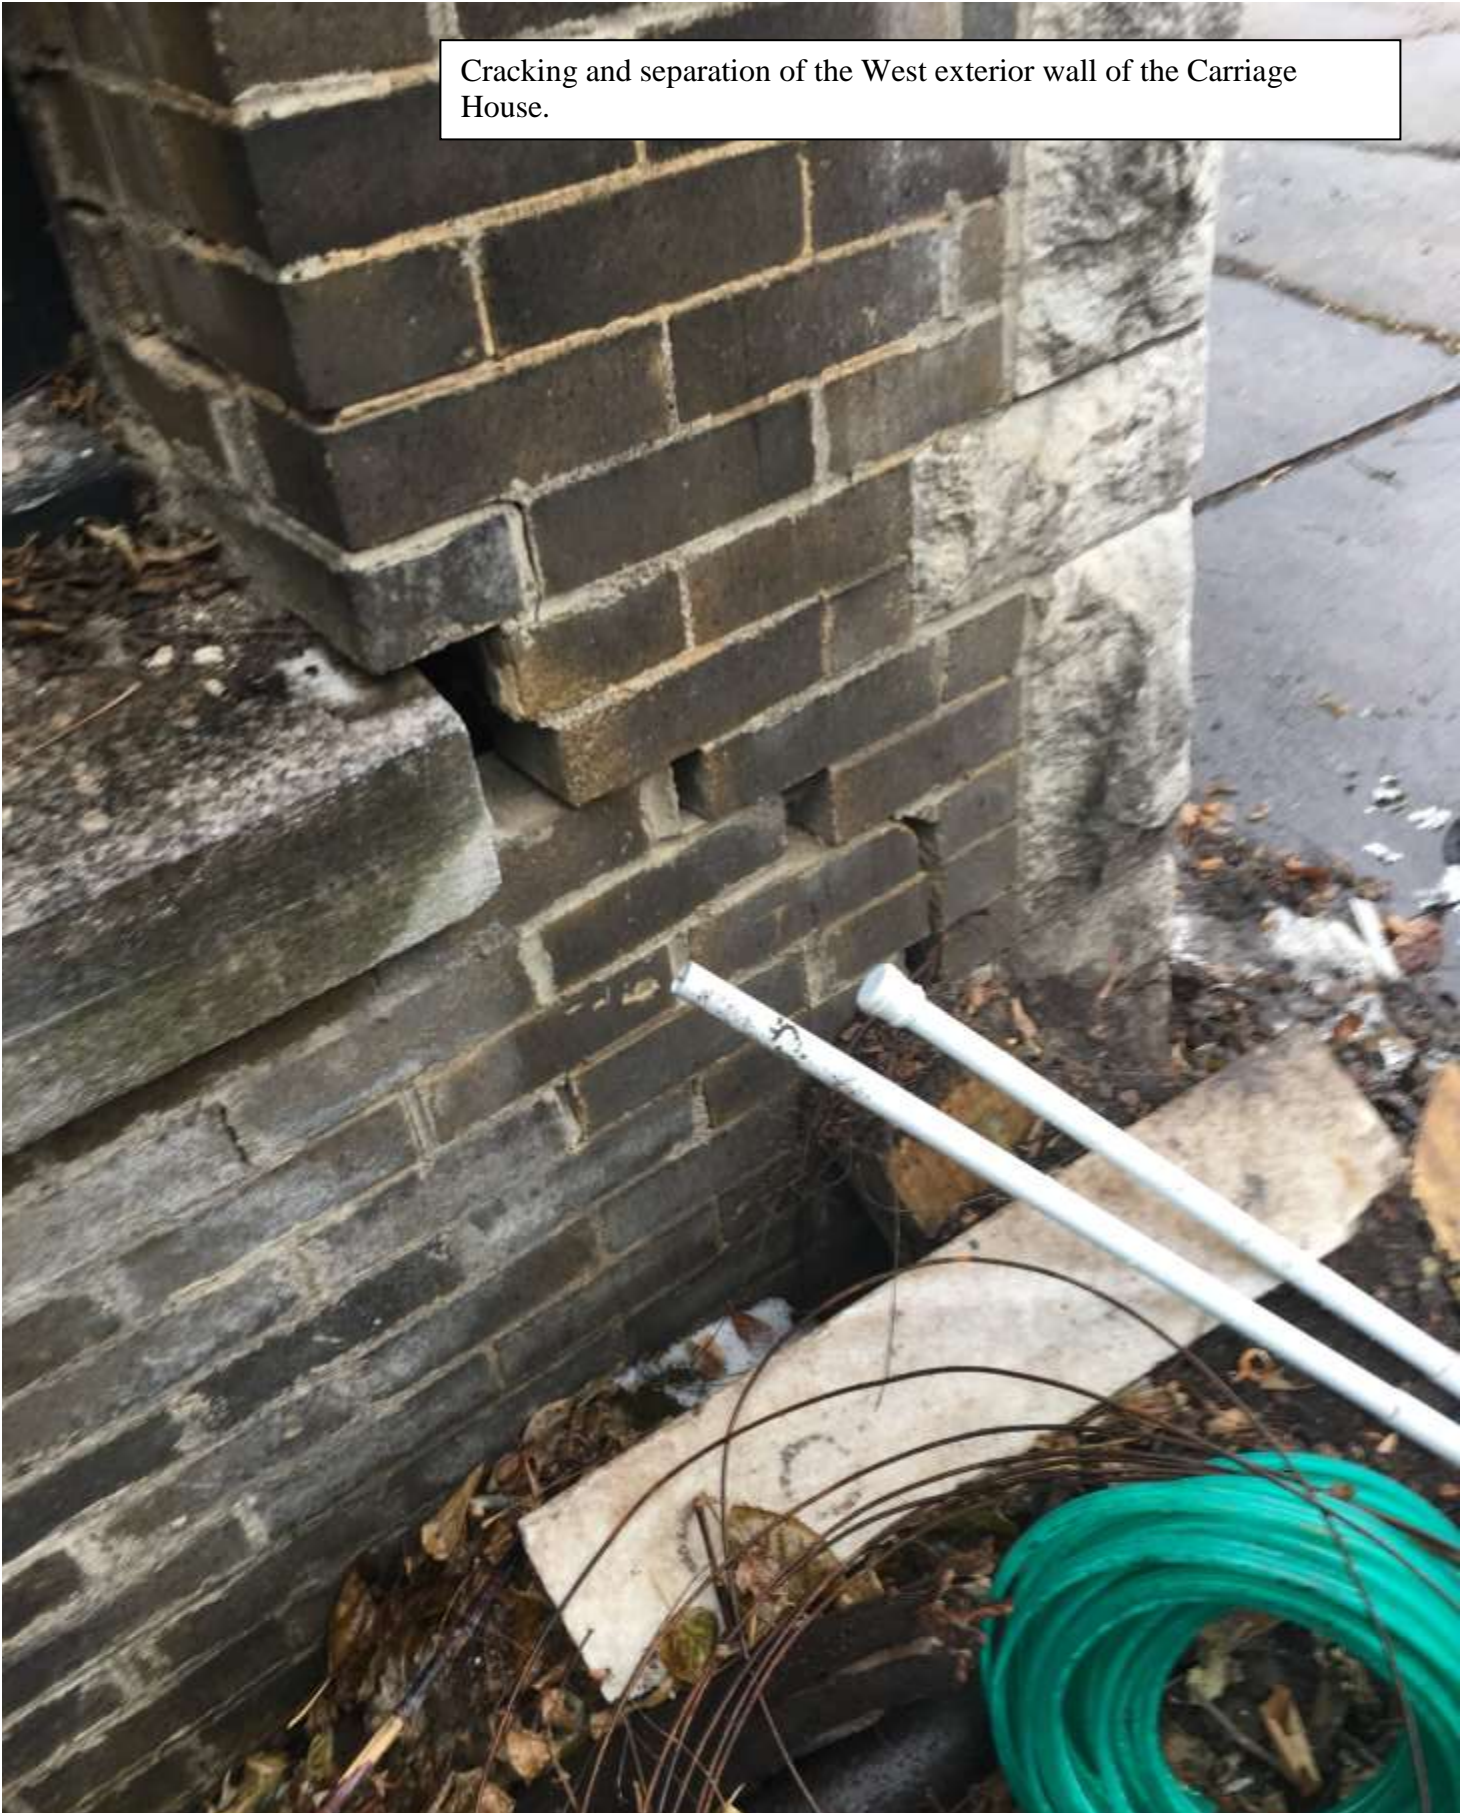
Cracking and separation of the West exterior wall of the Carriage House.

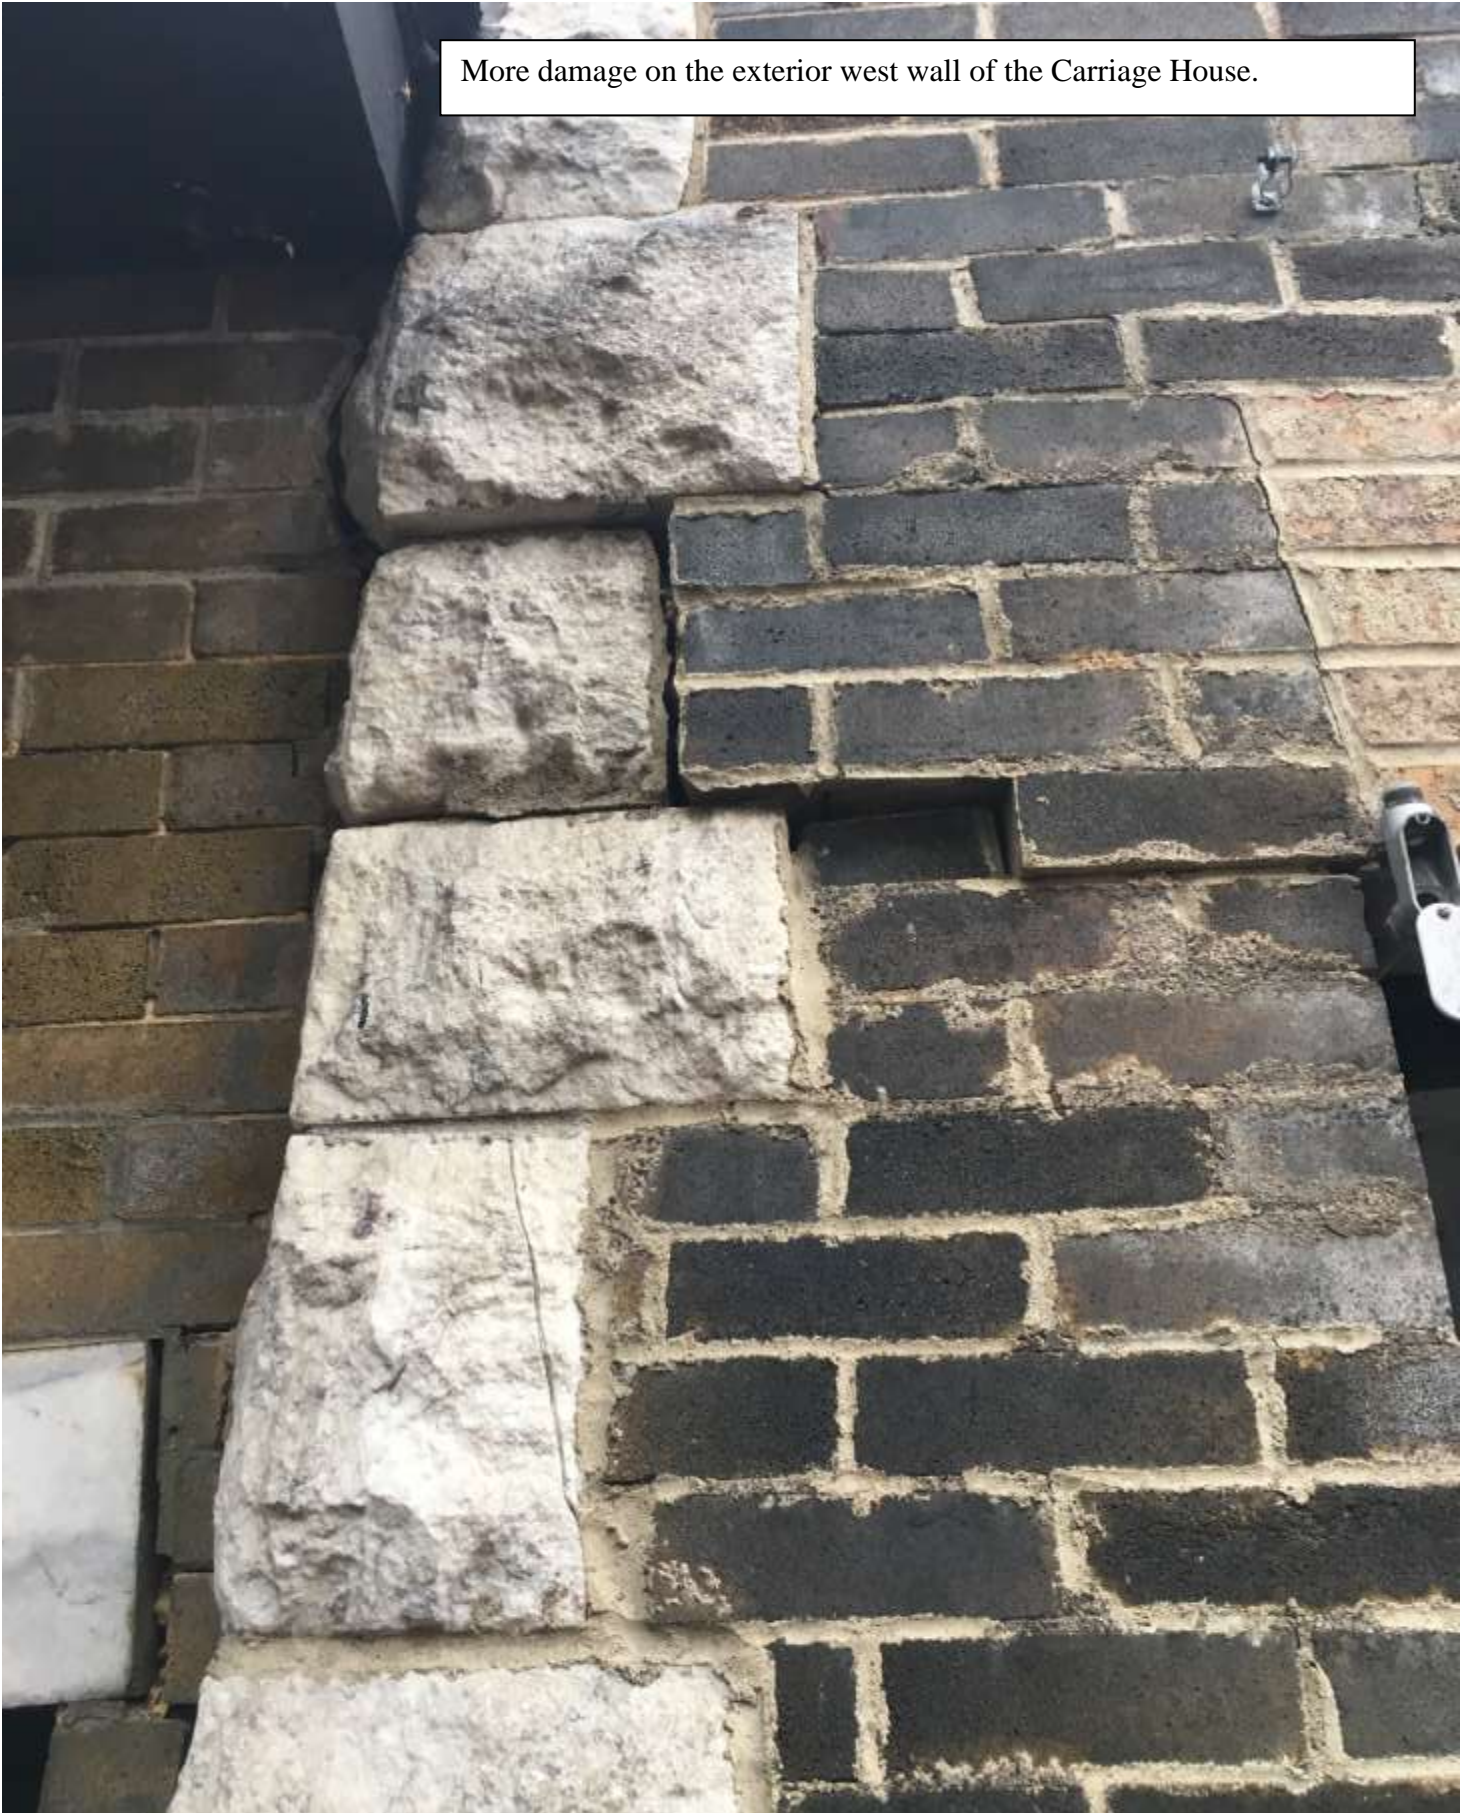
More damage on the exterior west wall of the Carriage House.

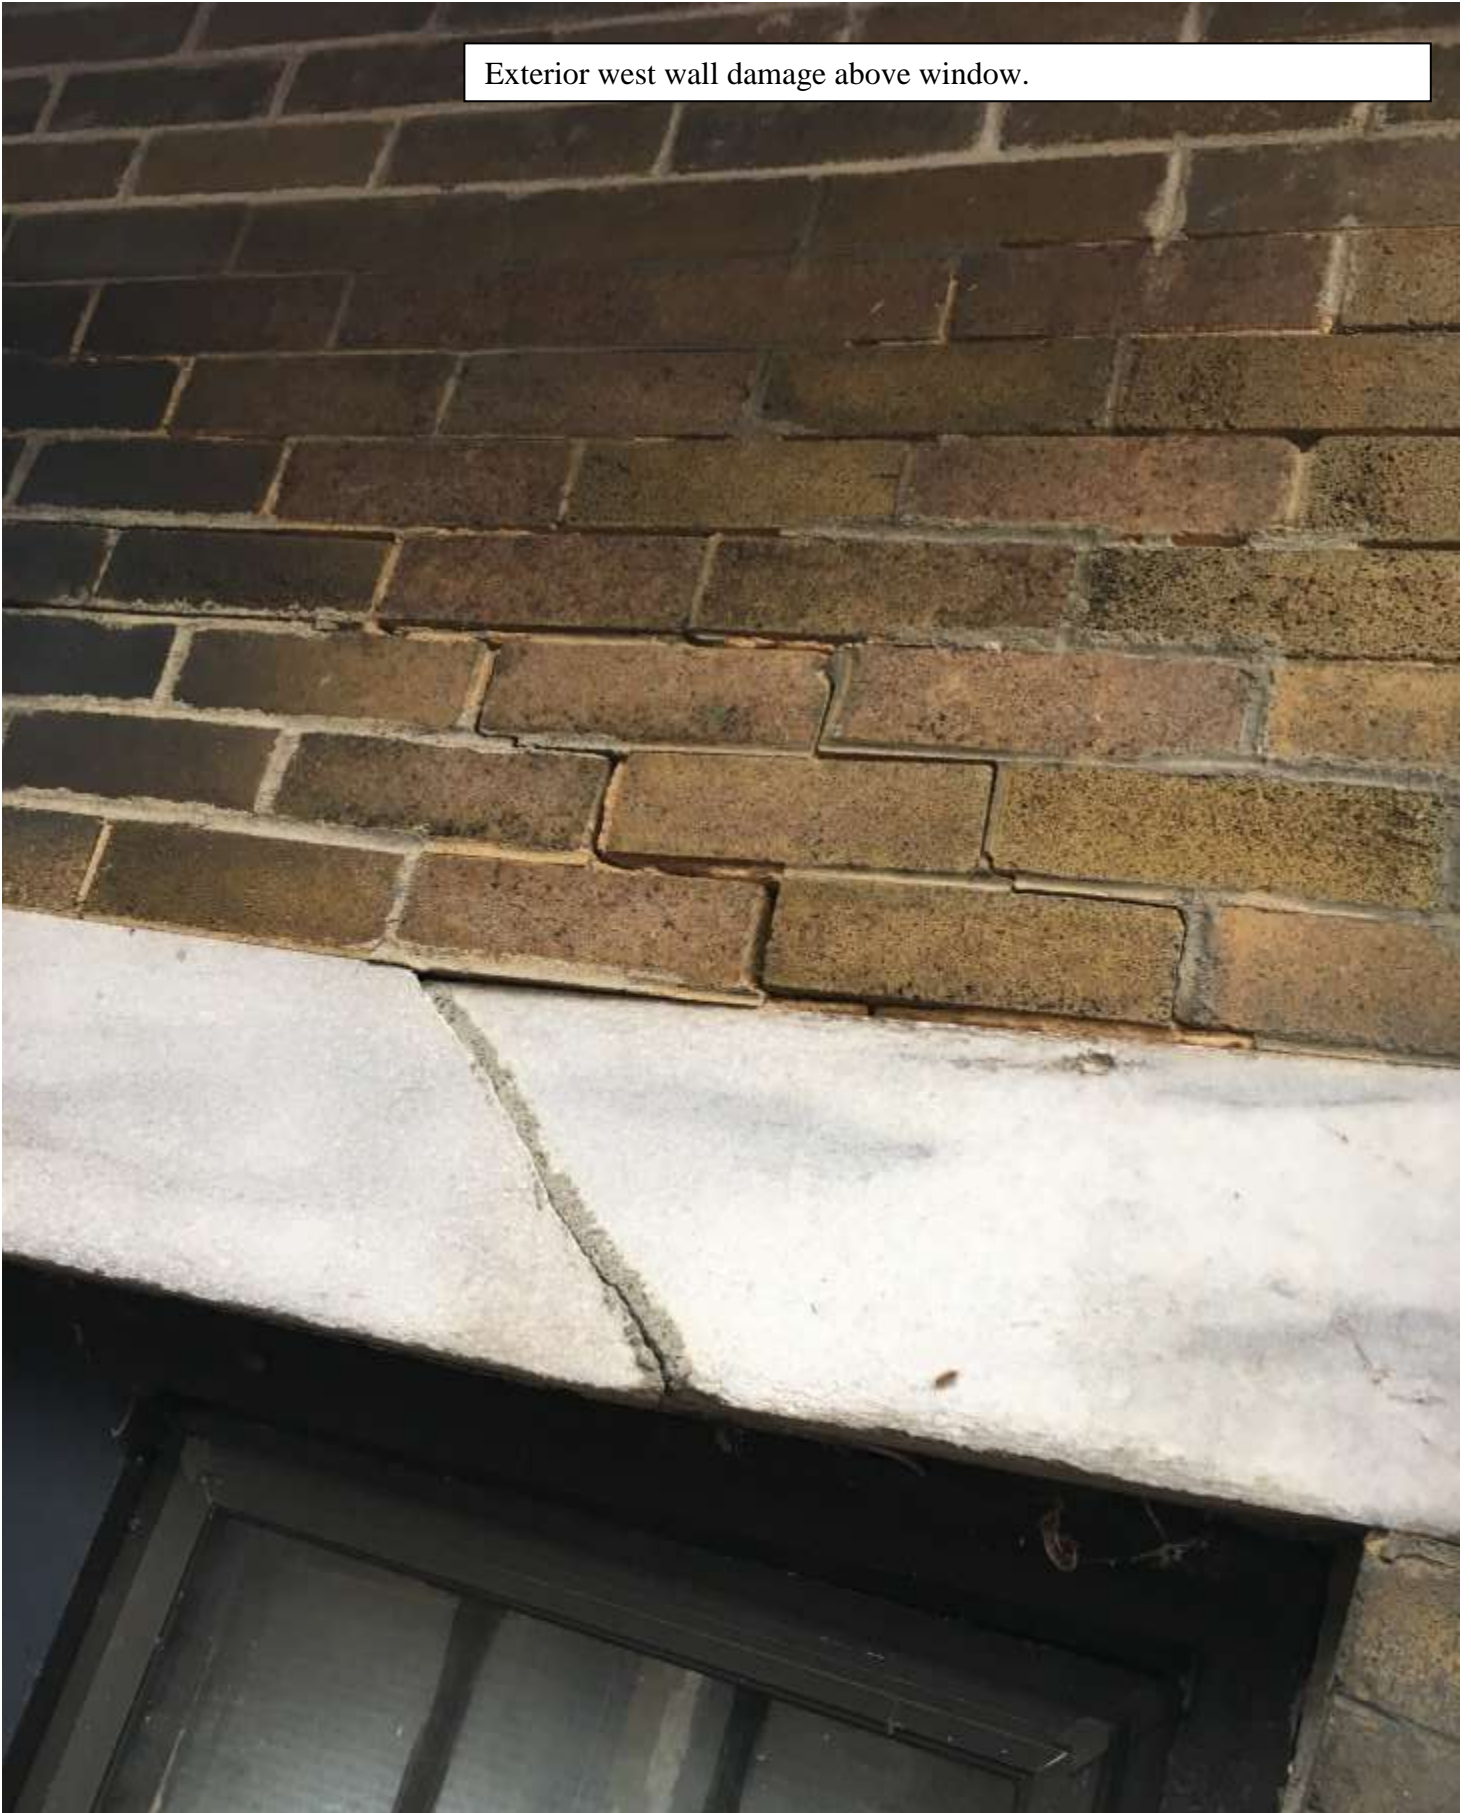
Exterior west wall damage above window.

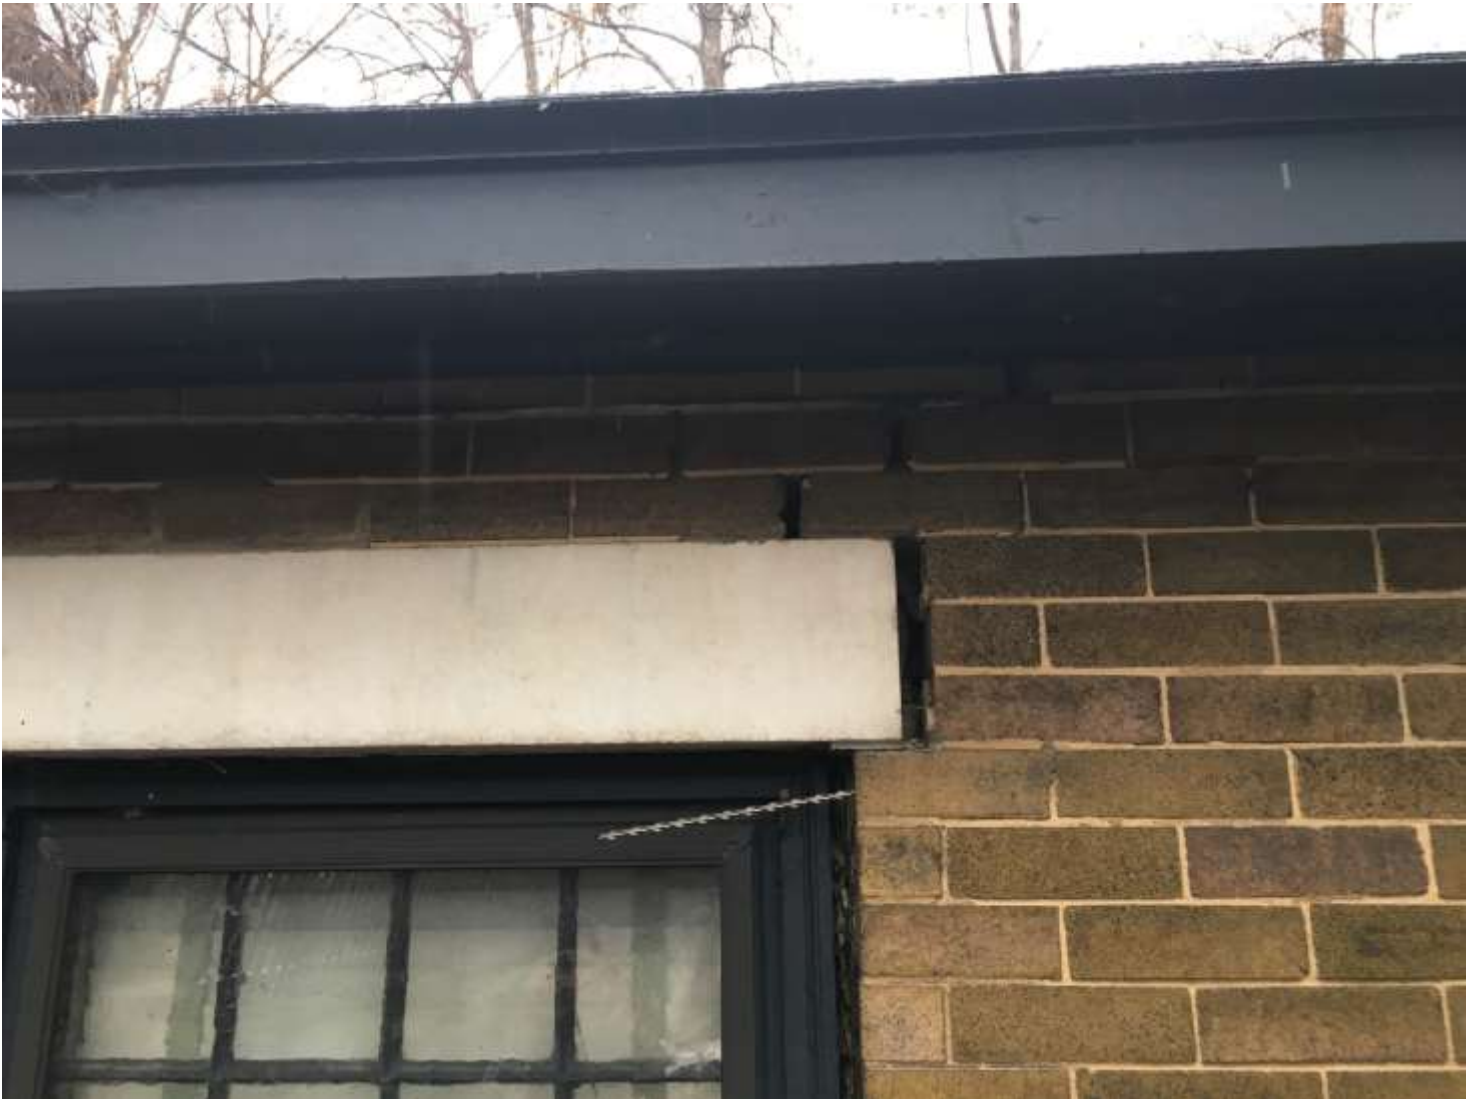
More damage exterior west wall. Window pulling away from the brick

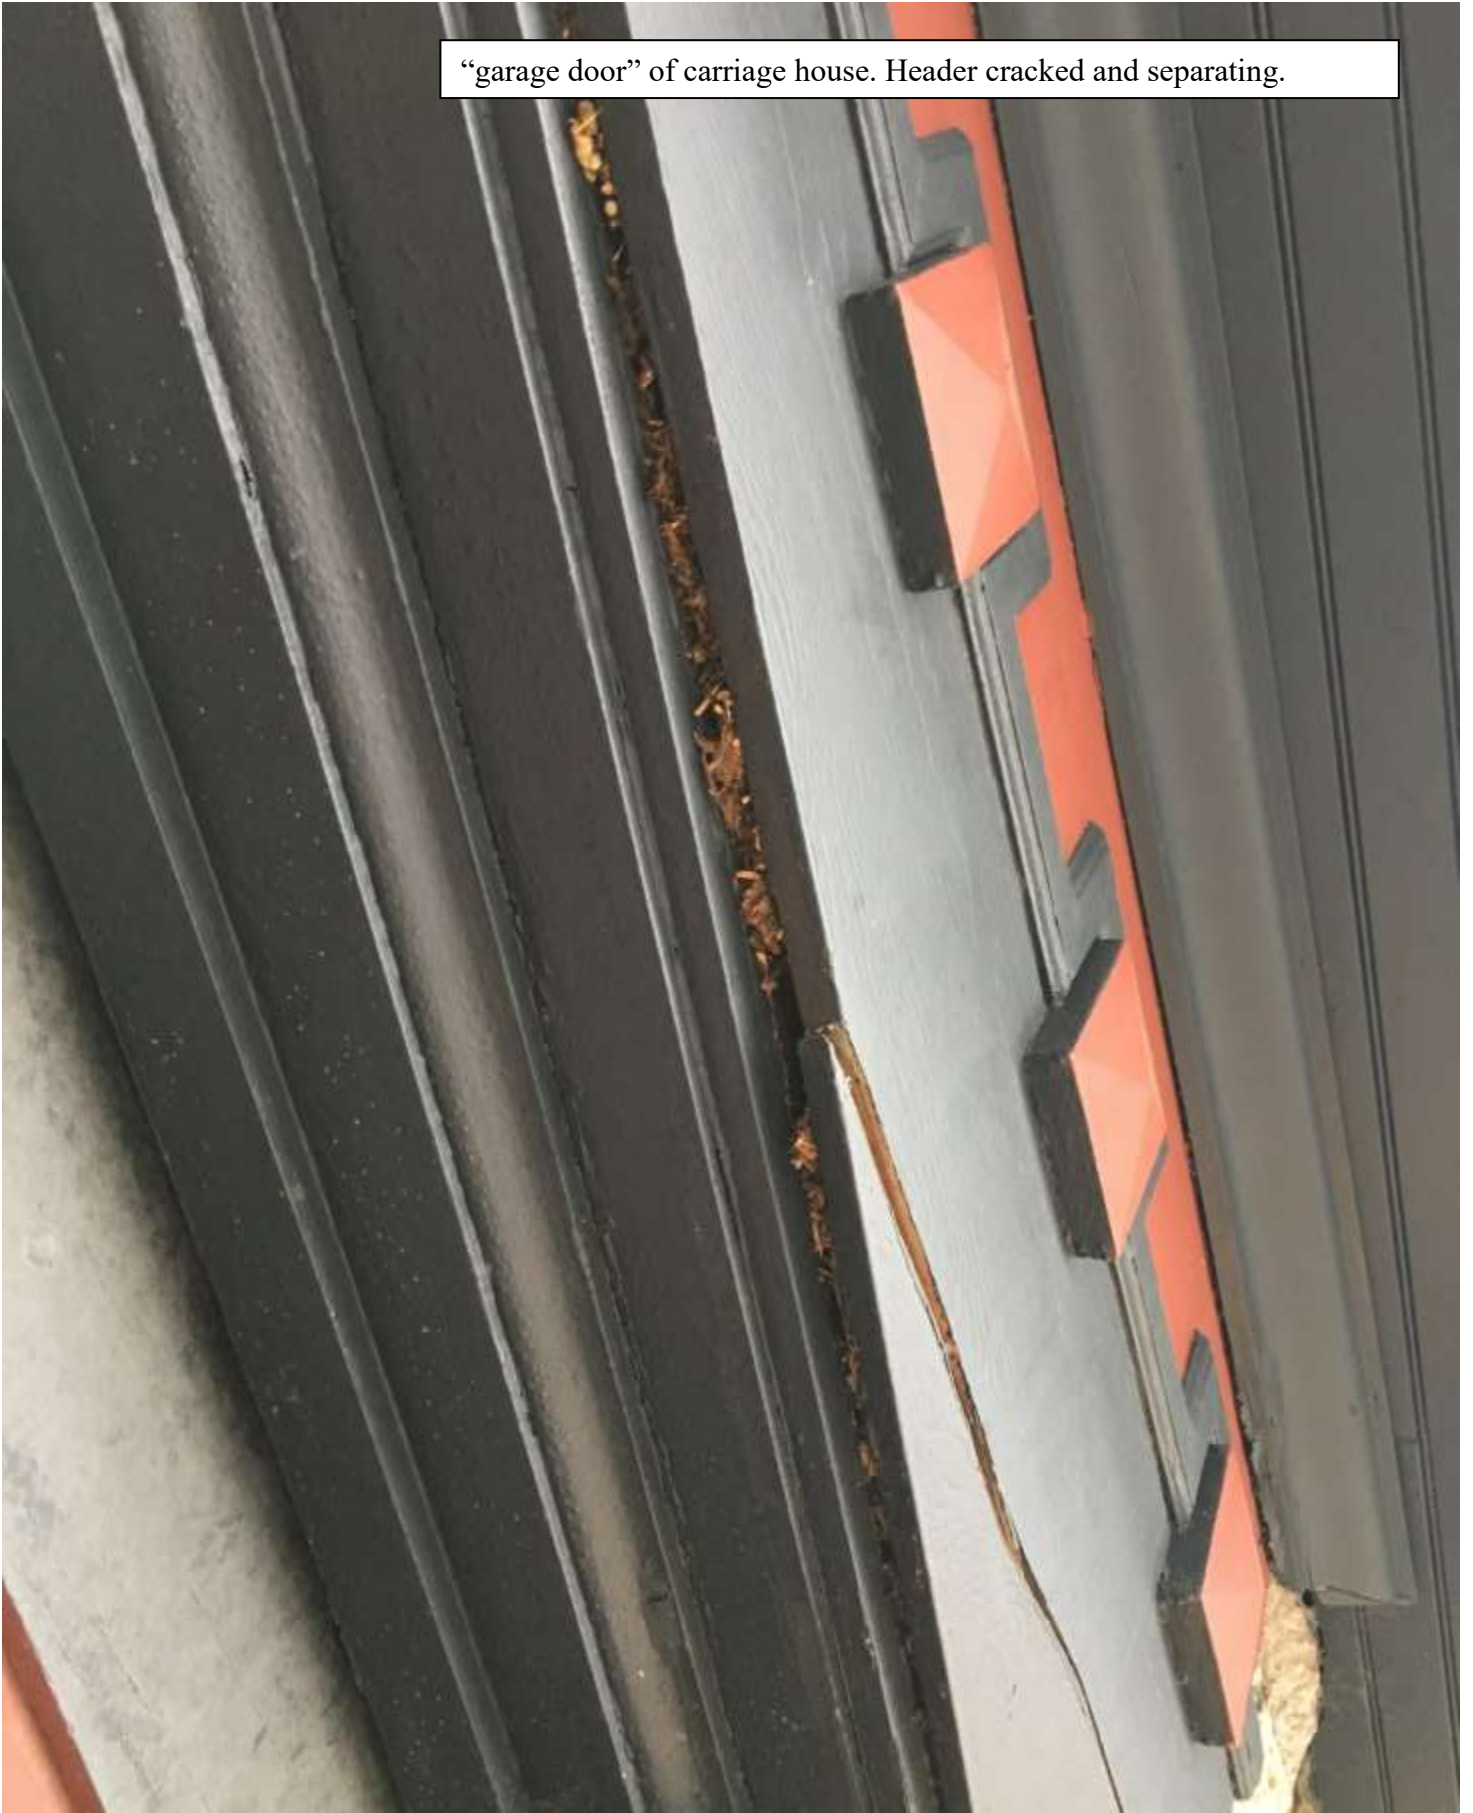
“garage door” of carriage house. Header cracked and separating.

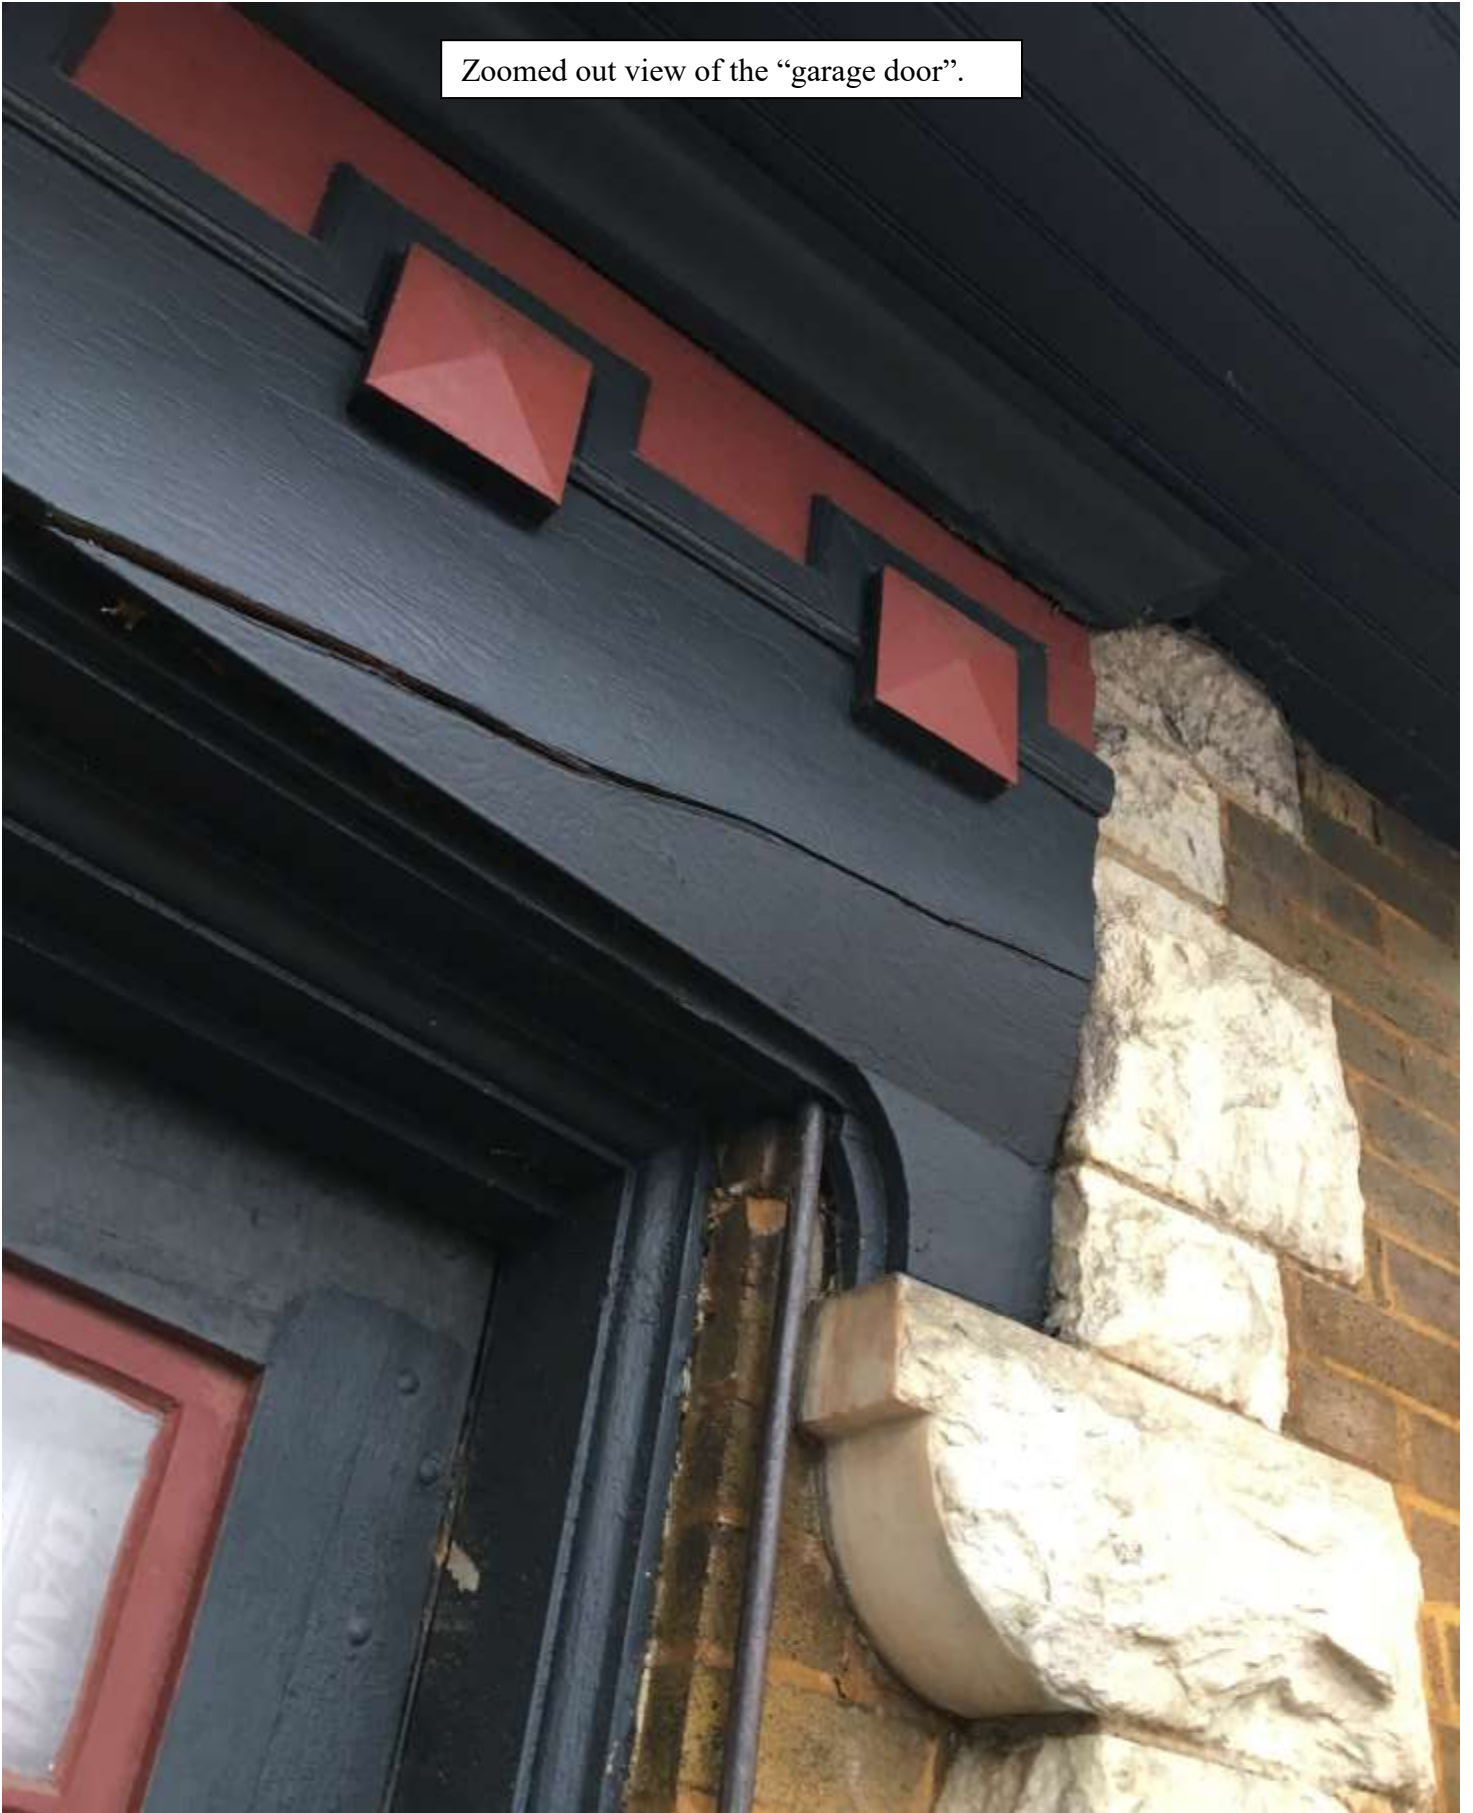
Zoomed out view of the “garage door”.

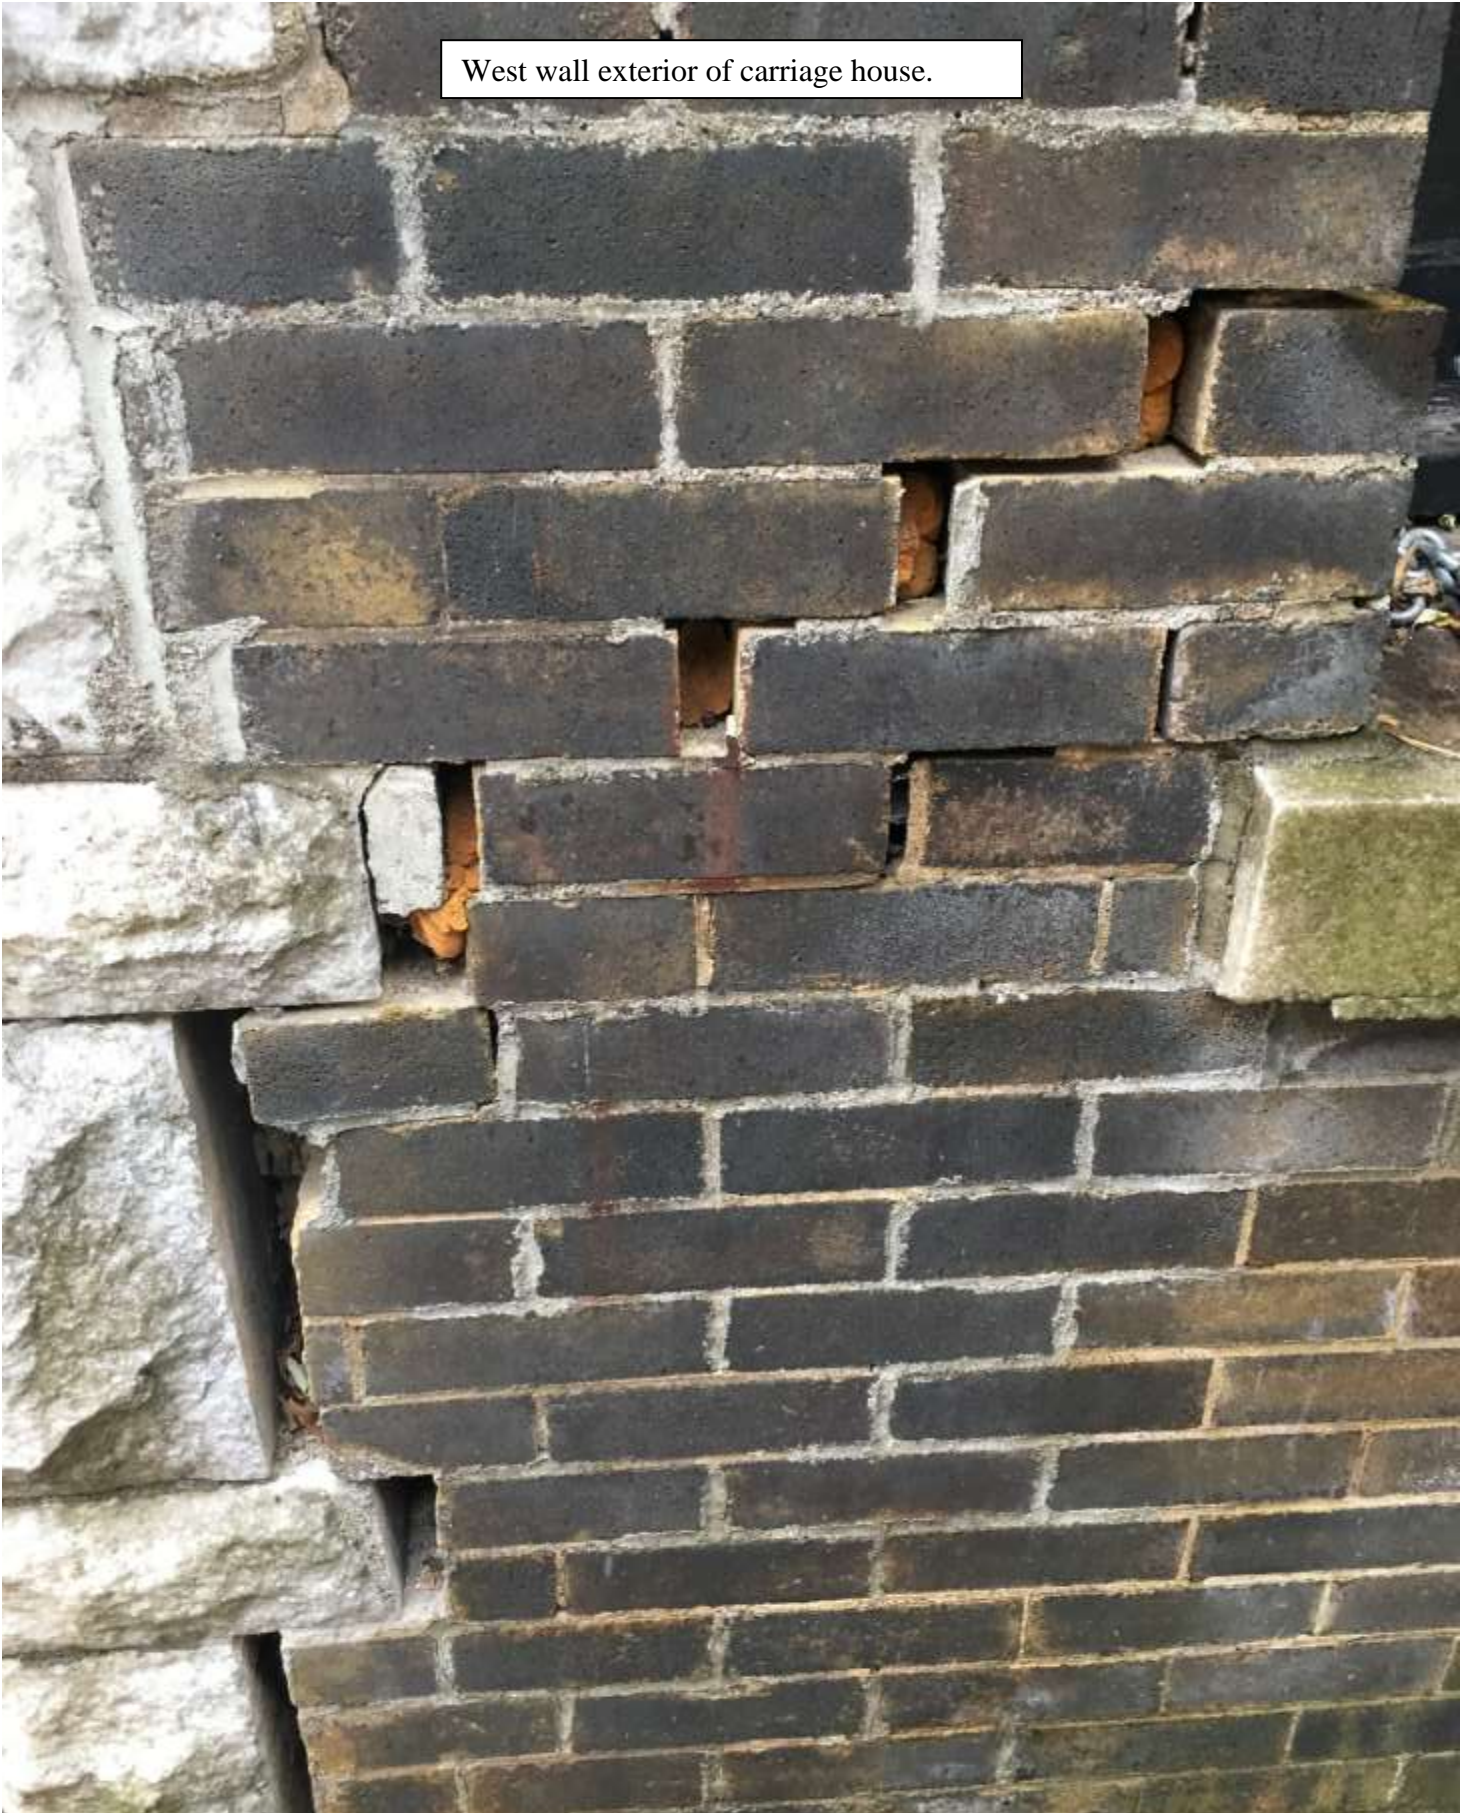
West wall exterior of carriage house.

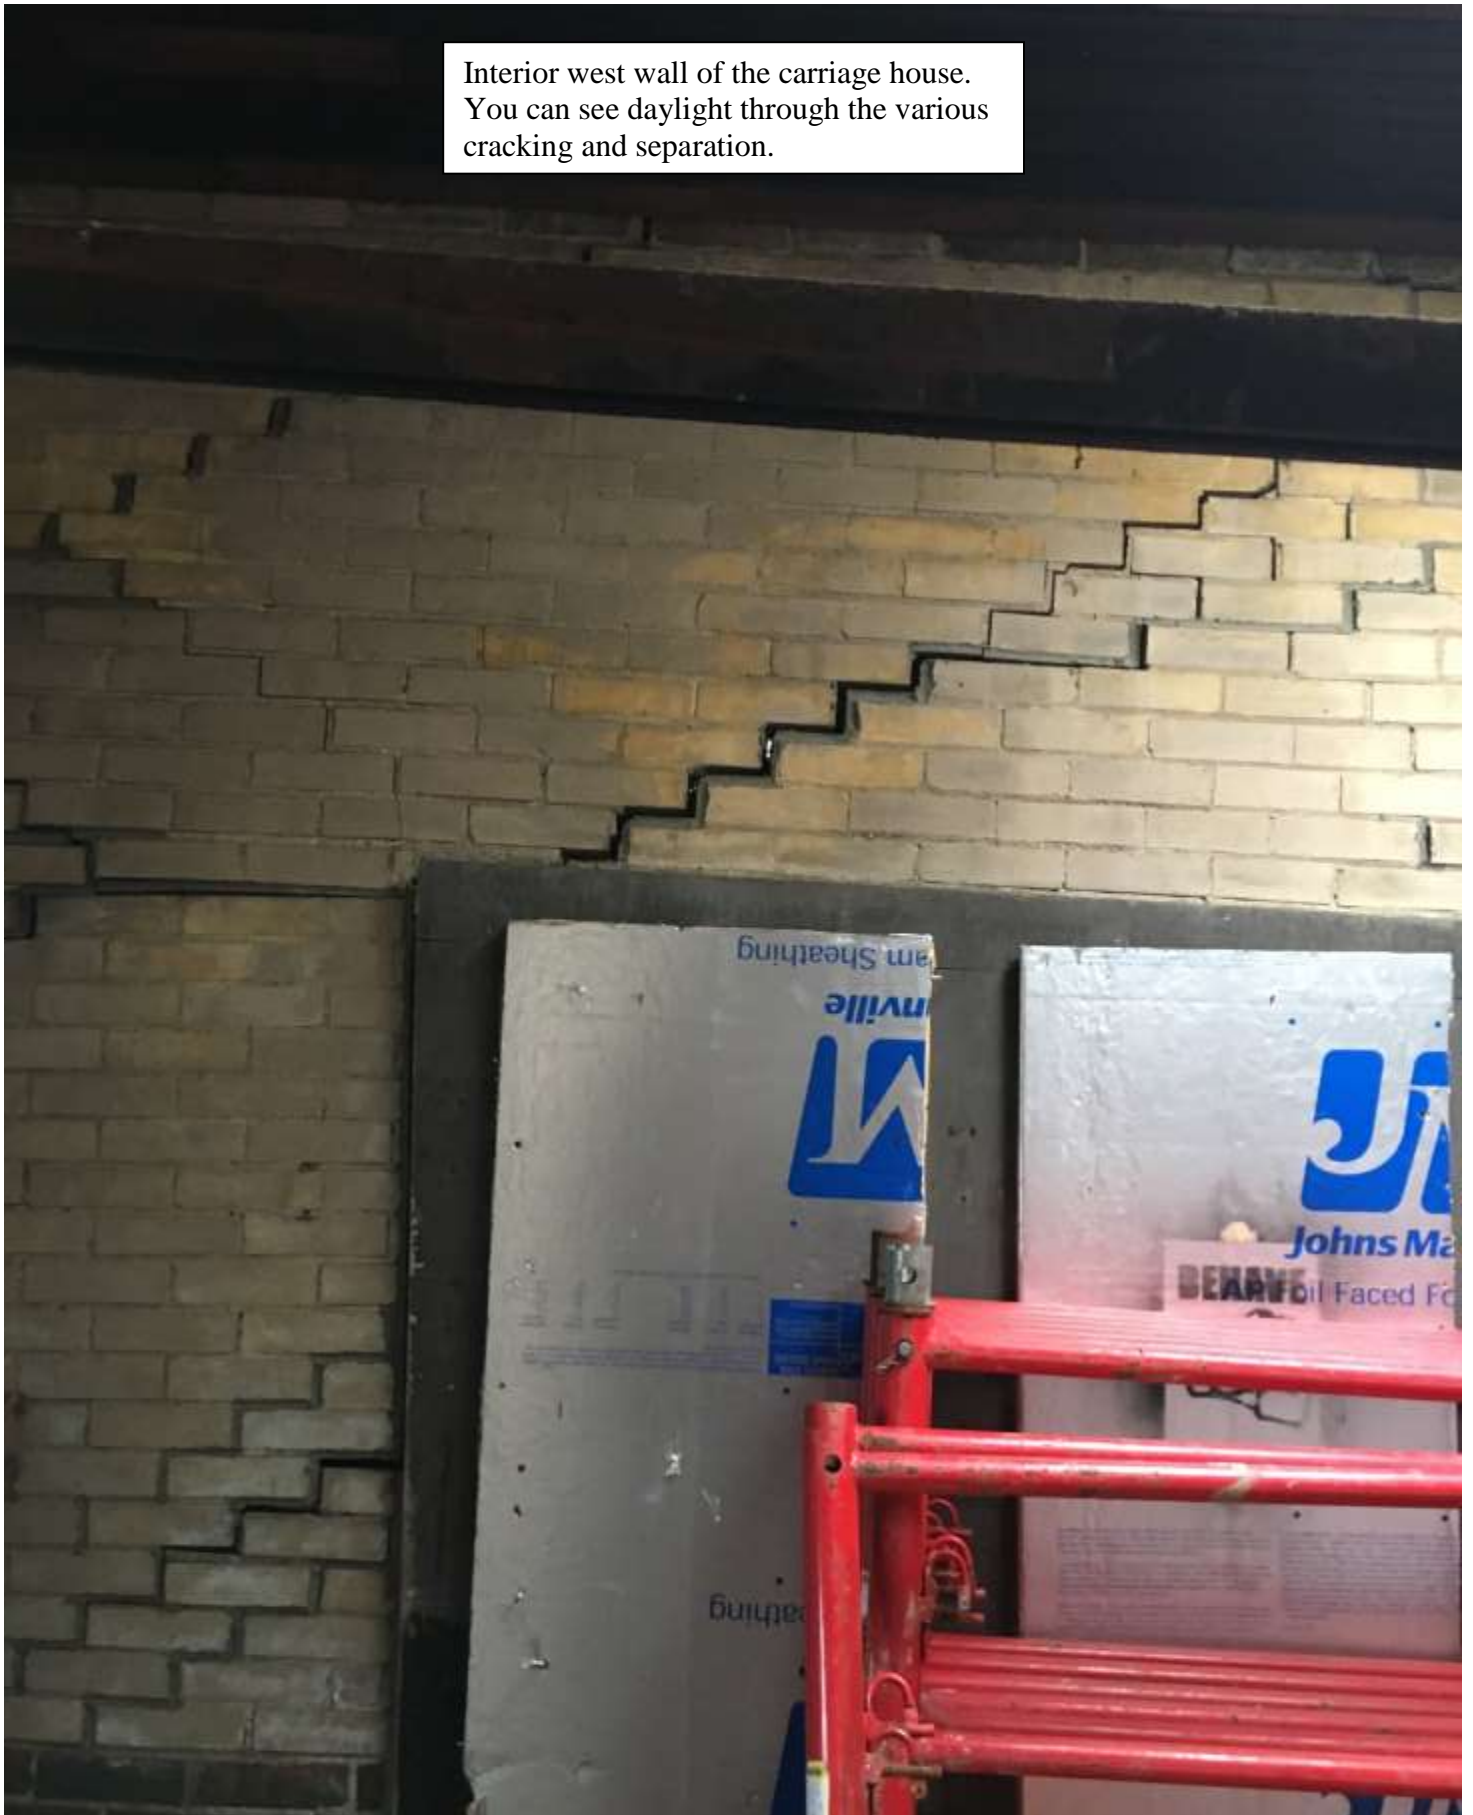
Interior west wall of the carriage house.  
You can see daylight through the various  
cracking and separation.
