**Date:** January 17, 2019  
**File #:** 16 - 032685  
**Folder Name:** 455 GRAND AVE  
**PIN:** 012823310114

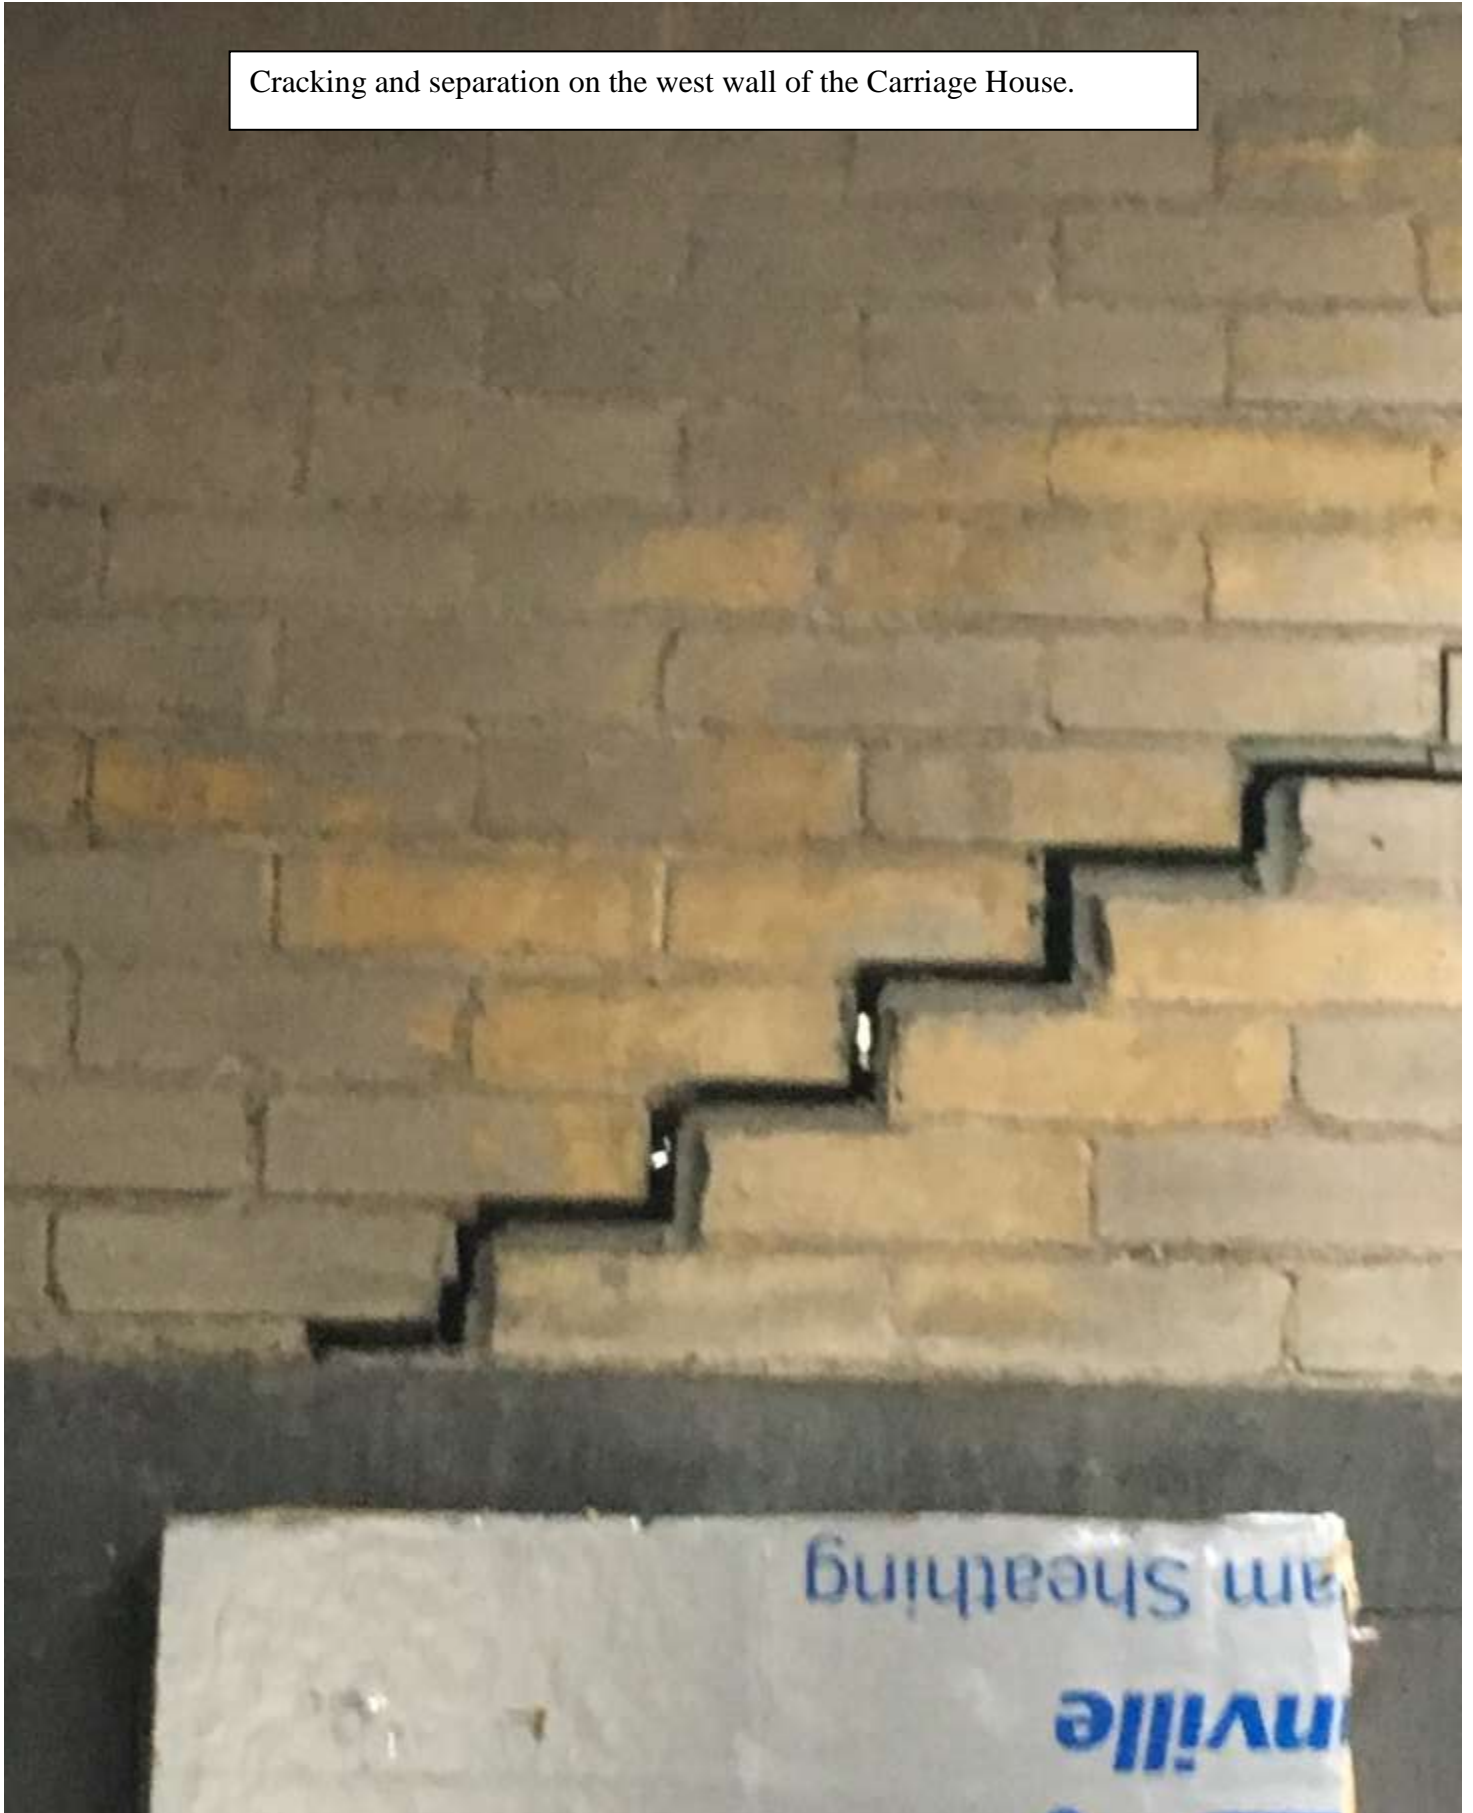
Cracking and separation on the west wall of the Carriage House.

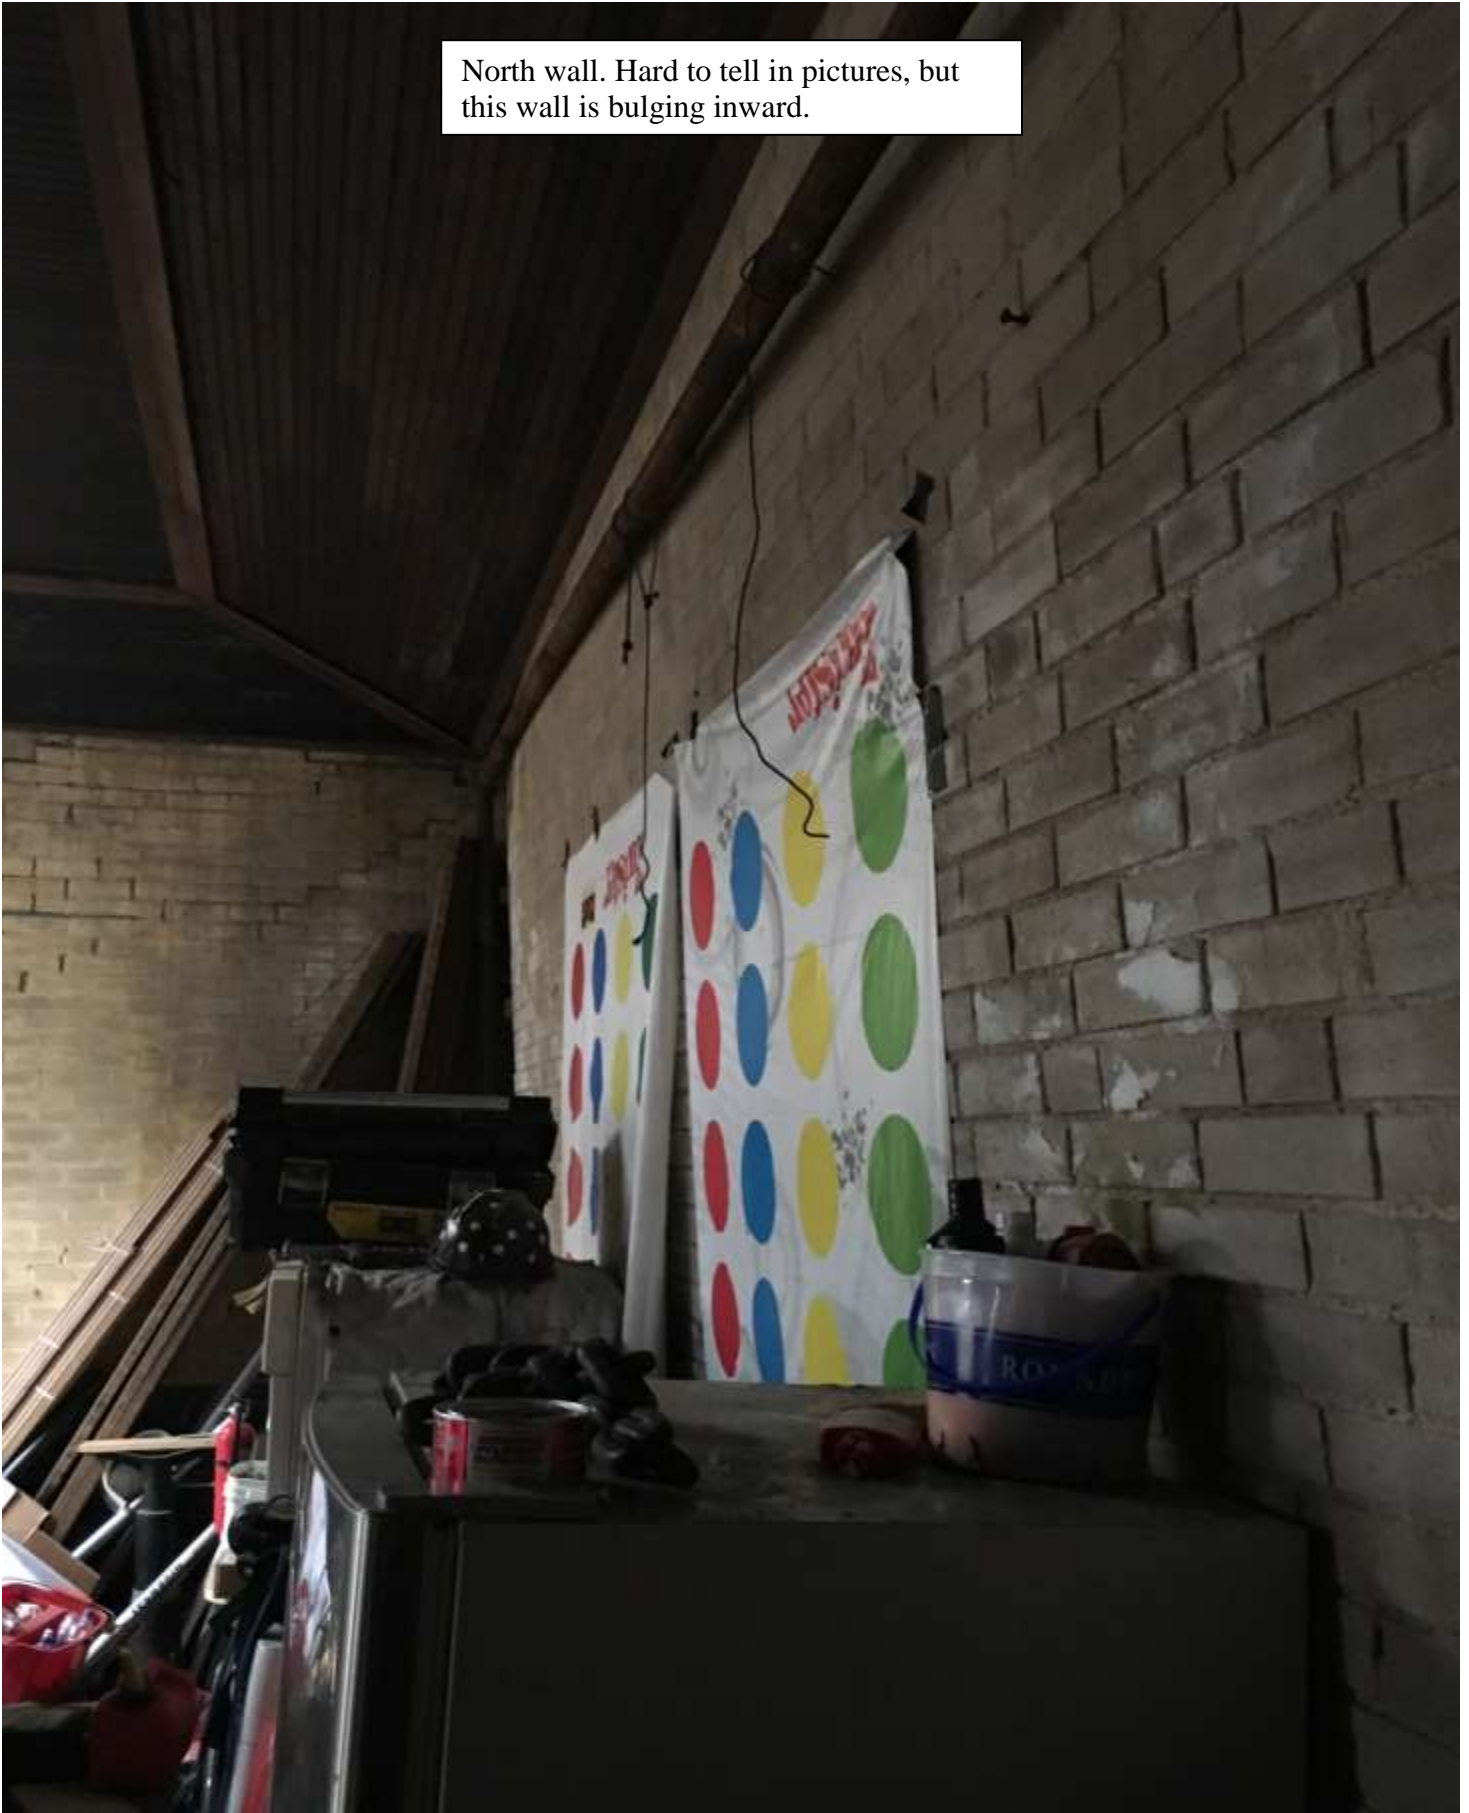
North wall. Hard to tell in pictures, but  
this wall is bulging inward.

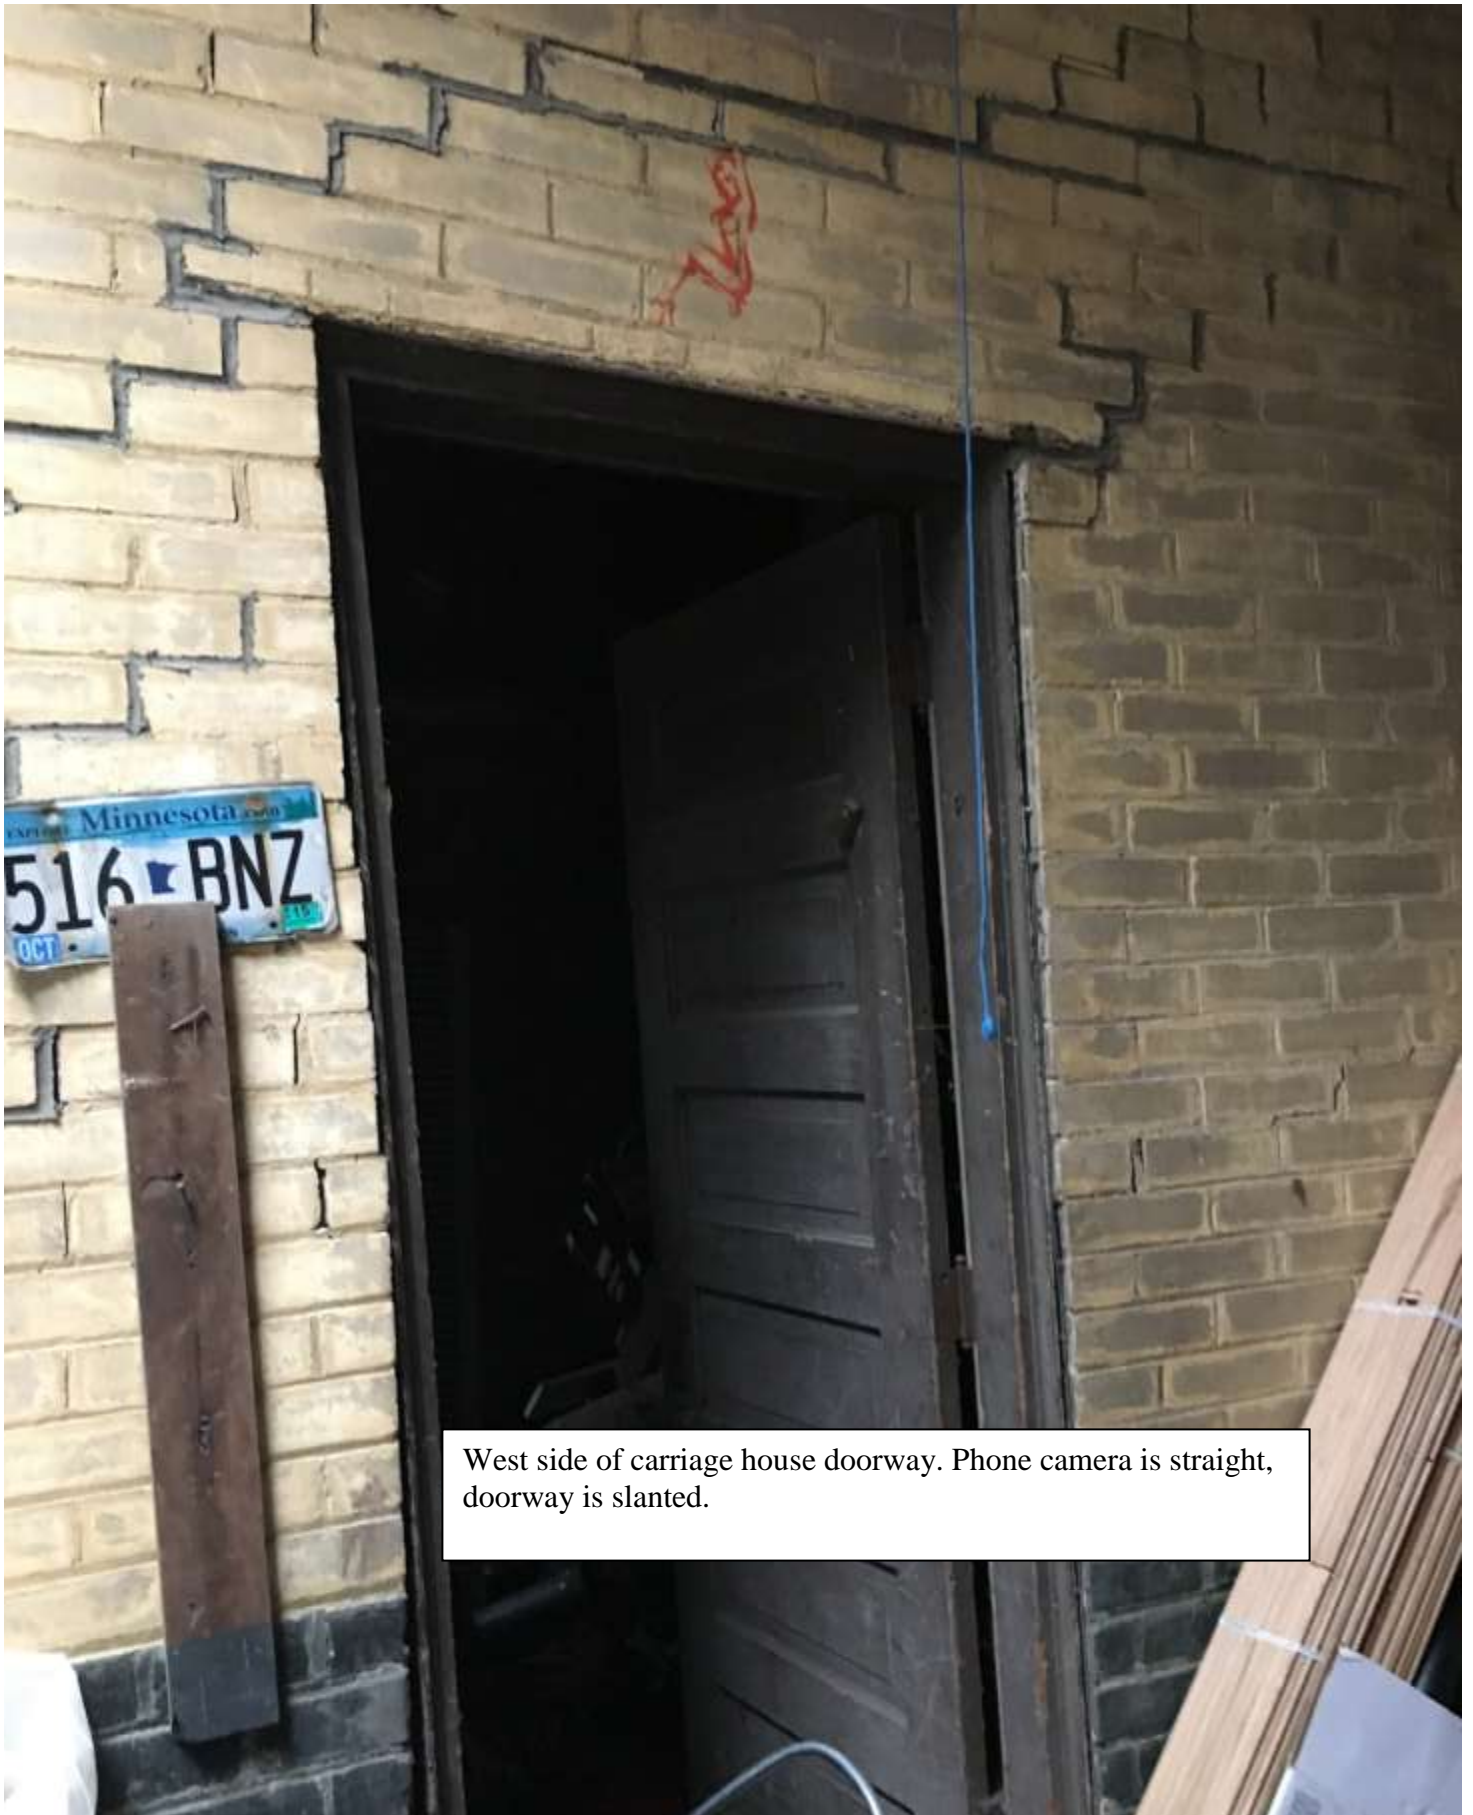
West side of carriage house doorway. Phone camera is straight, doorway is slanted.

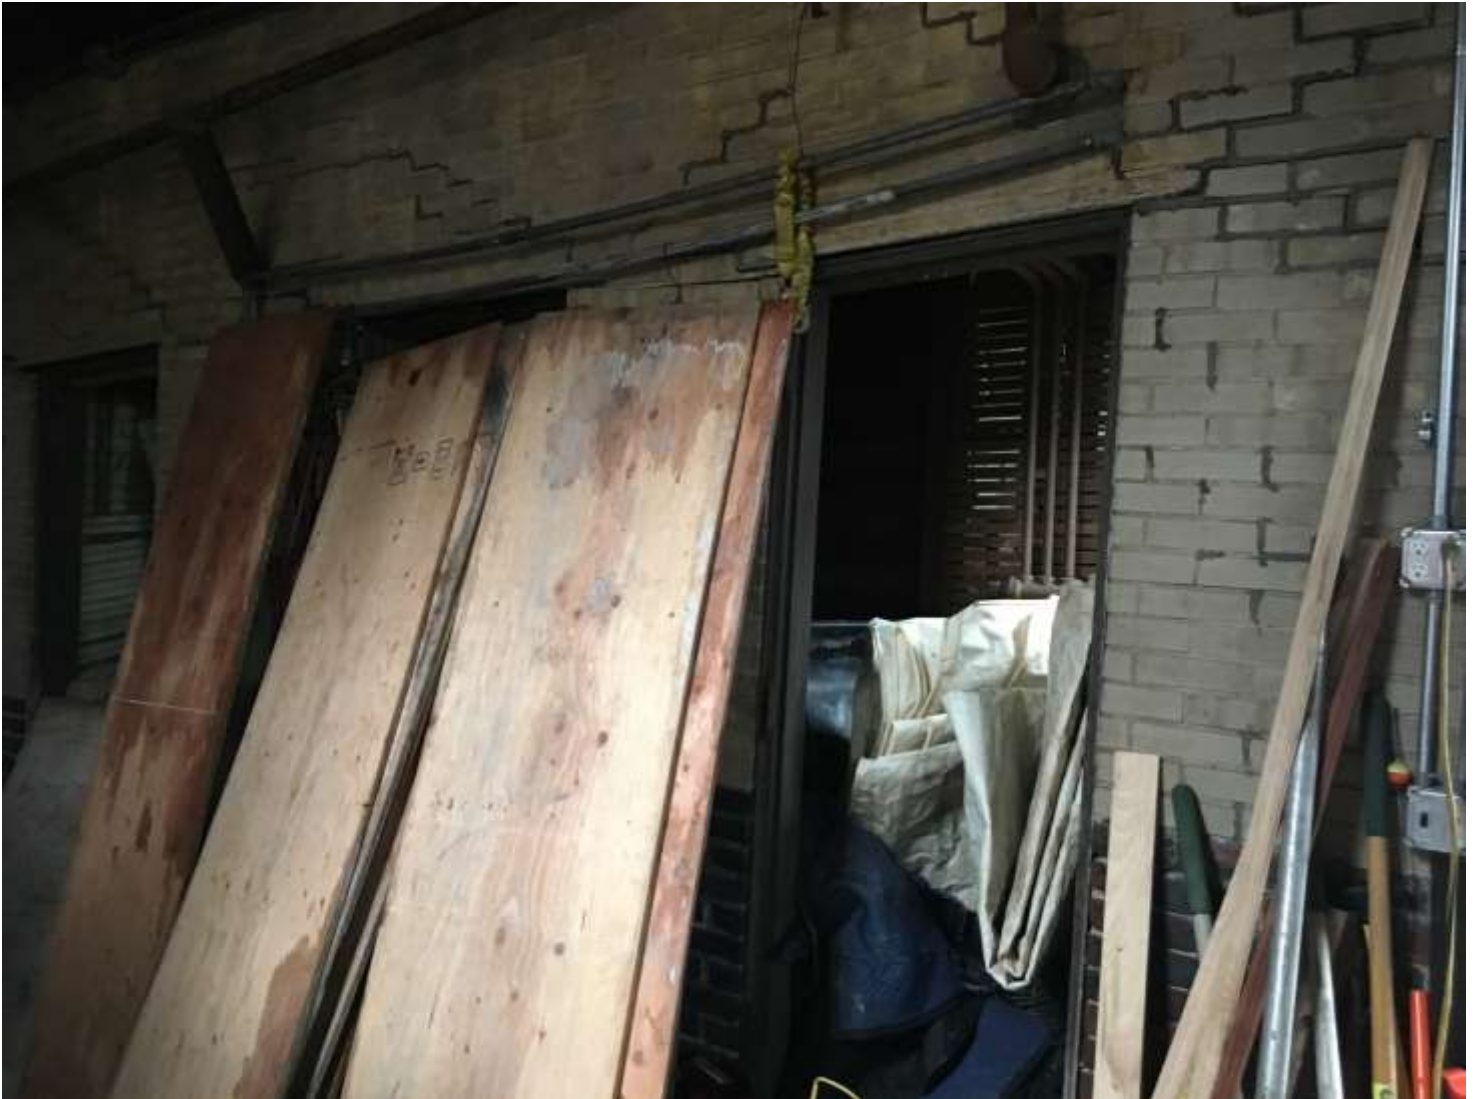
Interior East wall damage with carious cracking. Note the piping.
