**Date:** January 17, 2019  
**File #:** 16 - 032685  
**Folder Name:** 455 GRAND AVE  
**PIN:** 012823310114

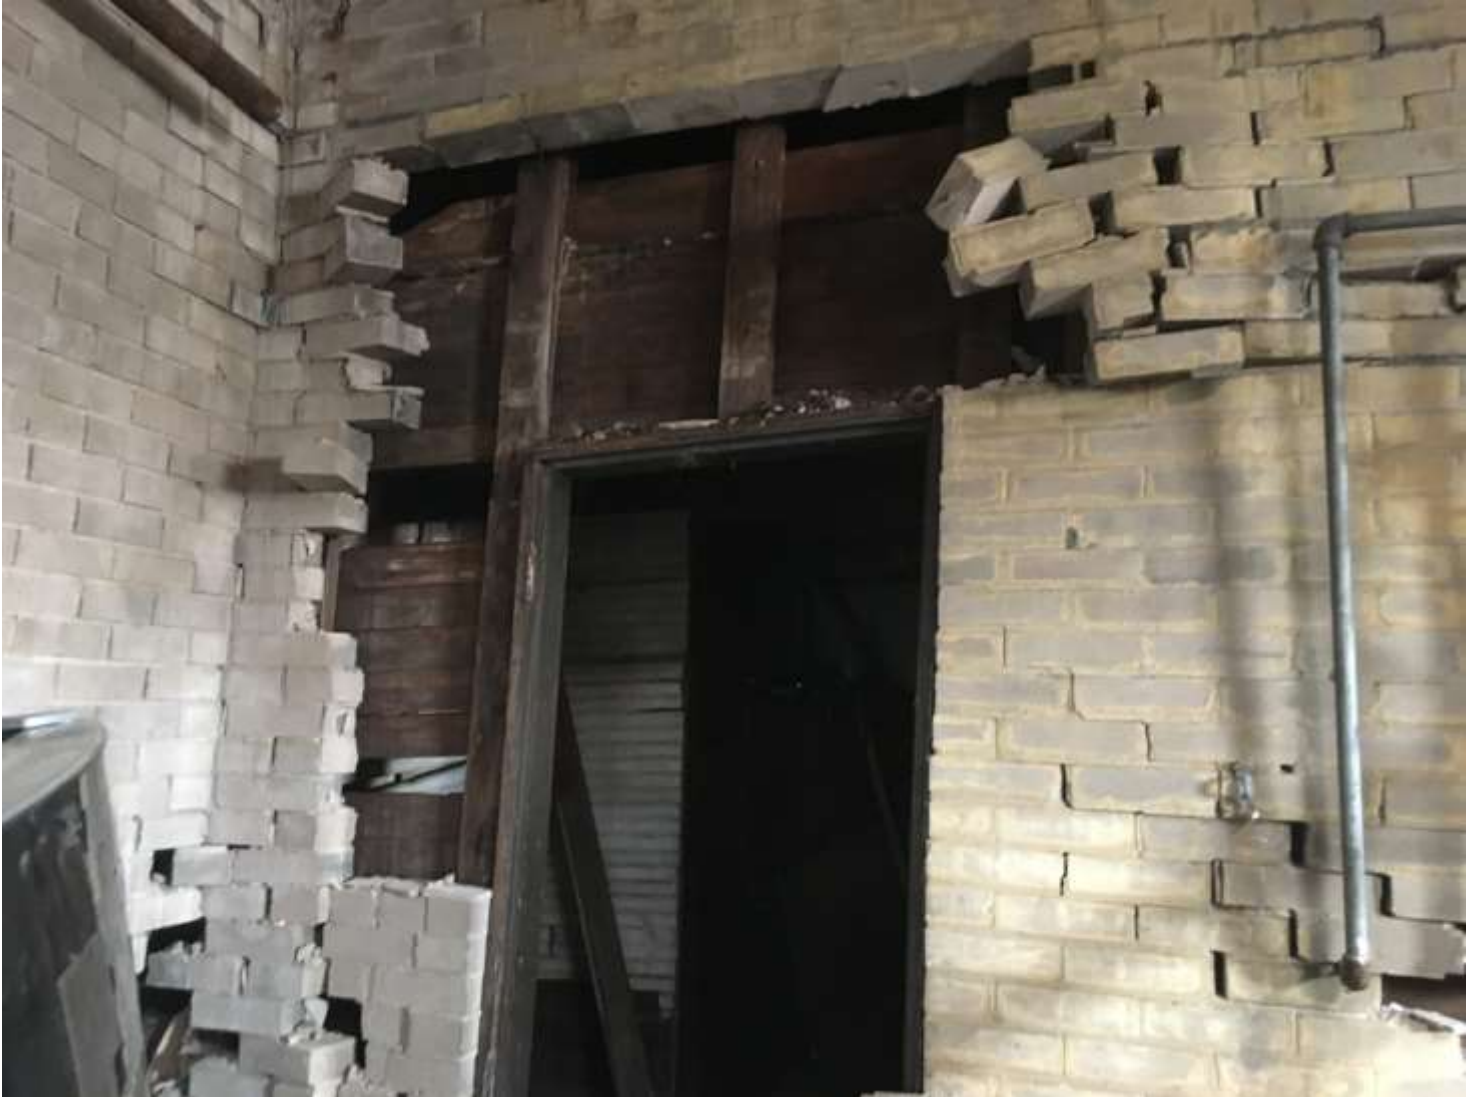
This is the interior, east side wall during the second visit.

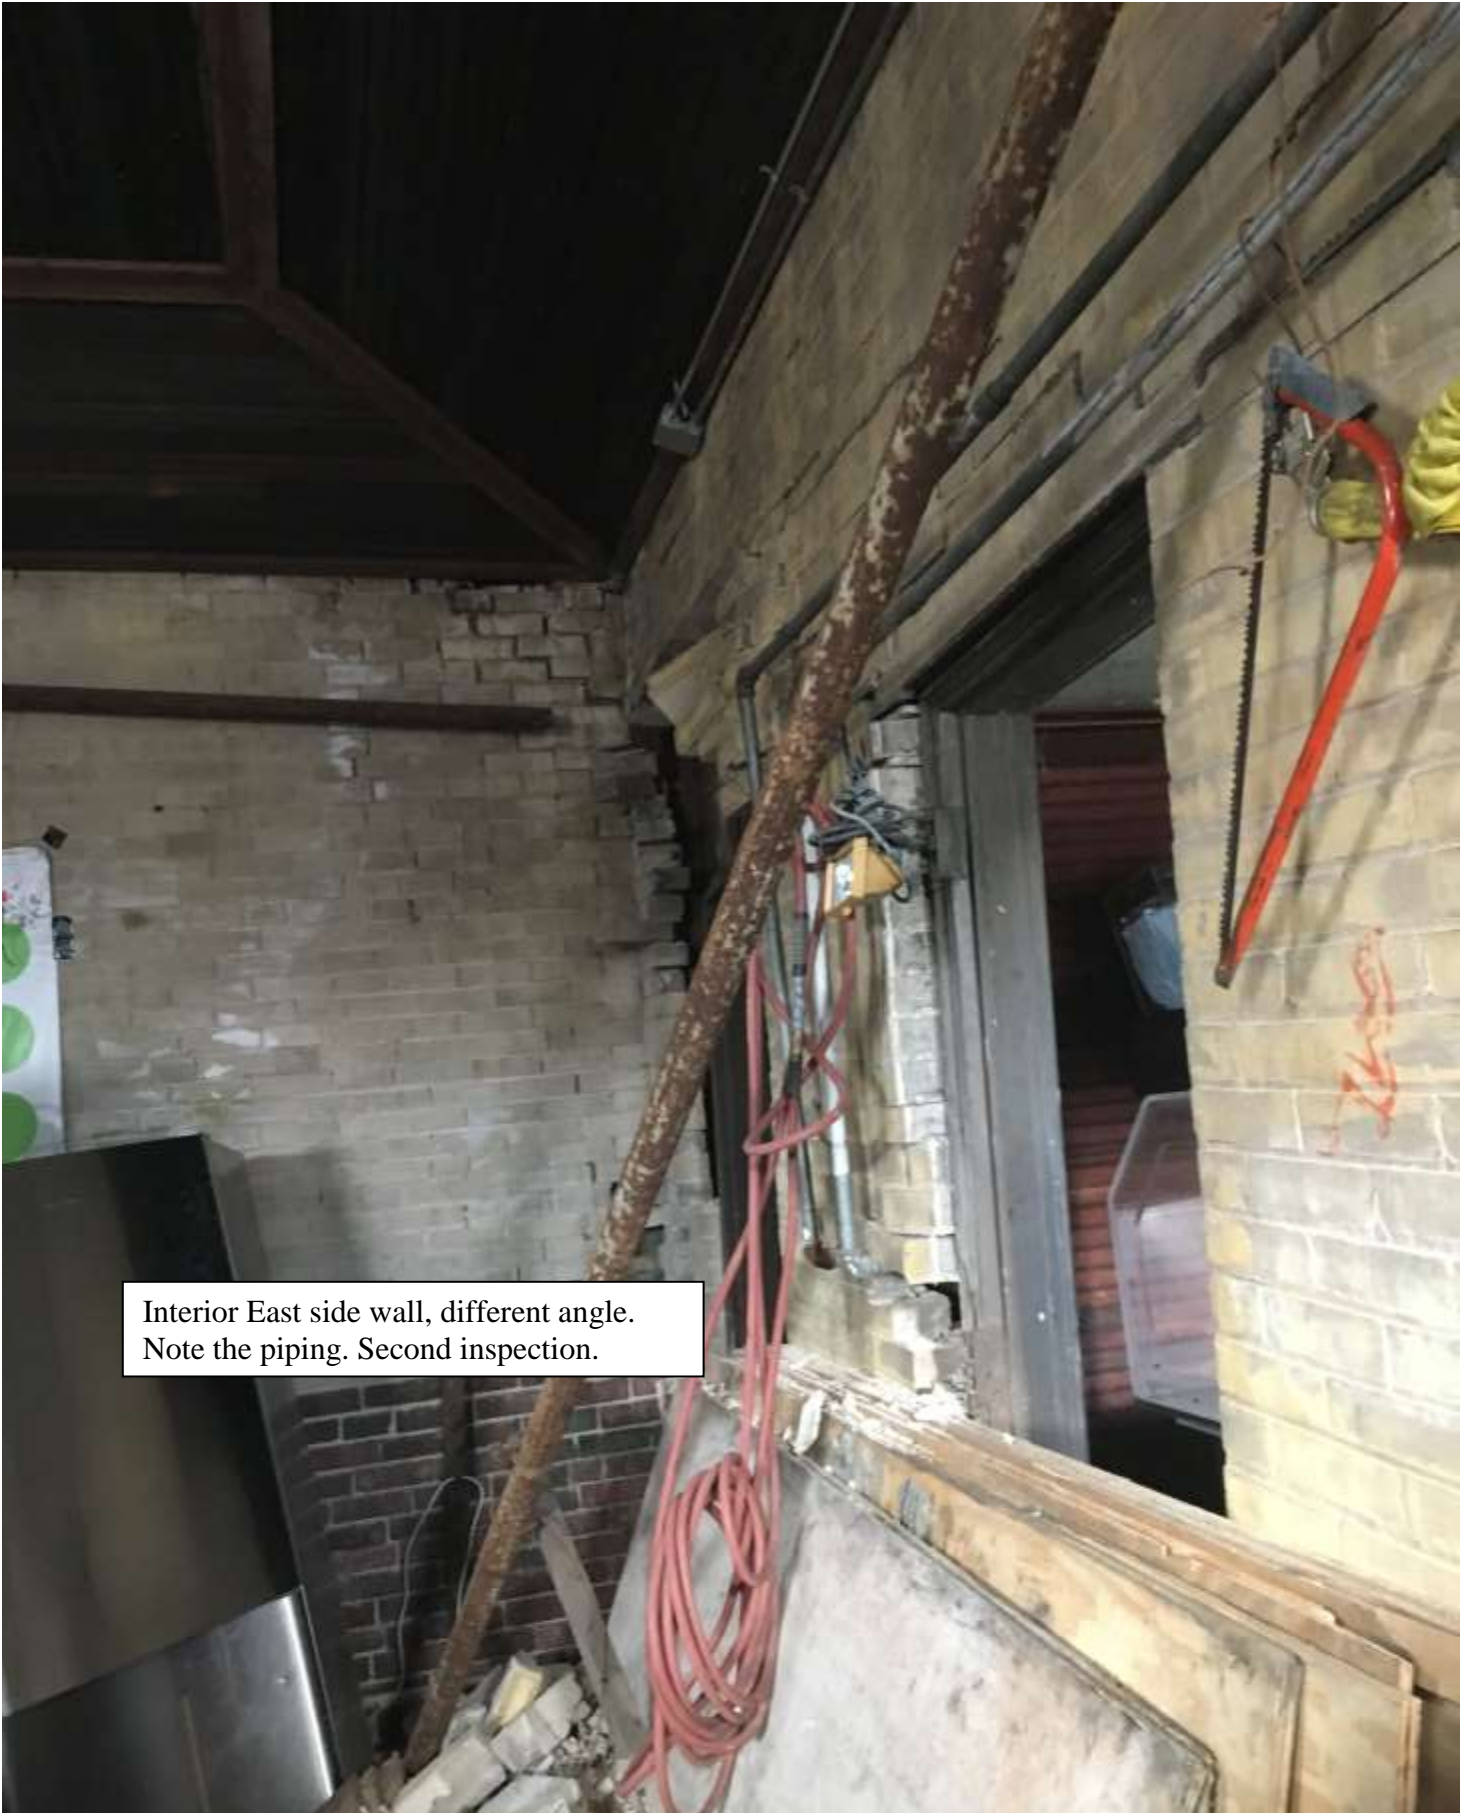
Interior East side wall, different angle.  
Note the piping. Second inspection.

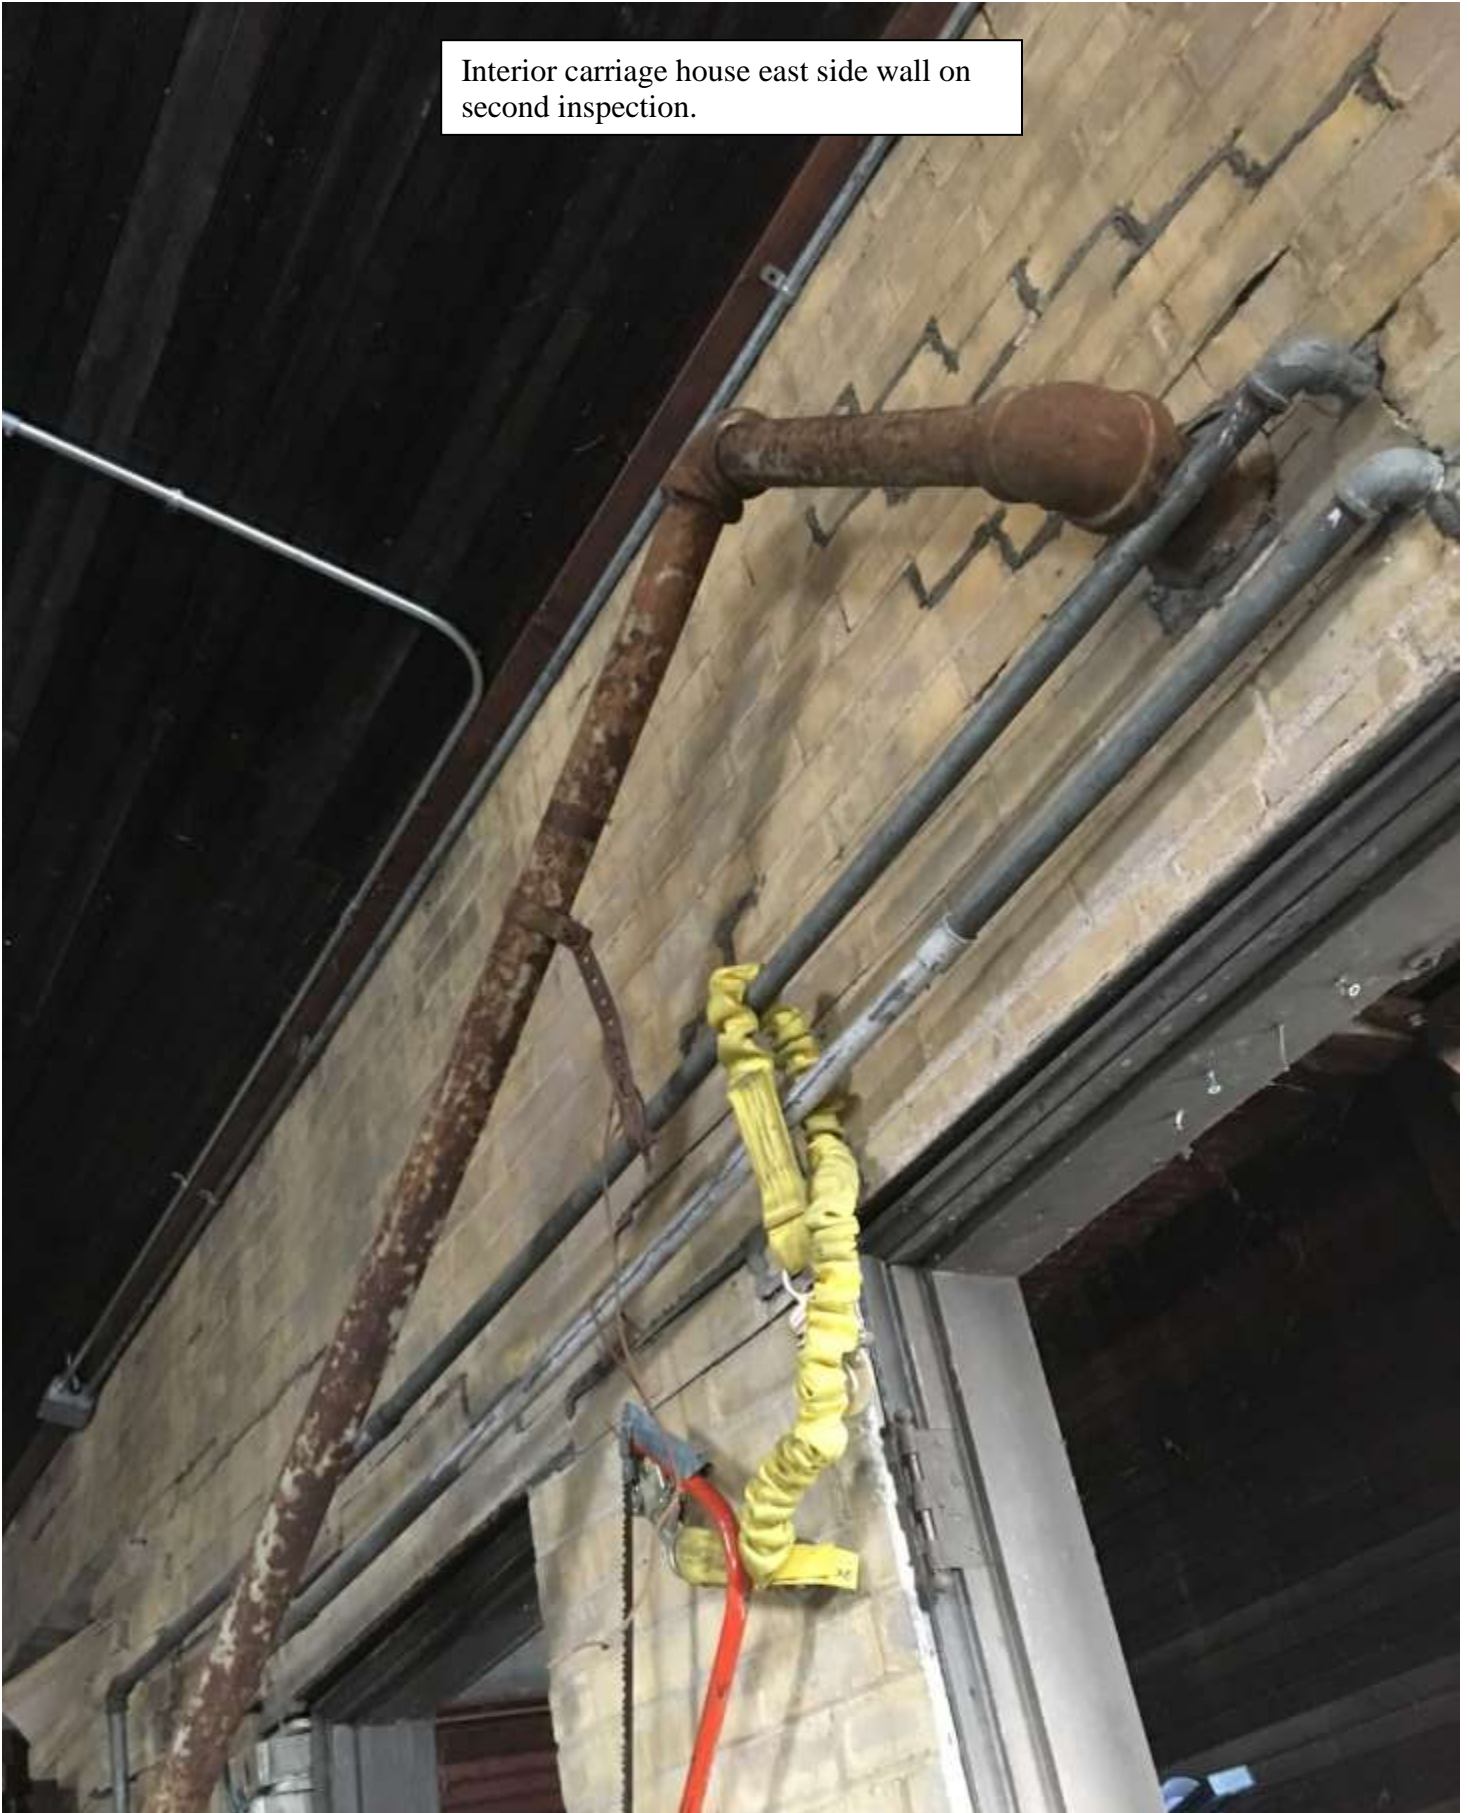
Interior carriage house east side wall on second inspection.

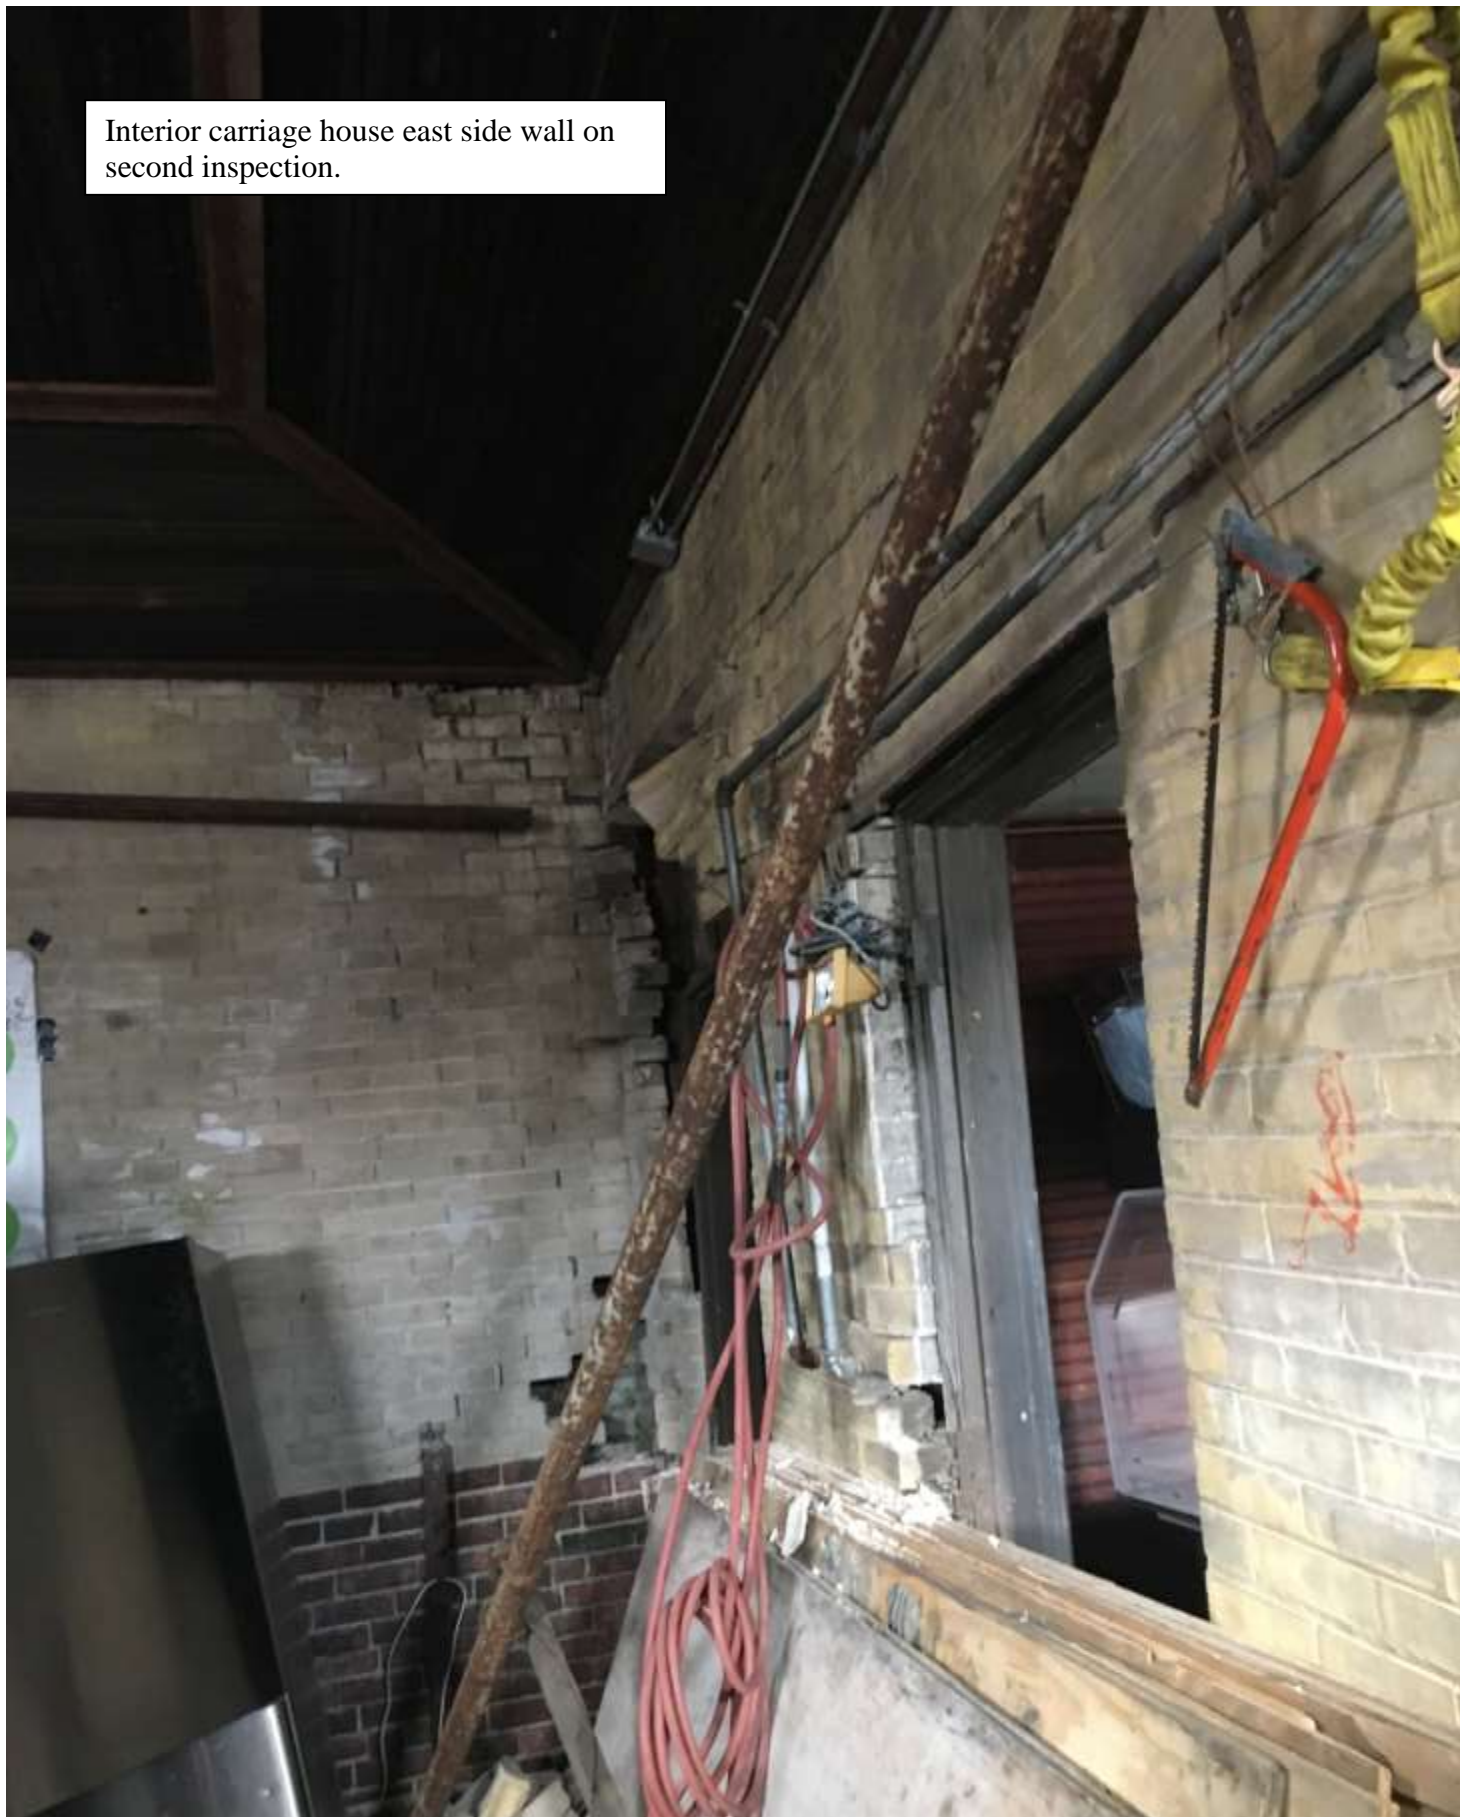
Interior carriage house east side wall on second inspection.

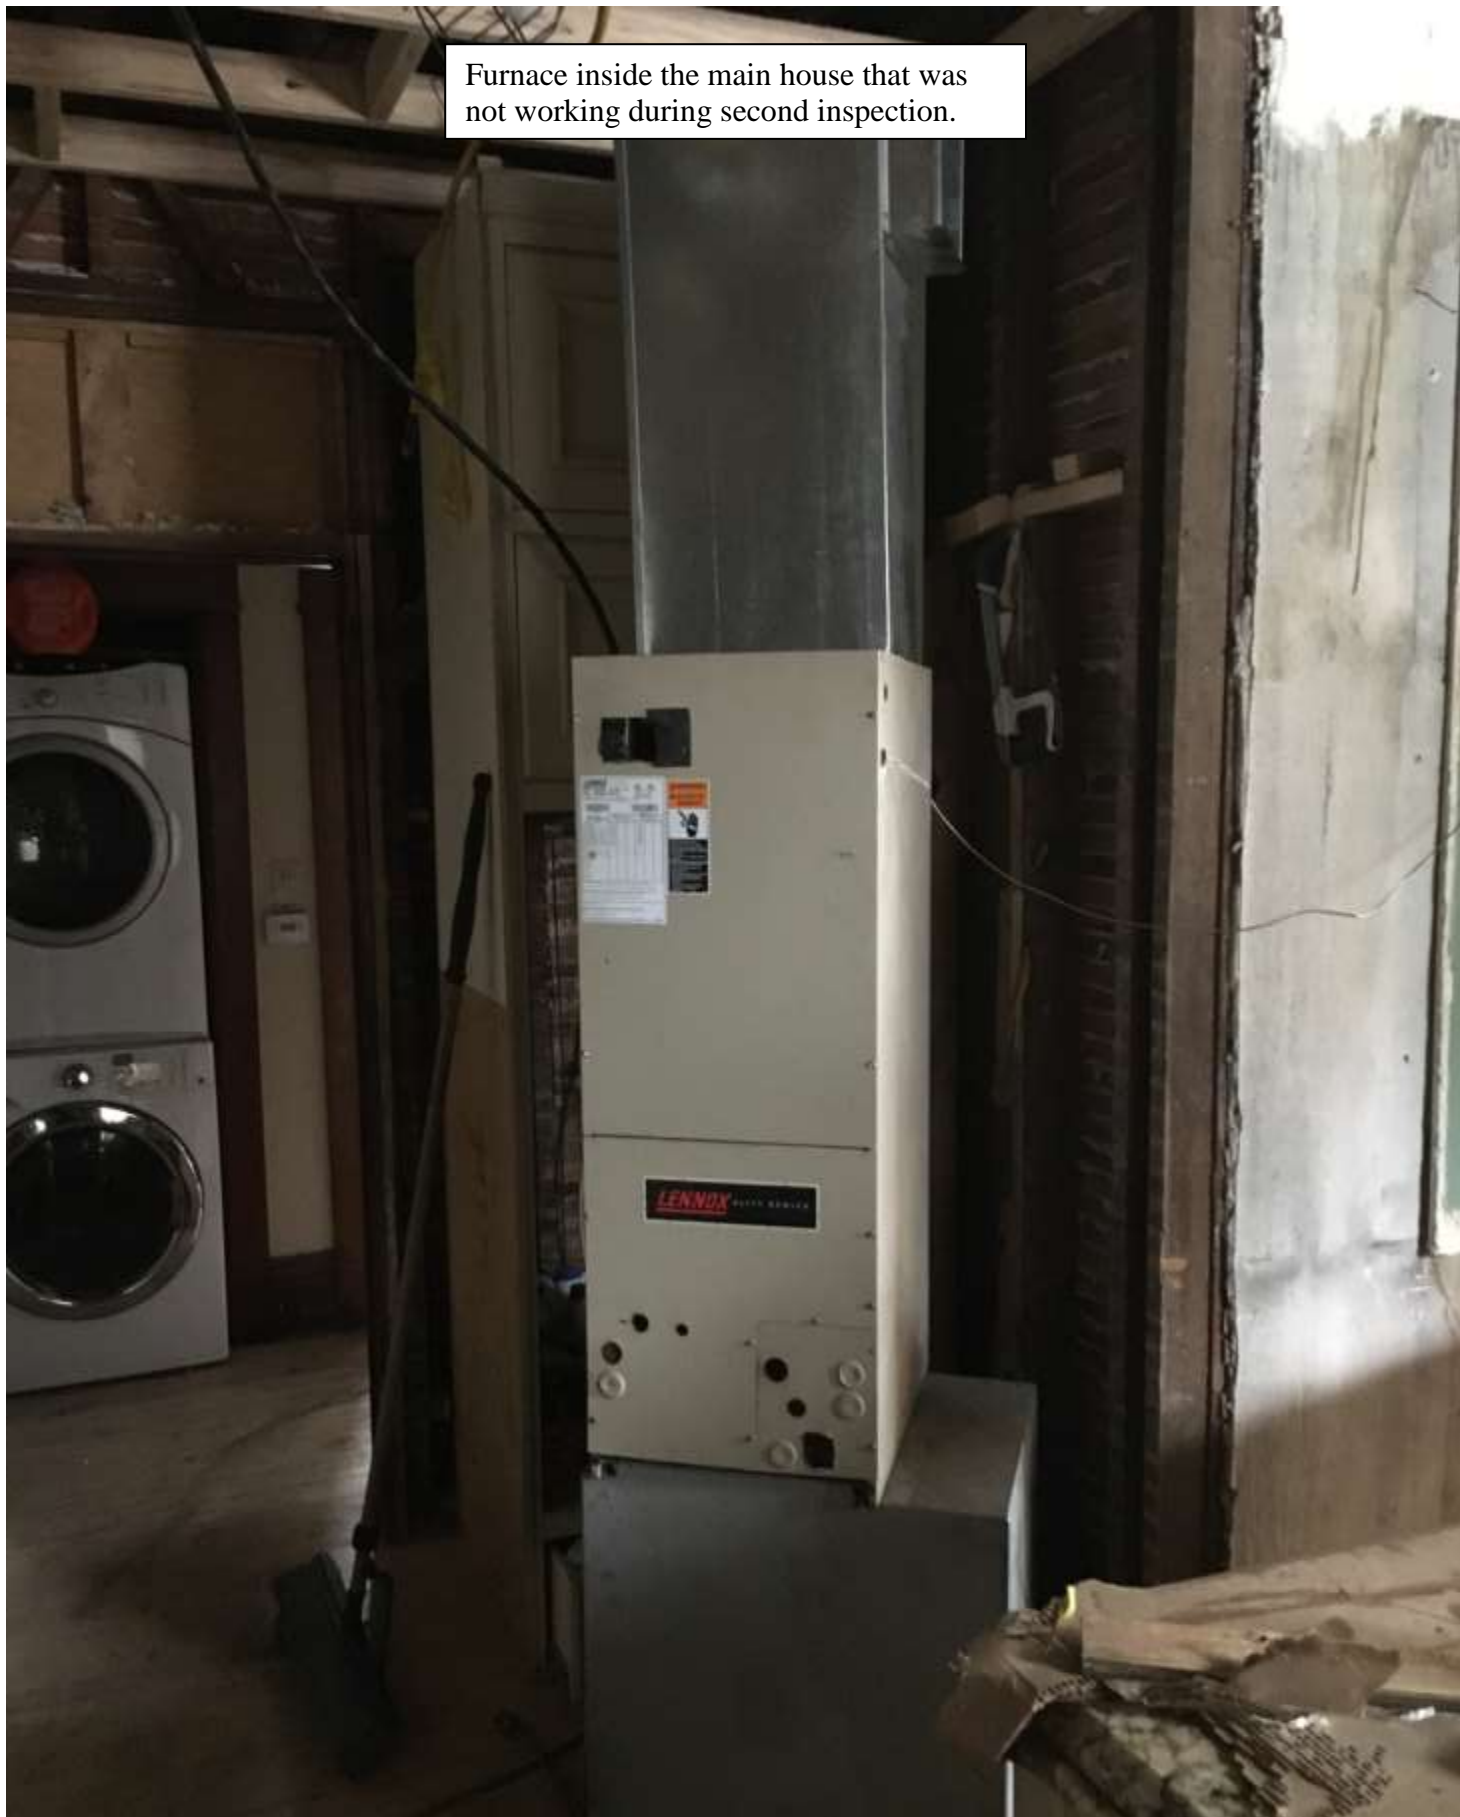
Furnace inside the main house that was not working during second inspection.

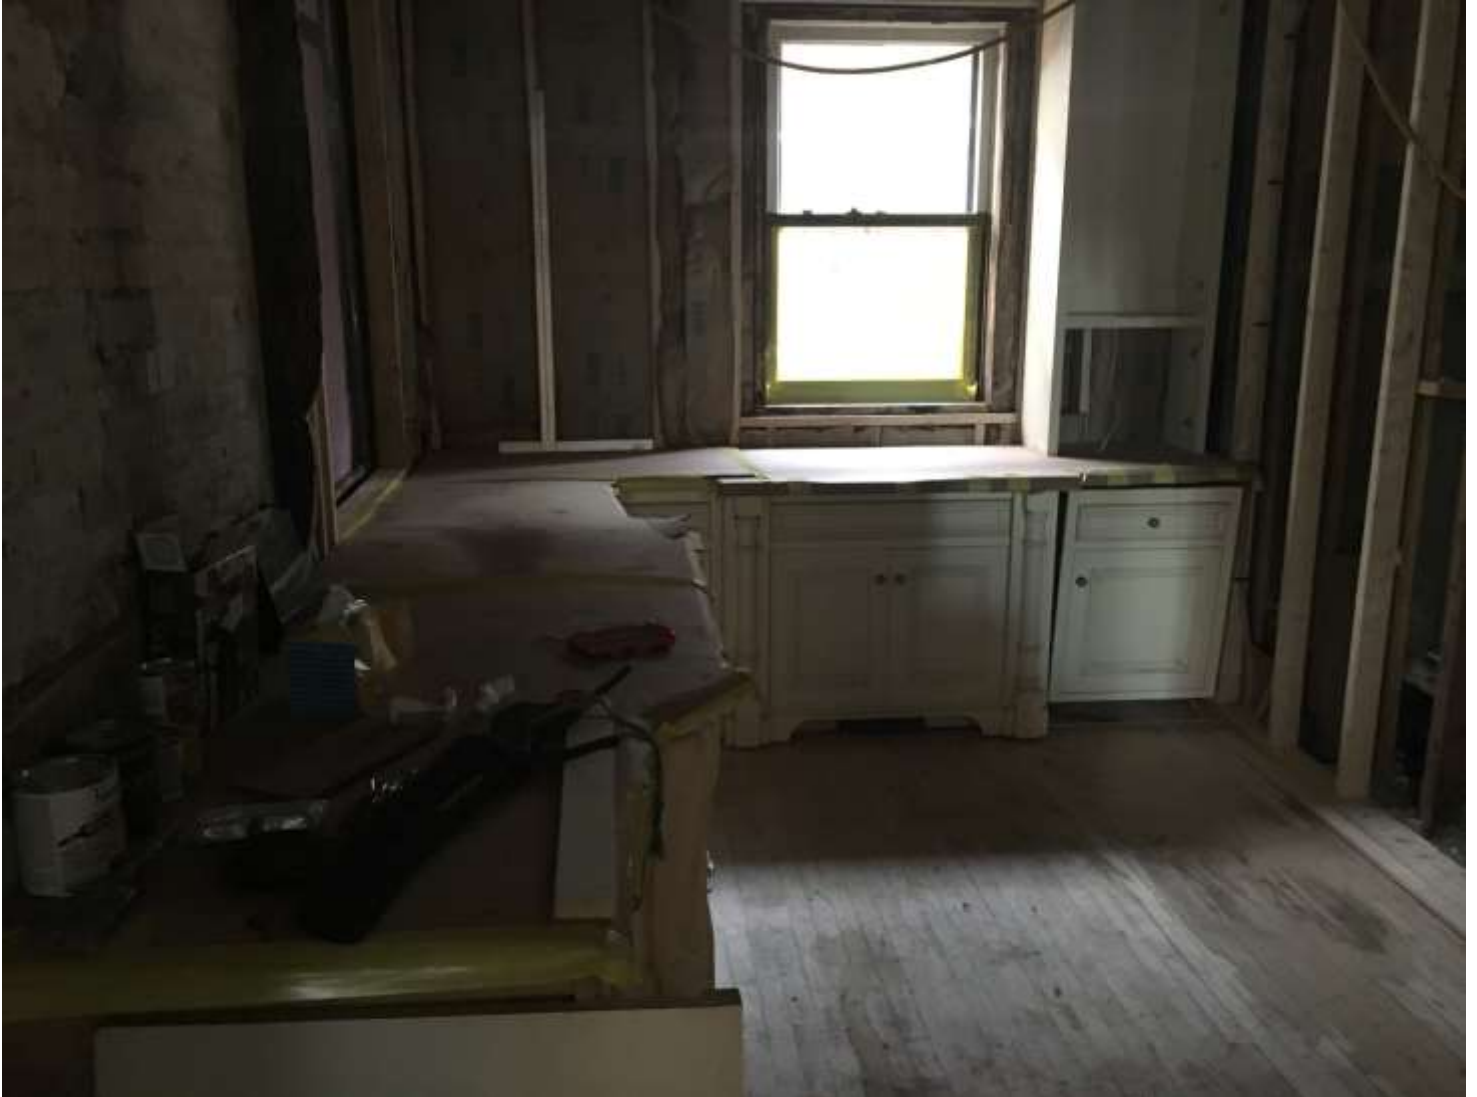
Kitchen remodel in the main house not done under permit.

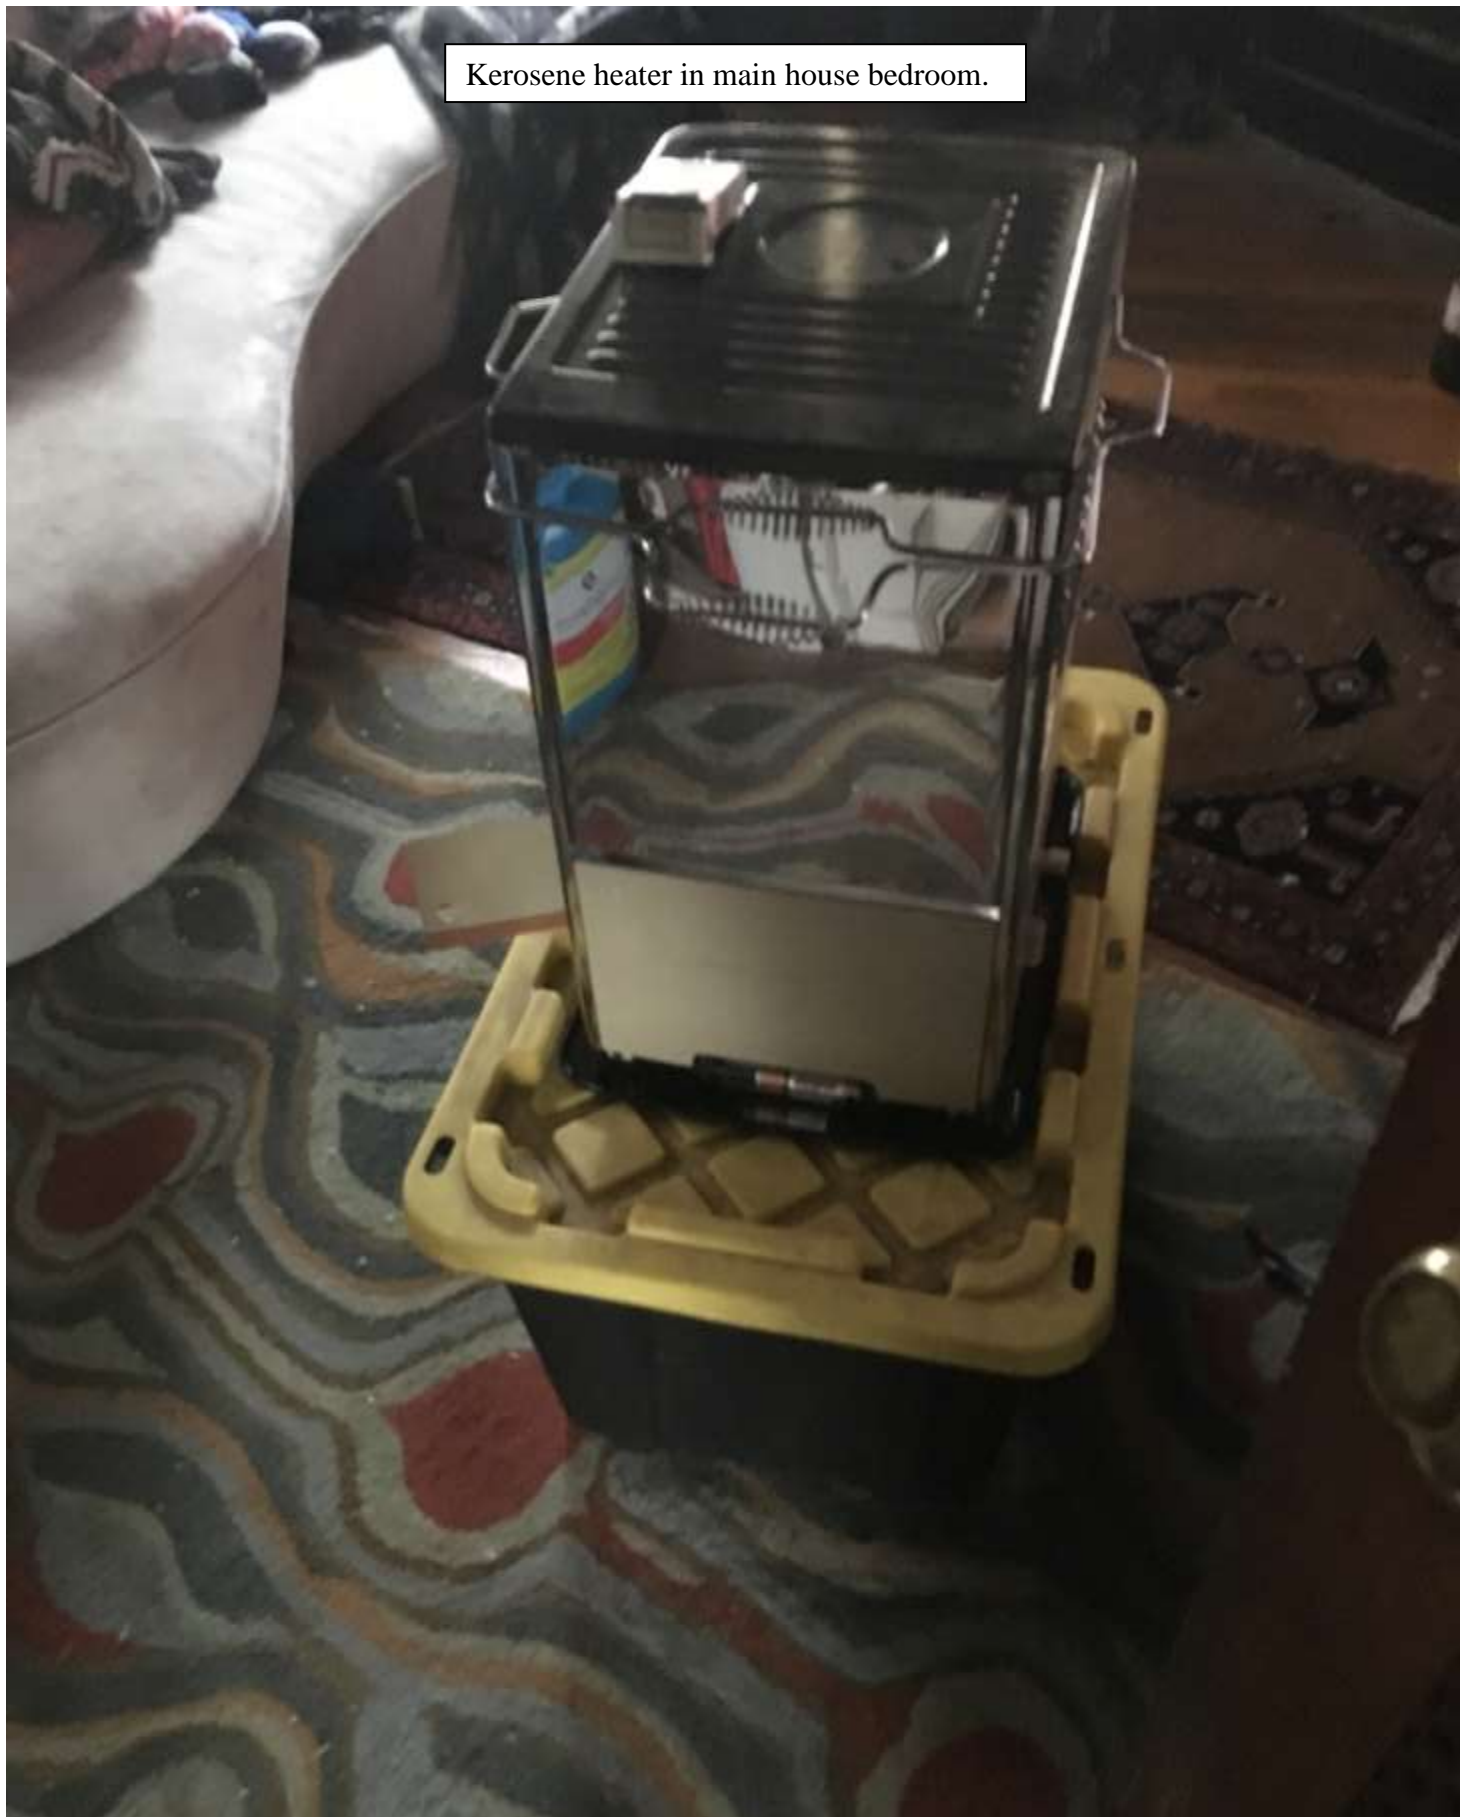
Kerosene heater in main house bedroom.

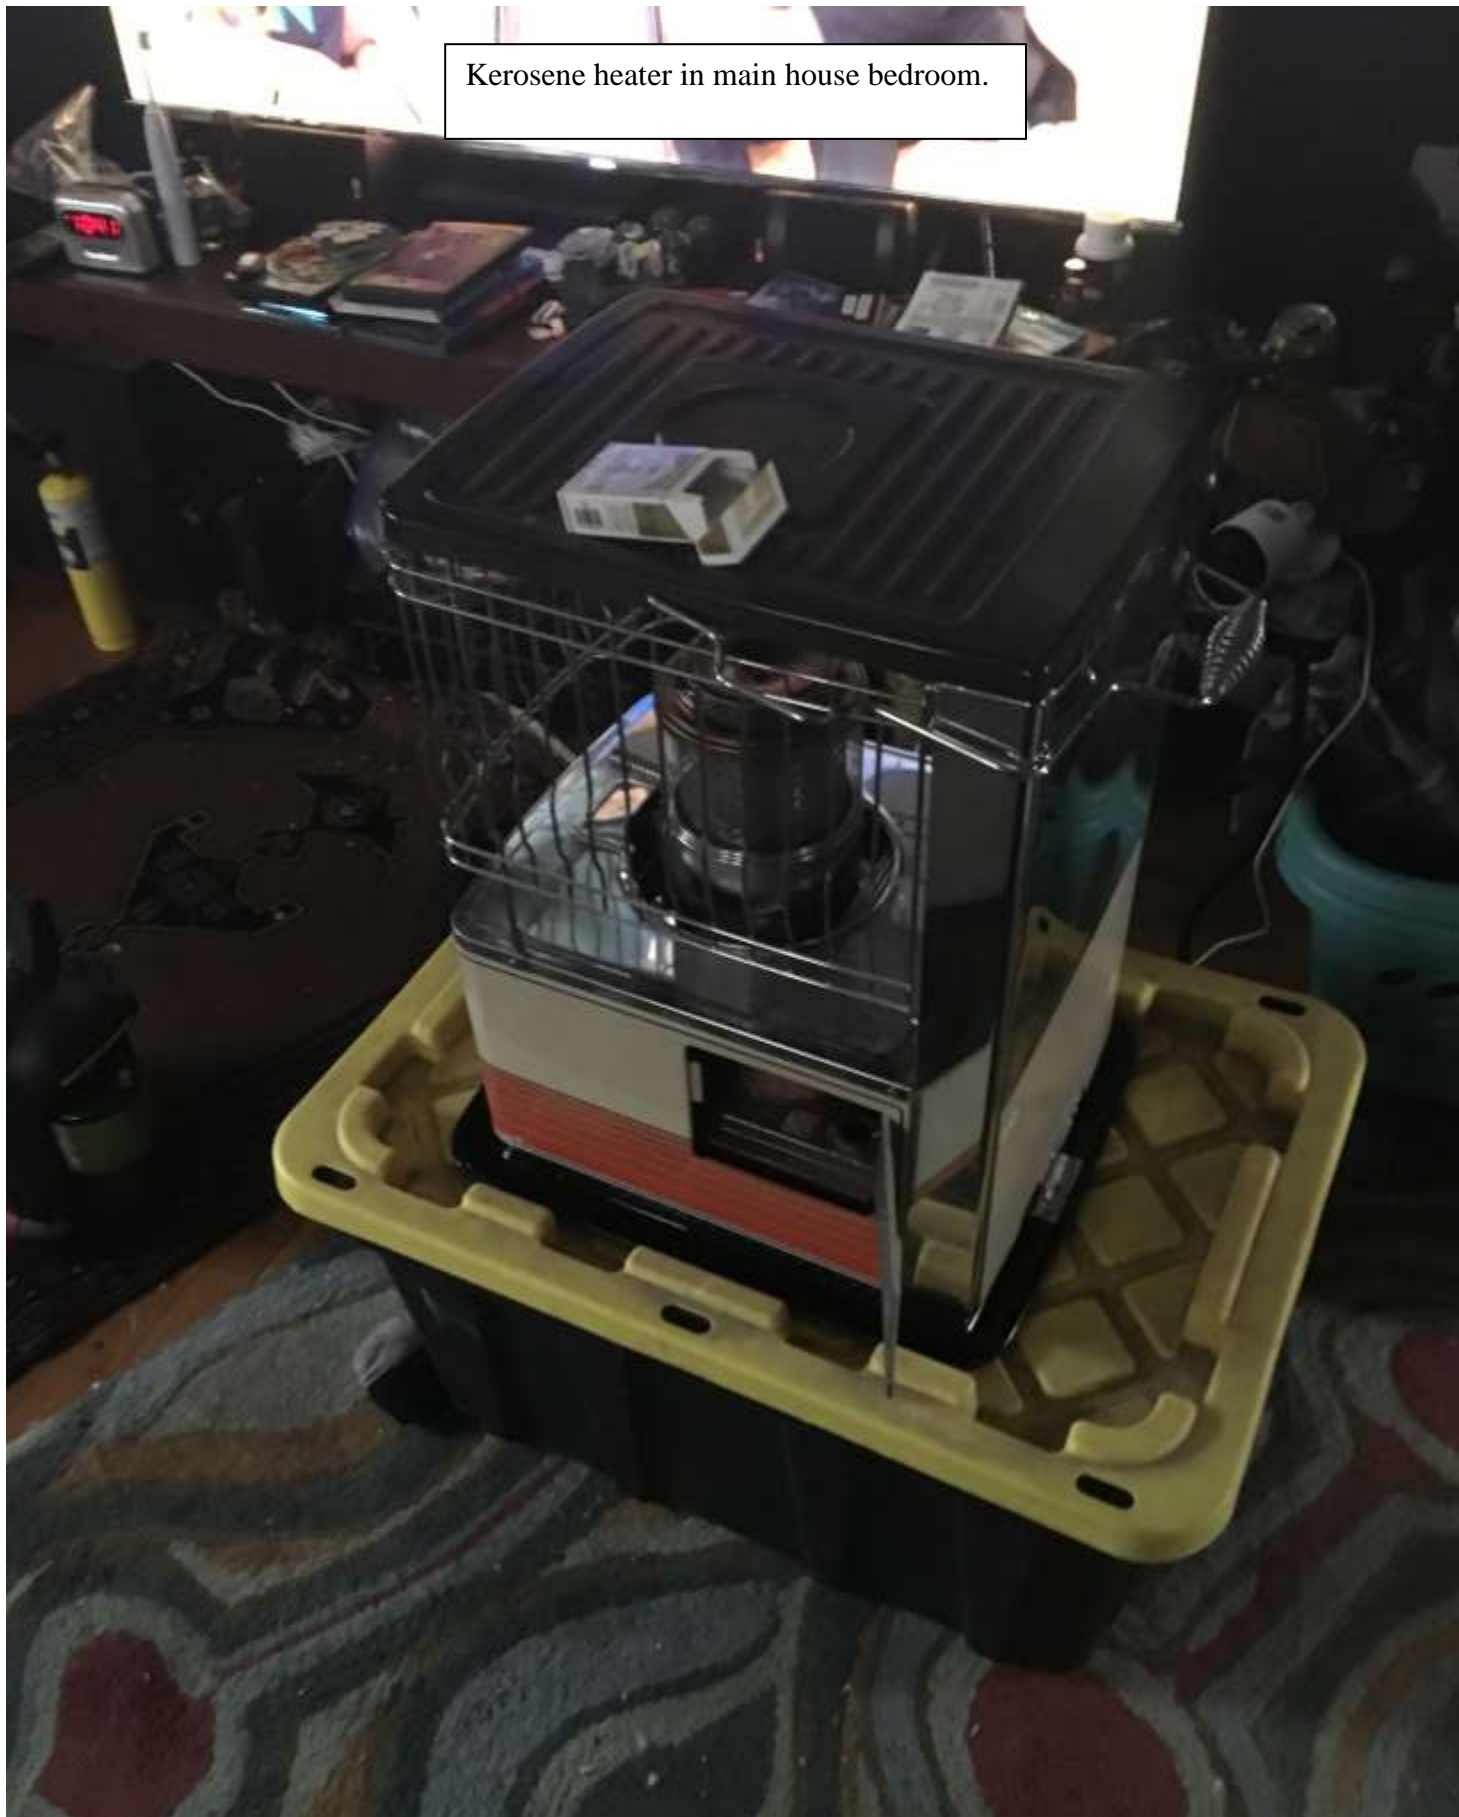
Kerosene heater in main house bedroom.

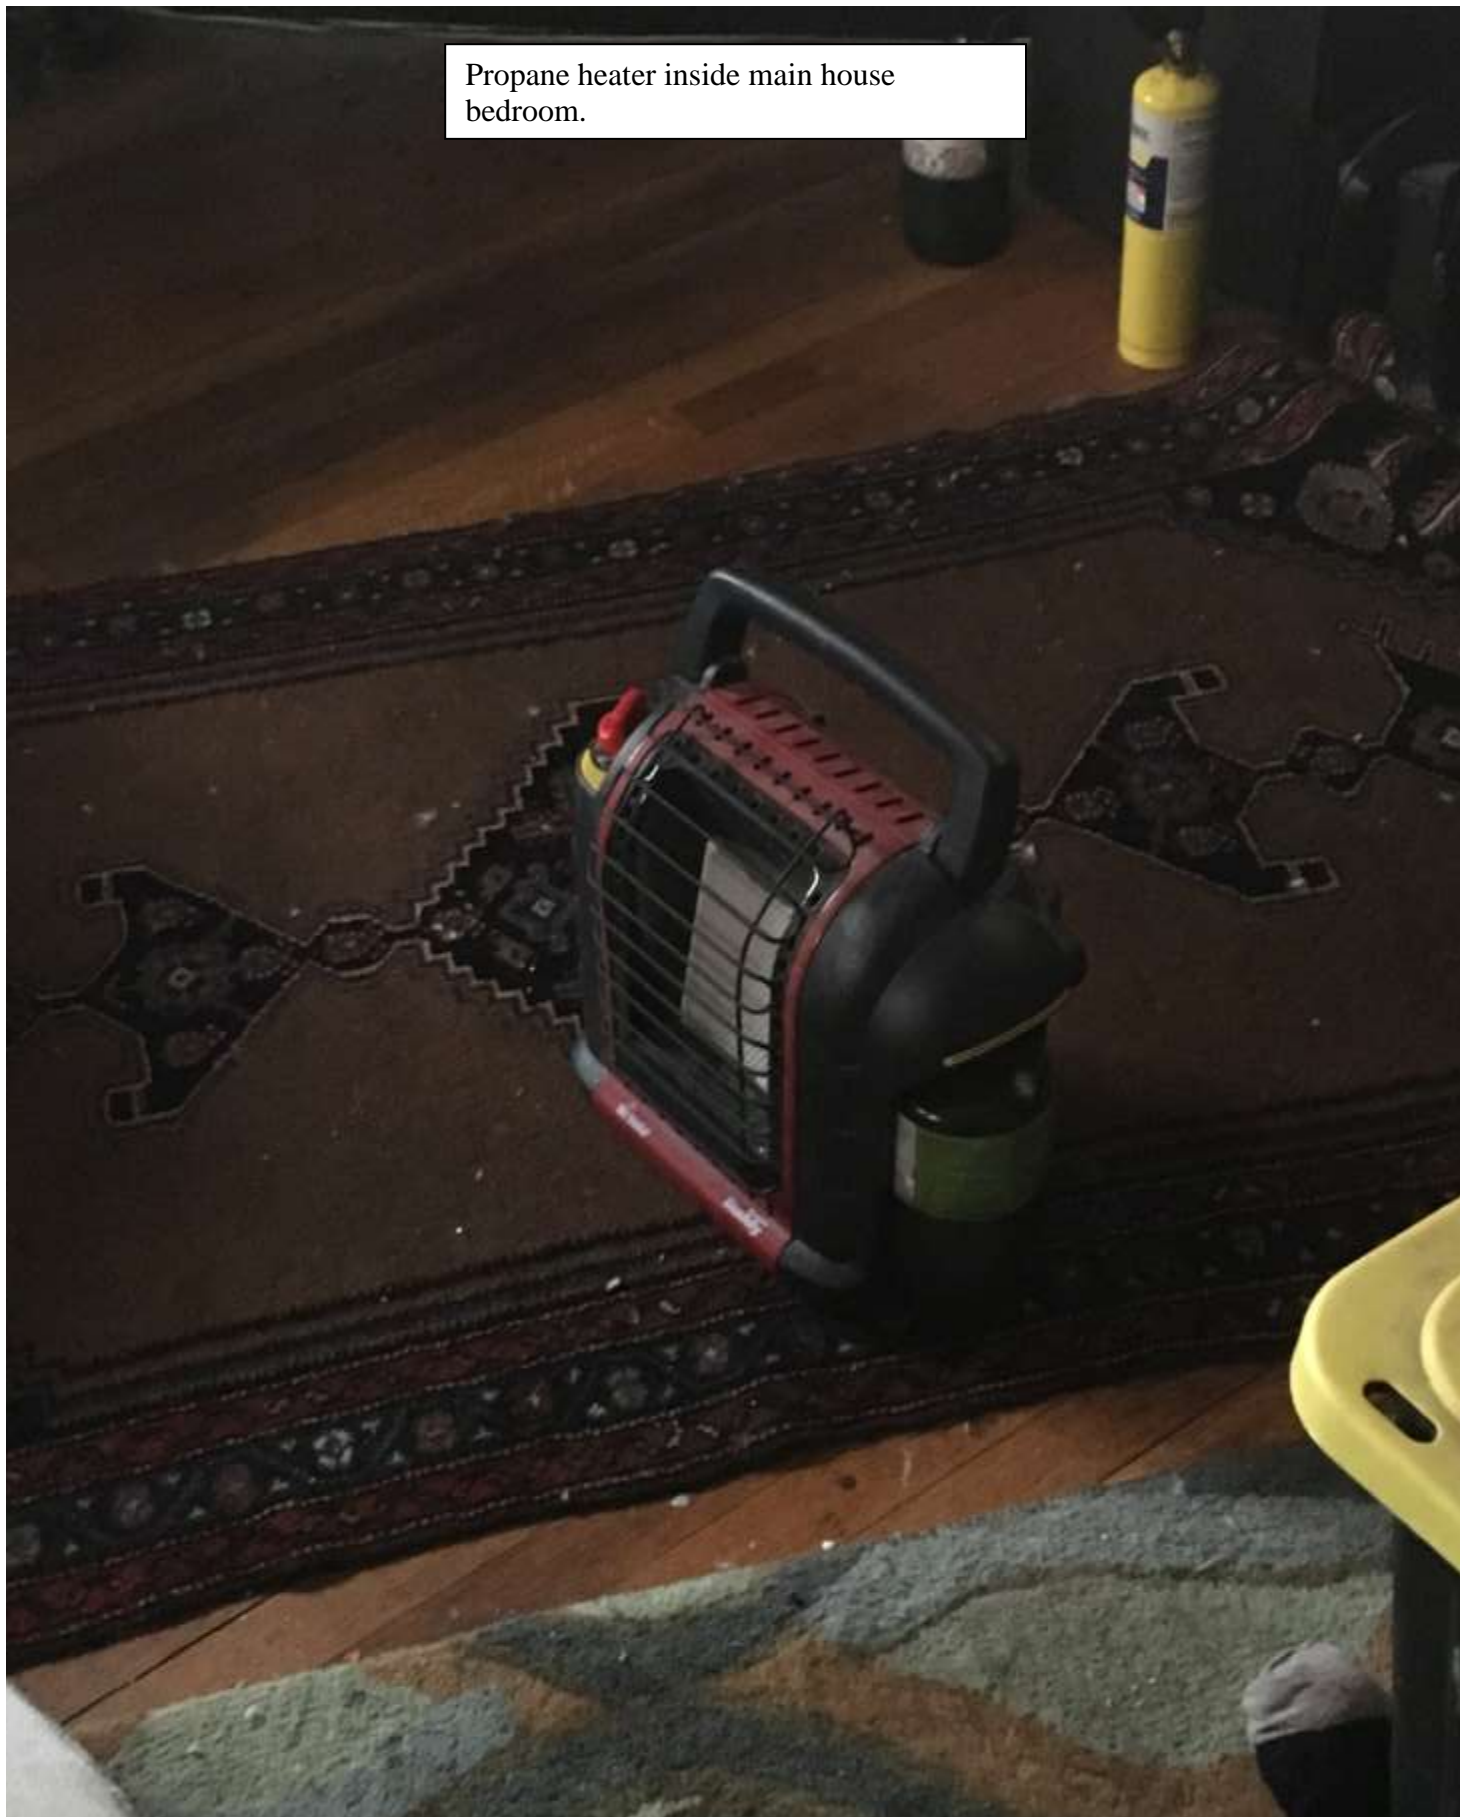
Propane heater inside main house  
bedroom.
