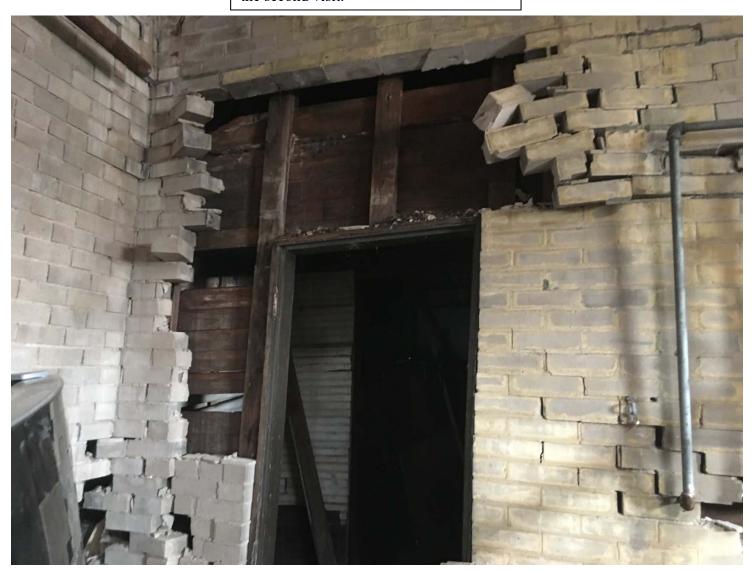
This is the interior, east side wall during the second visit.

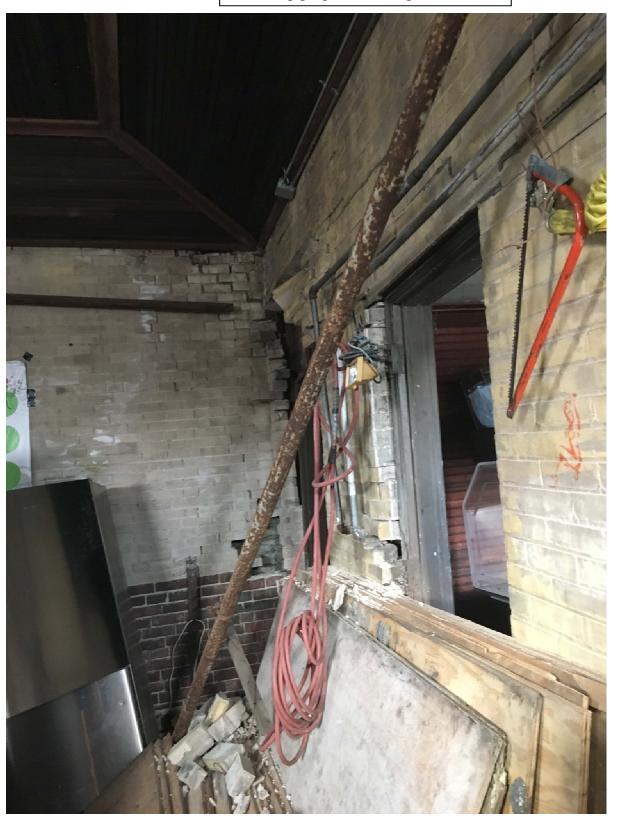
Interior East side wall, different angle. Note the piping. Second inspection.

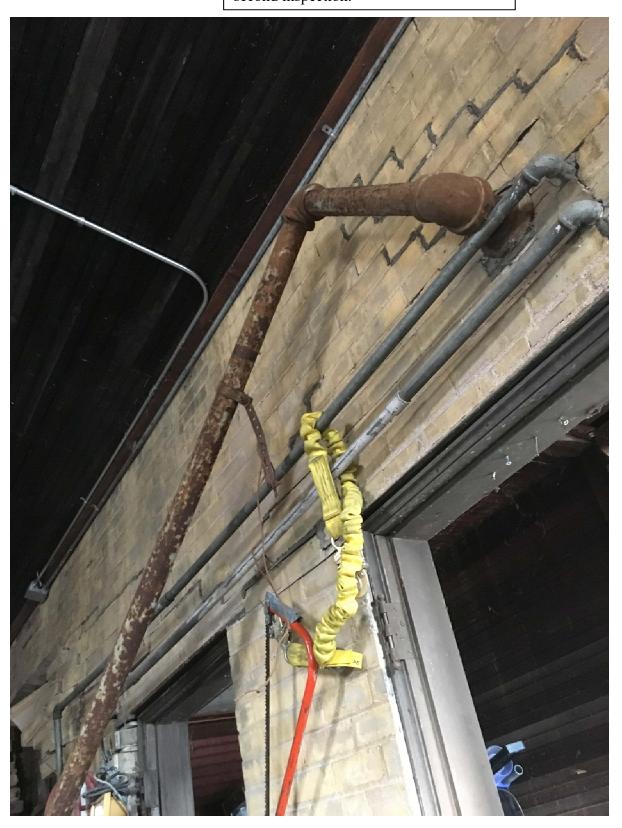
Interior carriage house east side wall on second inspection.

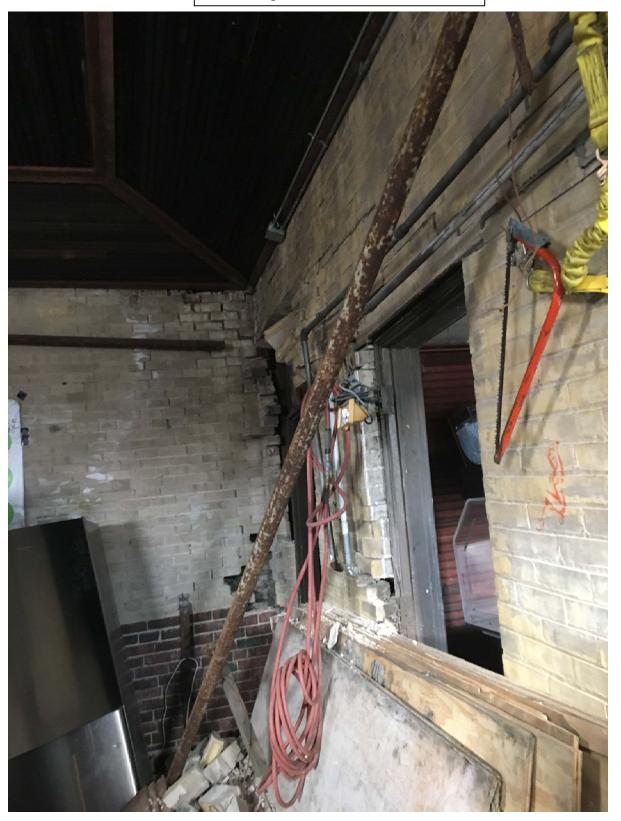
Interior carriage house east side wall on second inspection.

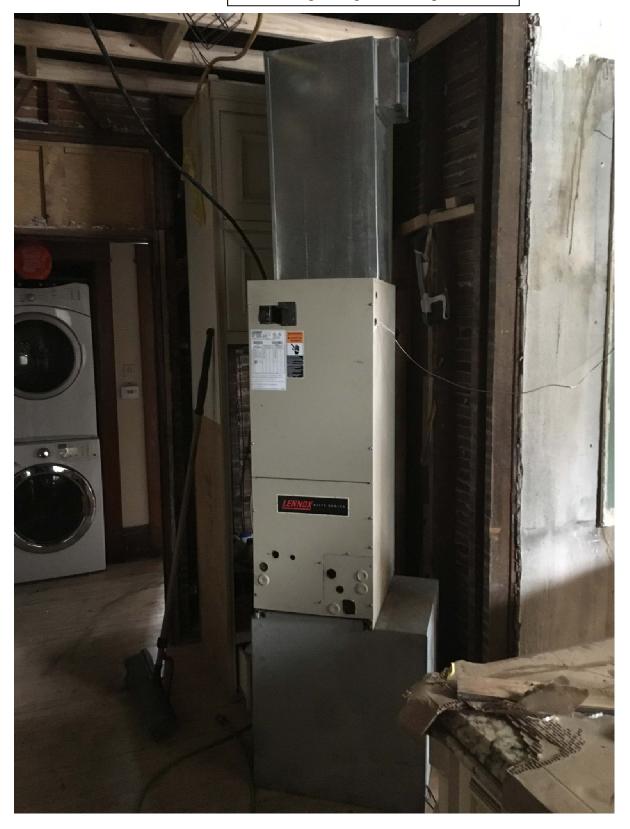
Furnace inside the main house that was not working during second inspection.

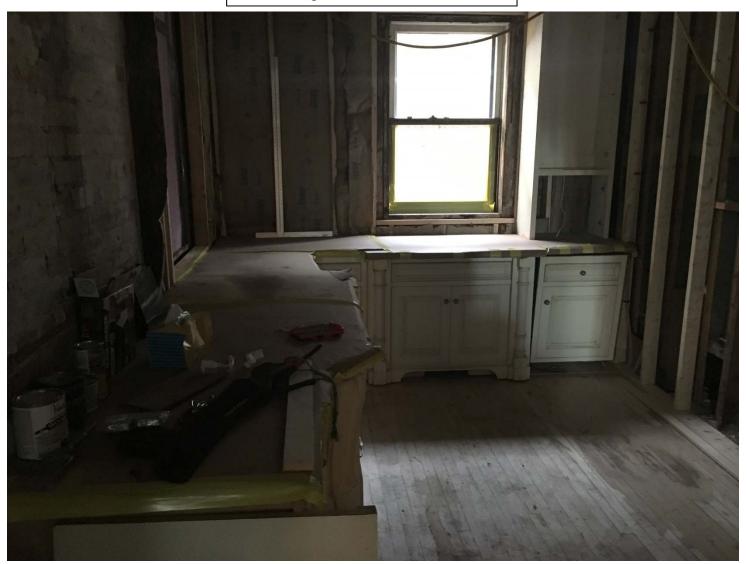
Kitchen remodel in the main house not done under permit.

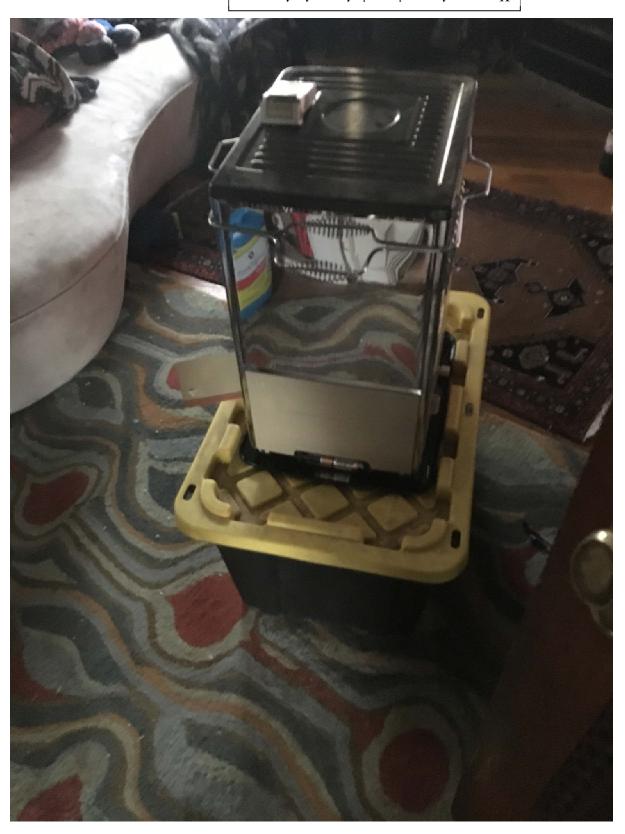
Kerosene heater in main house bedroom.

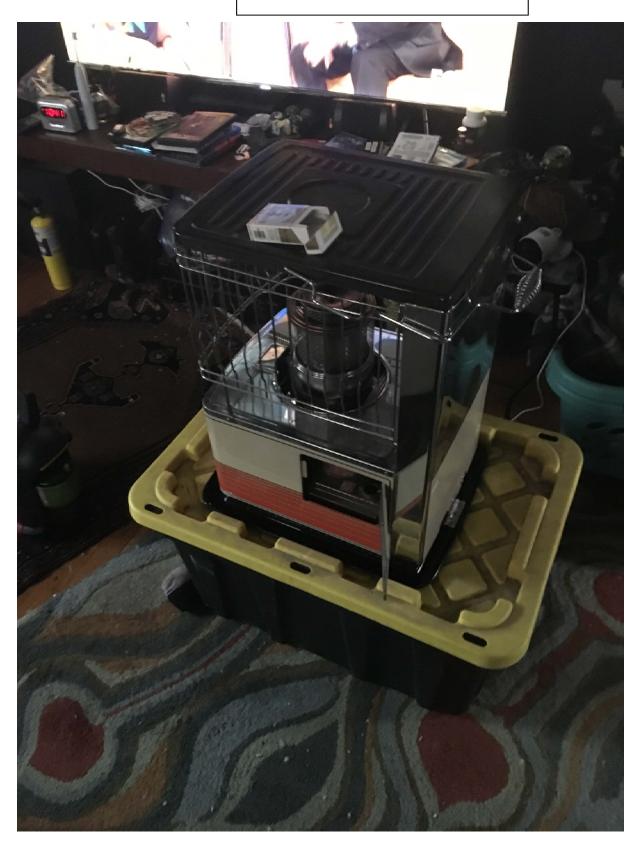
Kerosene heater in main house bedroom.

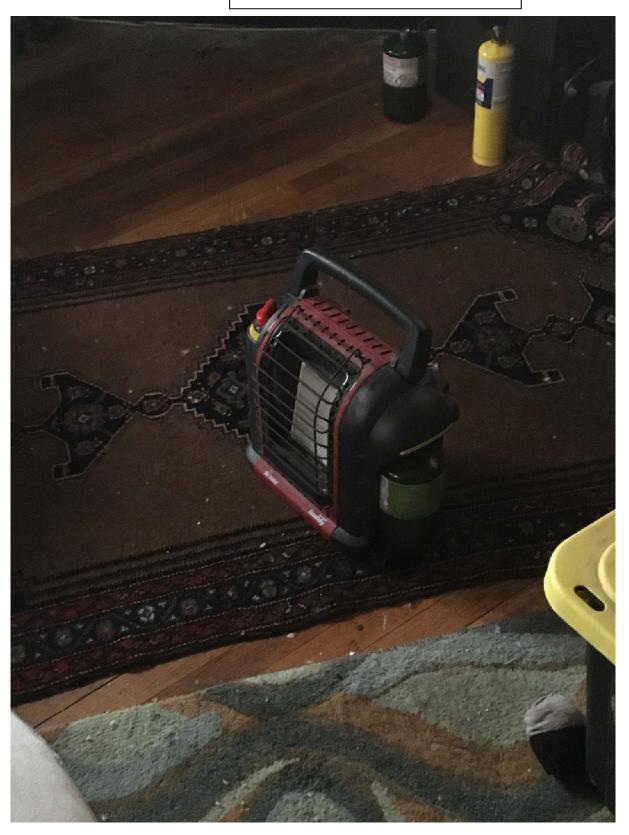
Propane heater inside main house bedroom.
