Date:	January 17, 2019
File #:	16 - 032685
Folder Name:	455 GRAND AVE
PIN:	012823310114

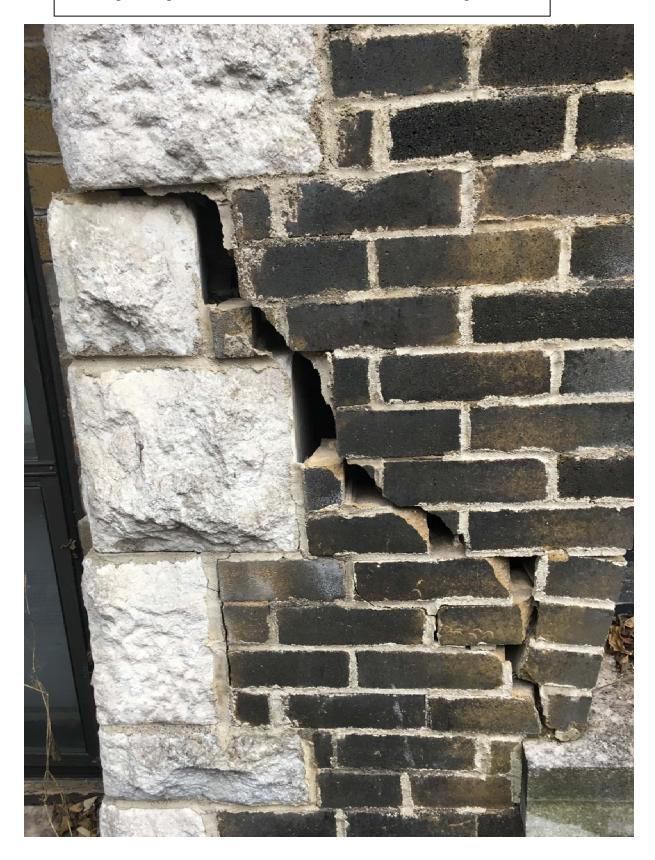
Cracking and separation on the East side exterior of the Carriage House.

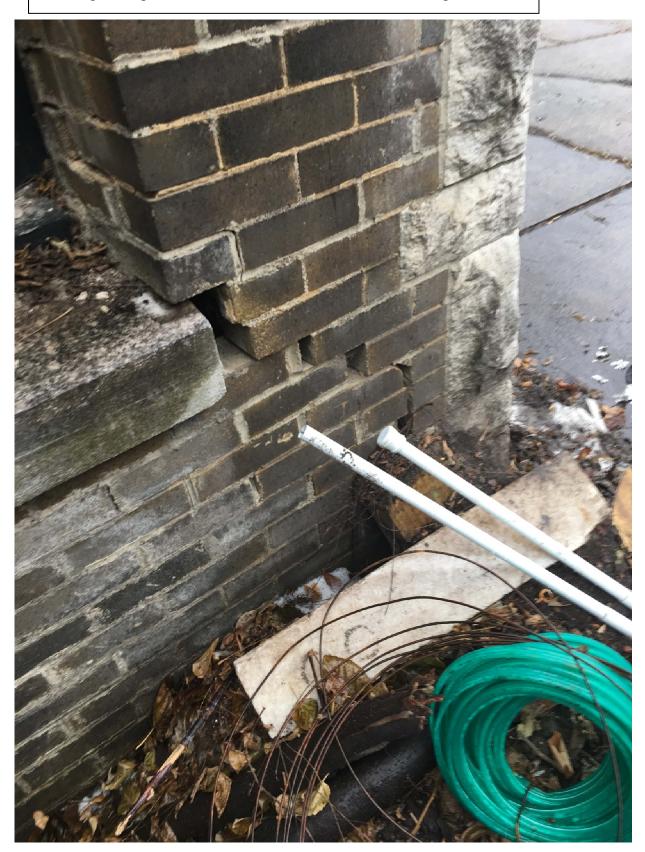
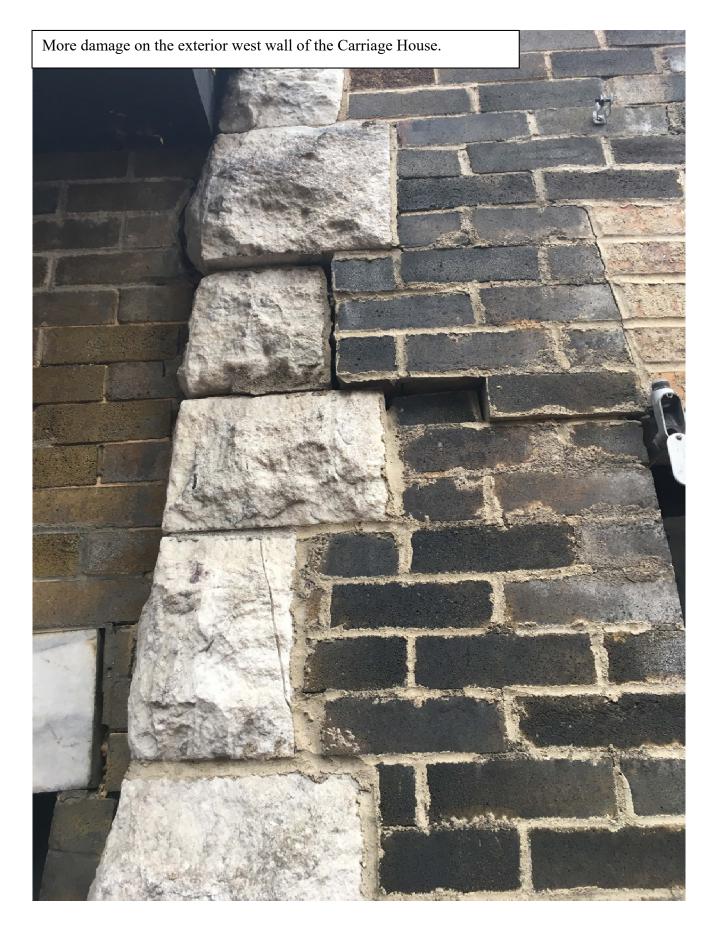
Cracking and separation of the West exterior wall of the Carriage House.

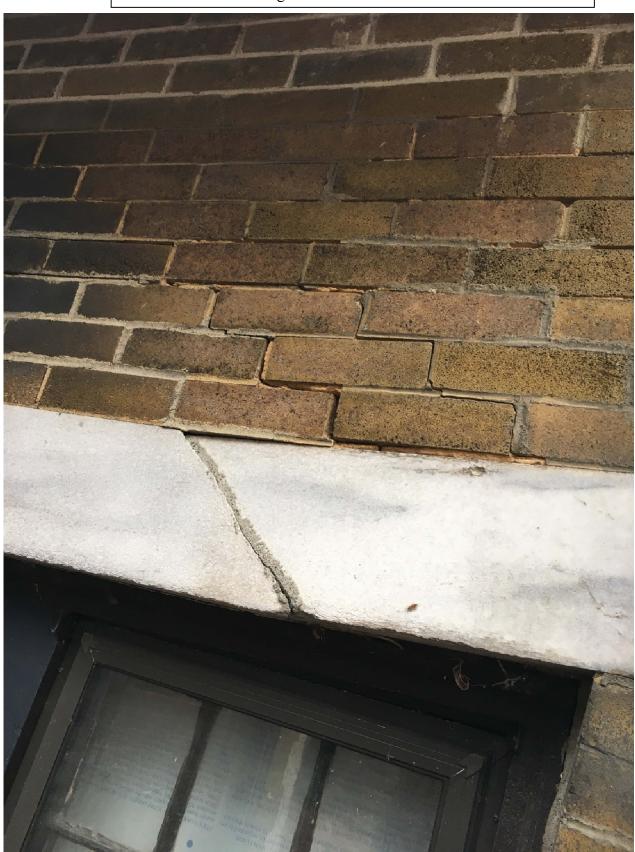
Exterior west wall damage above window.

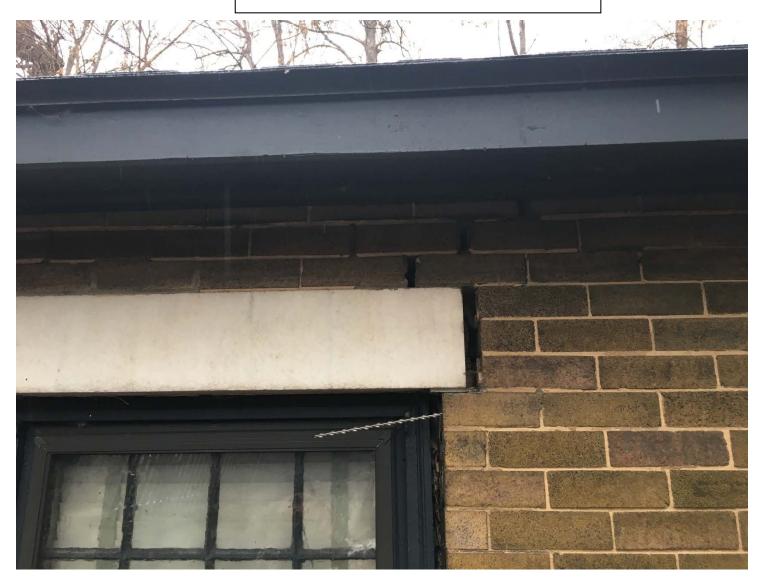
More damage exterior west wall. Window pulling away from the brick

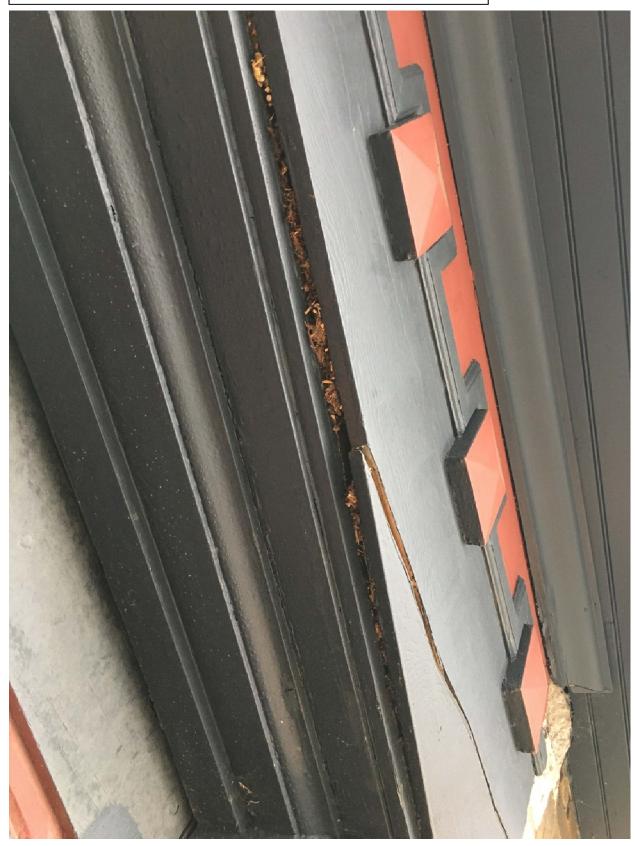
"garage door" of carriage house. Header cracked and separating.

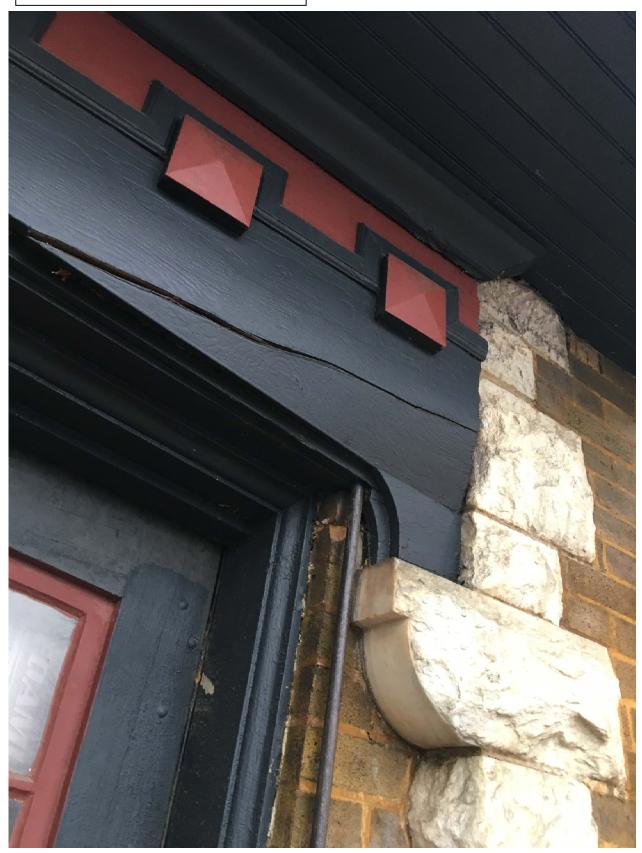
Zoomed out view of the "garage door".

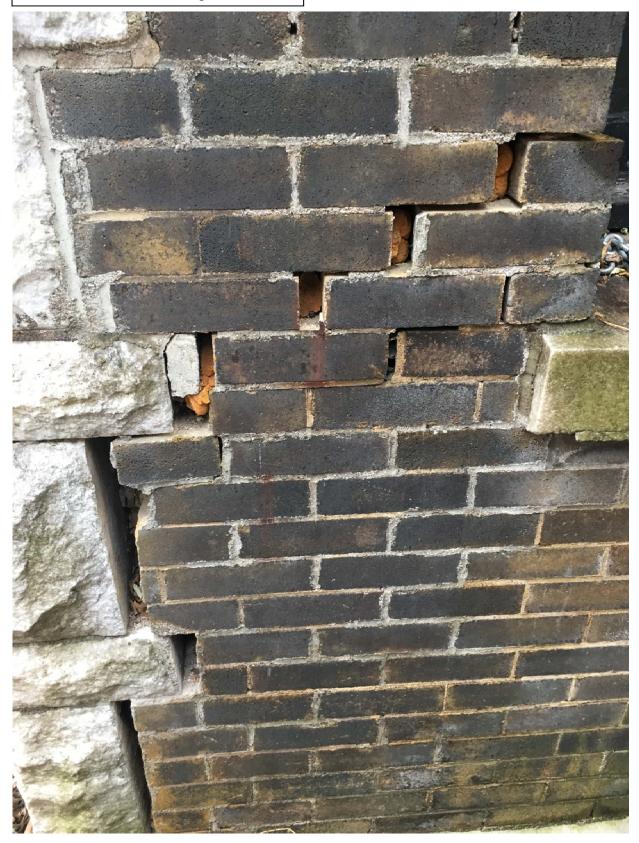
West wall exterior of carriage house.

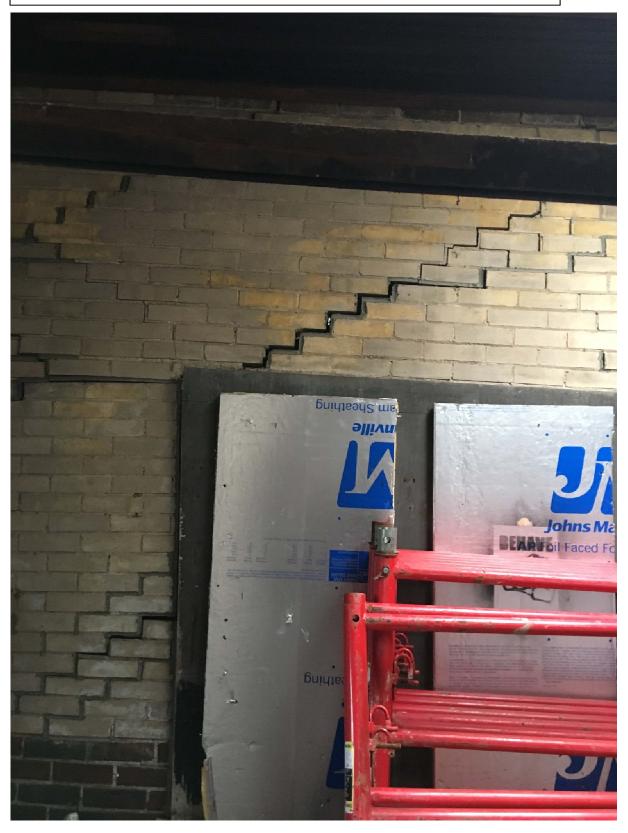
Interior west wall of the carriage house. You can see daylight through the various cracking and separation.

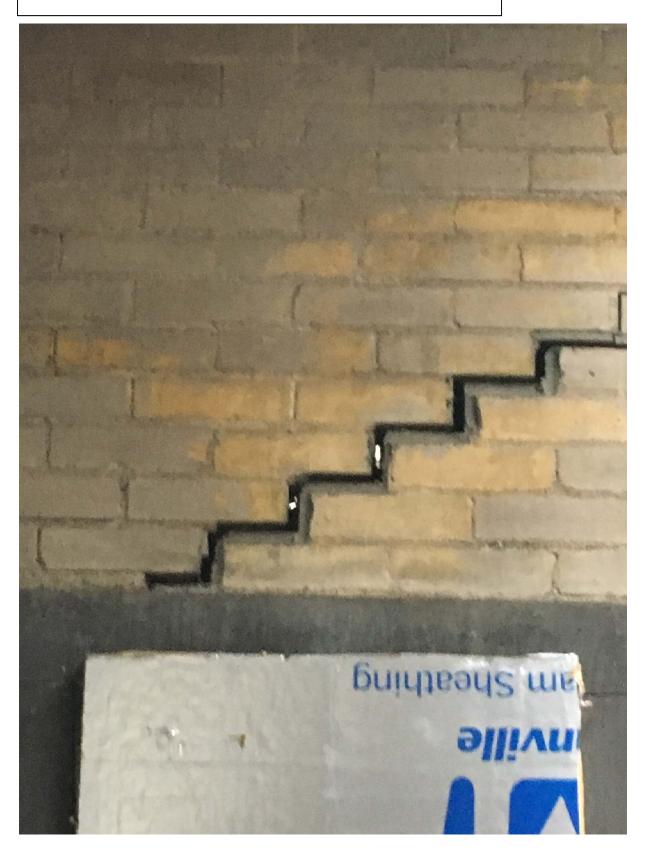
Cracking and separation on the west wall of the Carriage House.

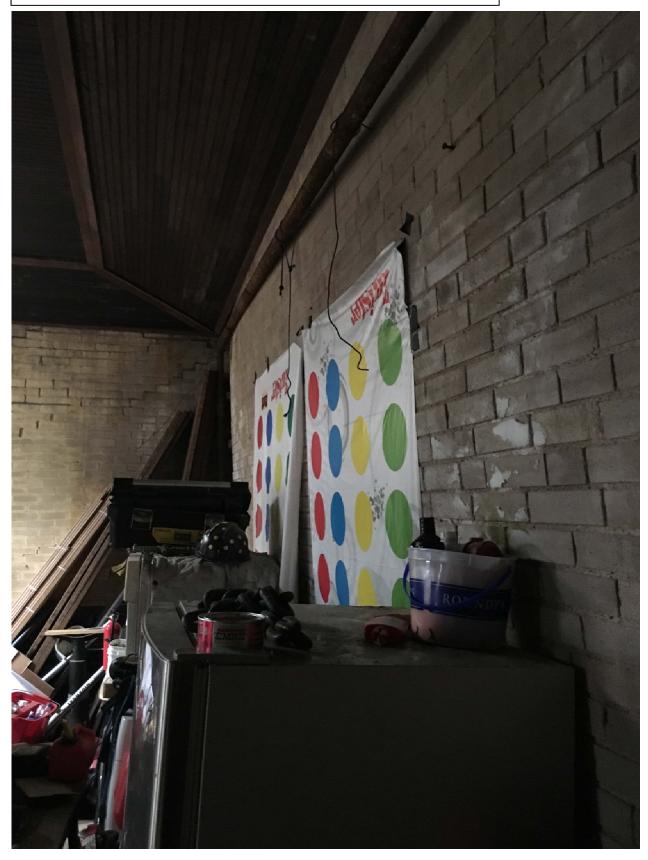
North wall. Hard to tell in pictures, but this wall is bulging inward.

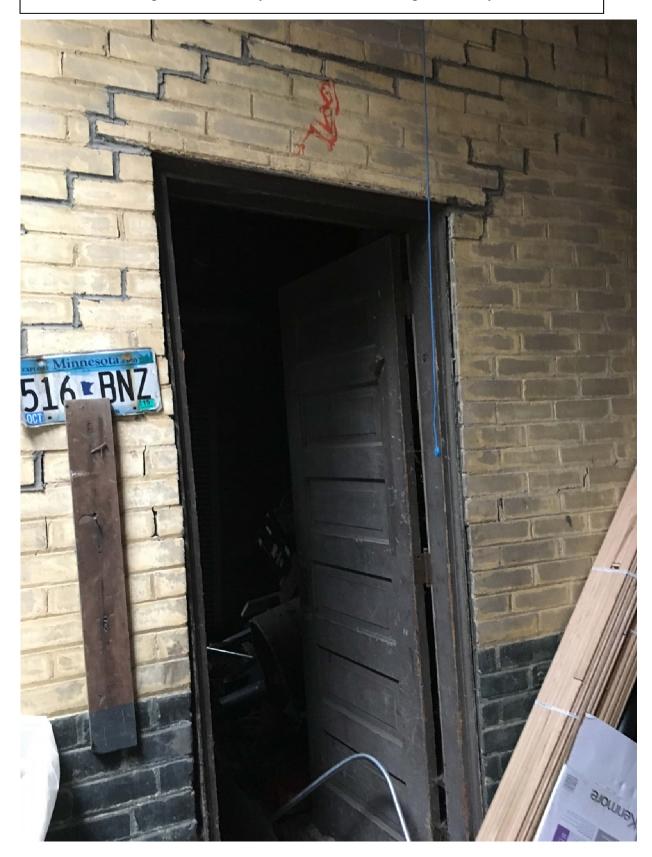
West side of carriage house doorway. Phone camera is straight, doorway is slanted.

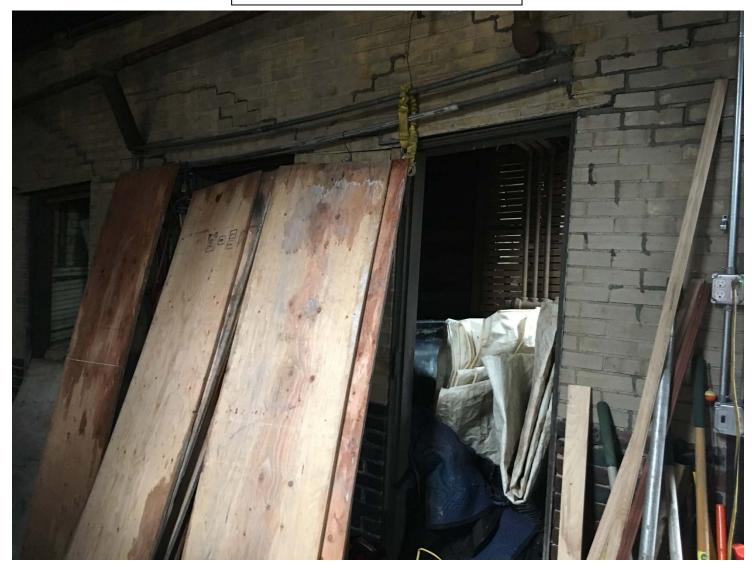
Interior East wall damage with carious cracking. Note the piping.
