Larson

November 11, 2019

Re: Building Facade Assessment
1258 Albemarle Street
Saint Paul, MN 55117
LEI Project No: 11191342.000

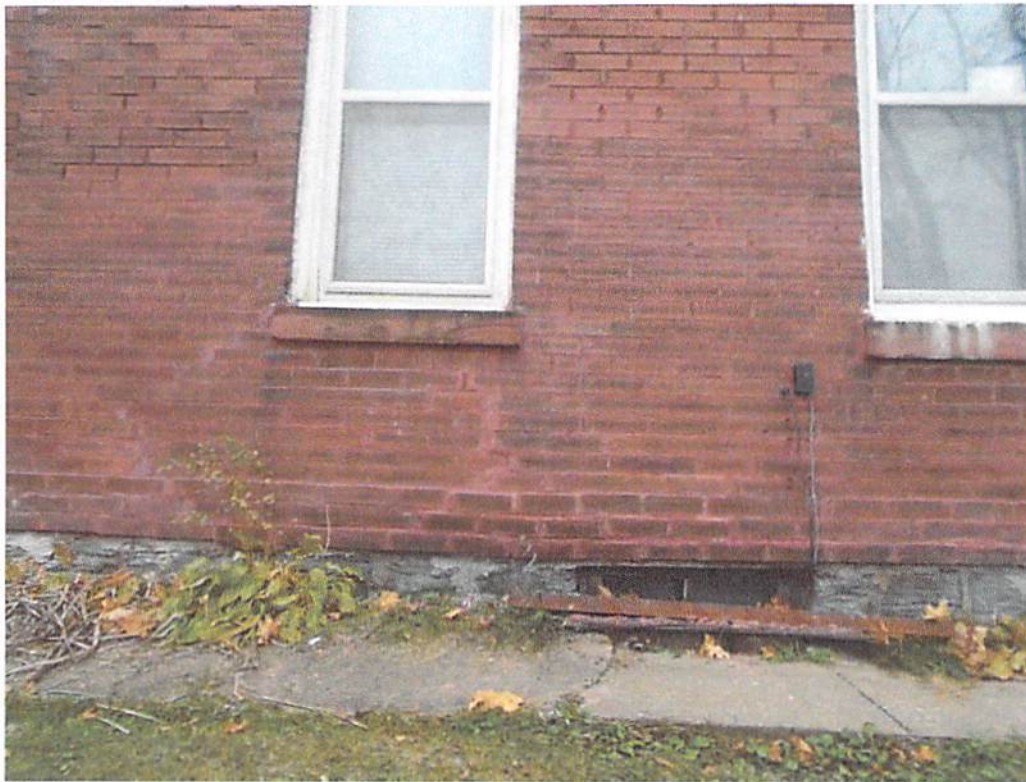
1. We observed some stair step cracking along the north wall at the main floor level of this residence (See Photos 1 and 2).
2. We also notice some wood infill framing around the perimeter of the exiting two windows on the north side of this residence. Some of the framing only extended two-thirds up the window jamb (See Photo 3). We also observed some deteriorated sealant along the jamb and at the head of the windows (See Photo 4).

Photo 1: Photo of the two main level windows on the north side of the residence.

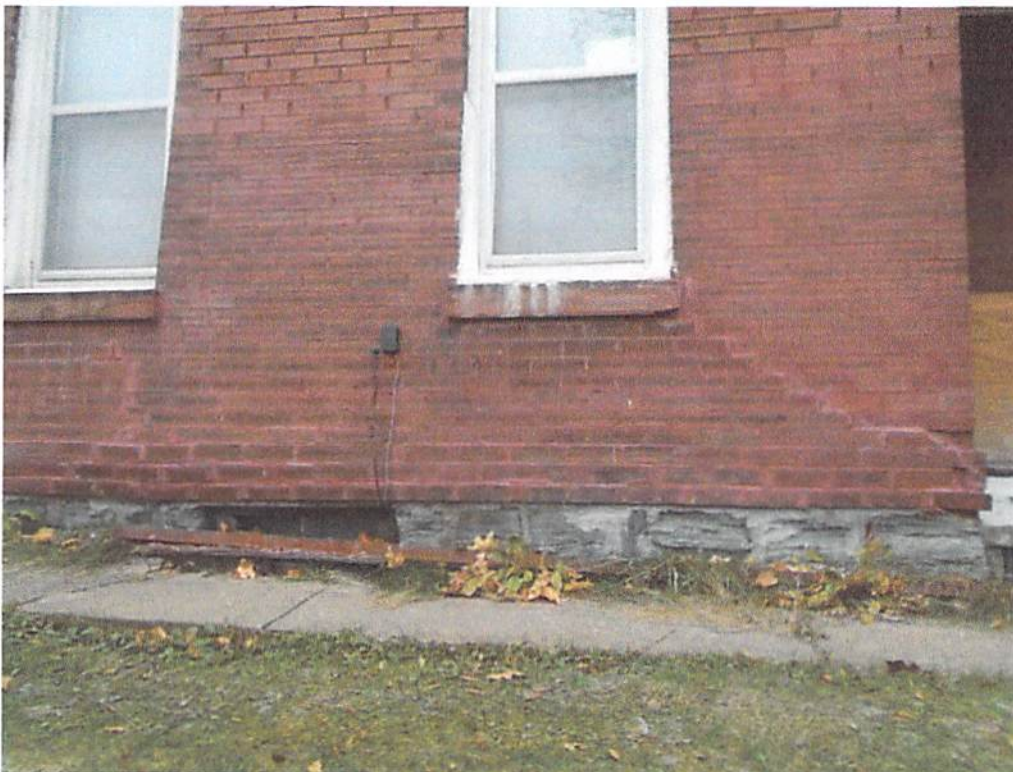
Photo 2: Another photo of the north wall in question, with stair step cracking starting at the sill of from the westernmost window.

The masonry around the two main level windows on the north side of the home appears to be intact and therefore, we would suggest monitoring this masonry wall and reviewing a year from now to evaluate the condition of the existing wall at this location. At the time of the follow-up evaluation, if the mortar has been displaced or severely cracked, we would suggest removing the bowed-out portion of the wall and rebuilding this portion of the wall.

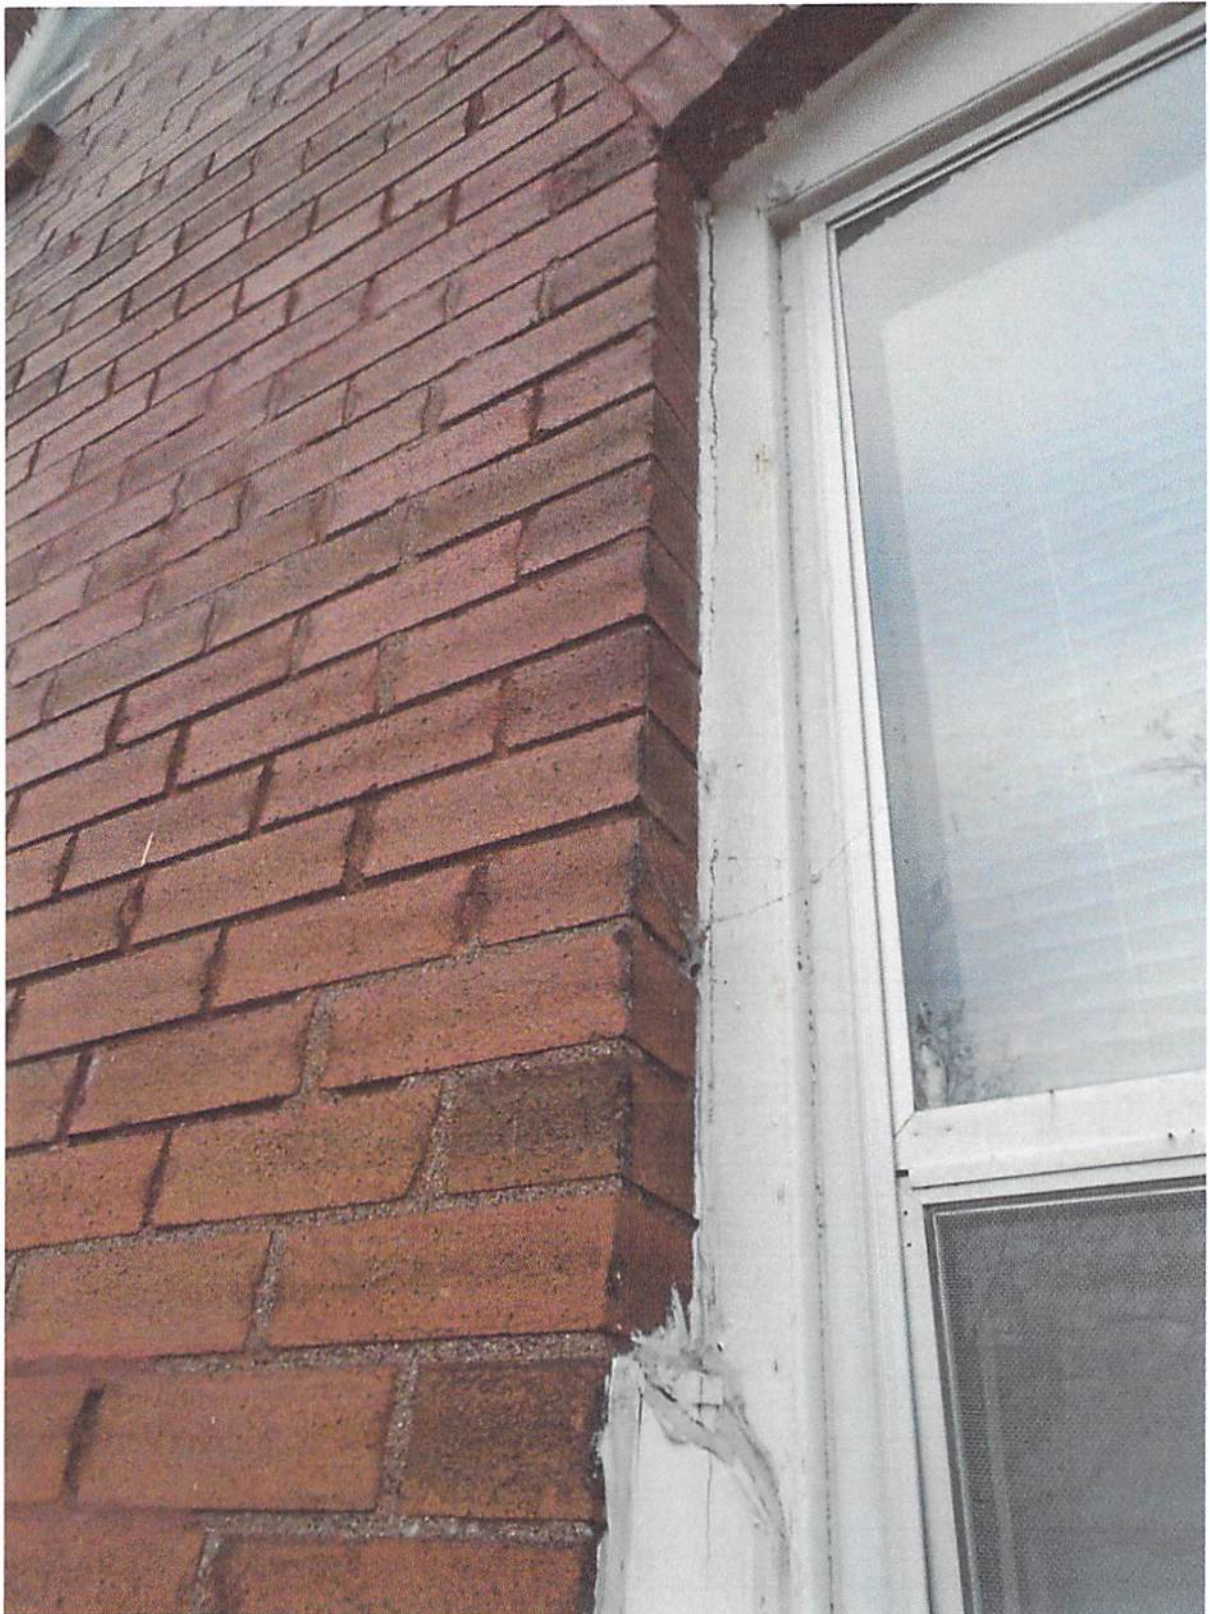
Photo 3: Deteriorated sealant on wood molding around perimeter of window stops show of window head.

Based on the conditions observed around the perimeter of the two main level windows on the north side of the home, we would suggest replacing the wood that only goes up to a portion of the jamb and replace it with wood that extends up to the window head. We would also suggest removing and replacing the deteriorated sealant around the perimeter of the window.

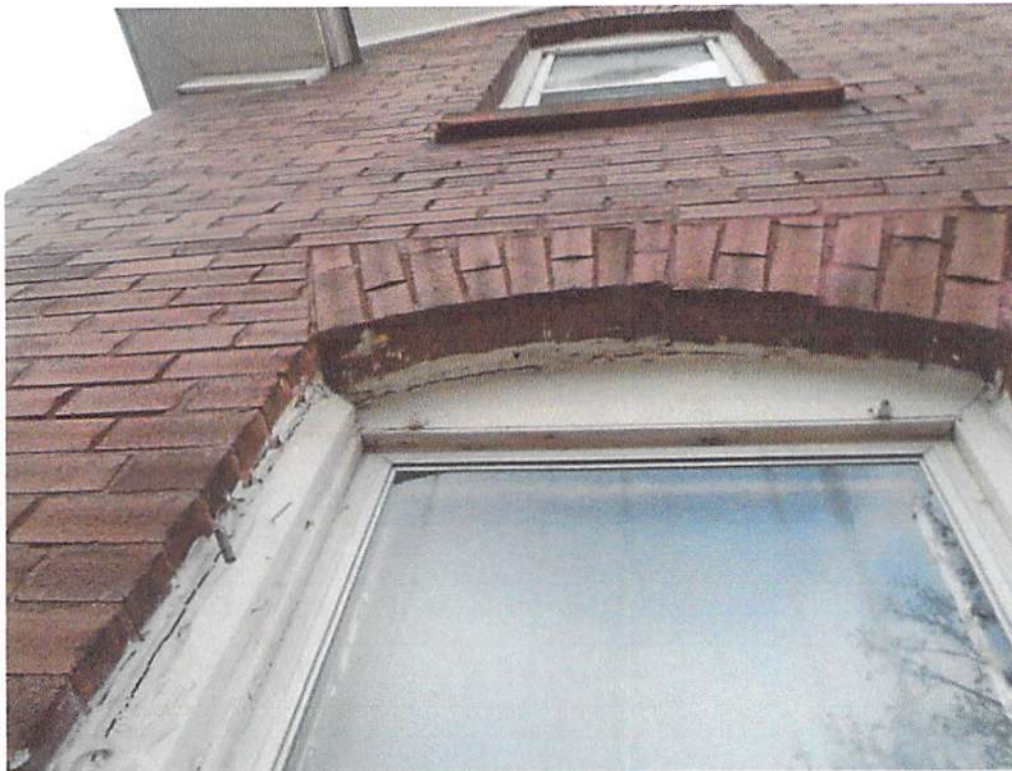
Photo 4: Deteriorated sealant observed around jamb and window head or easternmost window.

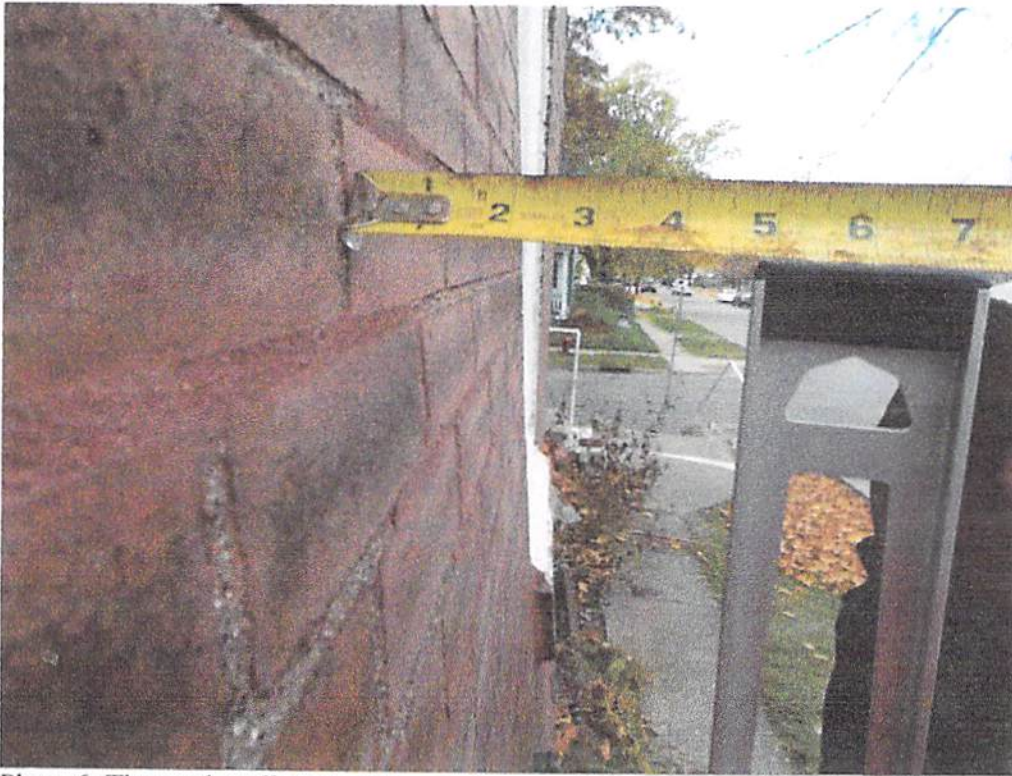
3. Six inches east of the easternmost window, the wall was observed to be out of plumb by 1-3/4" over 4ft (See Photo 5).
4. Six inches west of the easternmost window, the wall was observed to be out of plumb by approximately 4-3/4" over 4ft (See Photo 6).

Photo 6: The north wall west of the window opening was approximately $4\frac{3}{4}$ " out of plumb in 4ft.

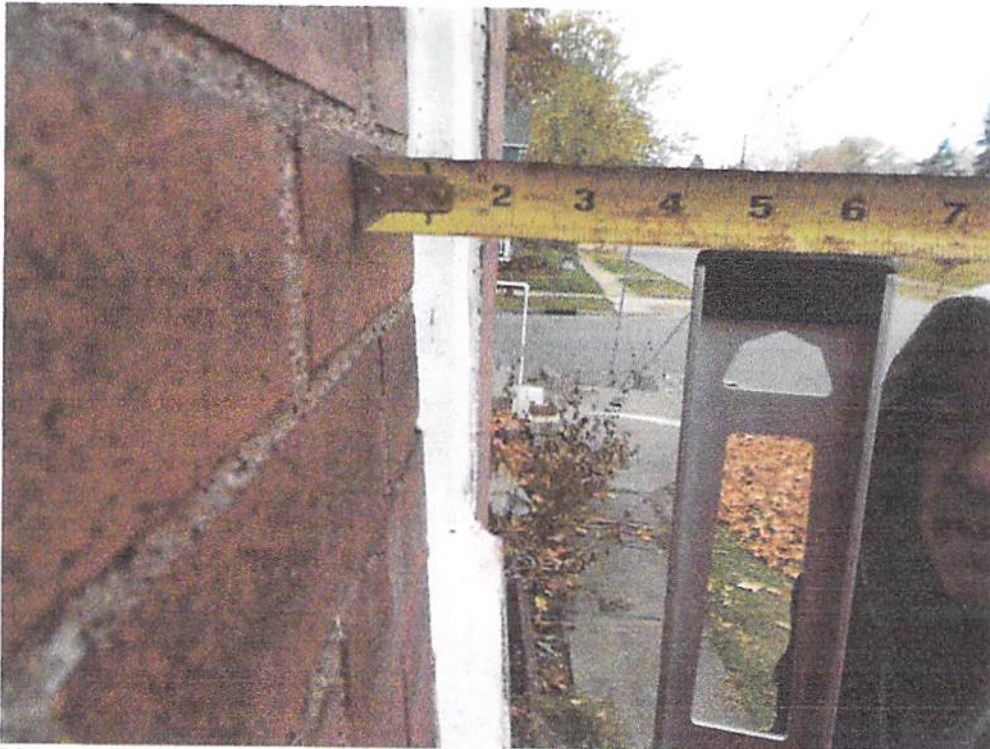
5. Six inches east of the westernmost window, the wall was observed to be out of plumb by approximately 4-3/16" over 4ft (See Photo 7).
6. Six inches west of the westernmost window, the wall was observed to be out of plumb by approximately 2.5" over 4ft (See Photo 8).

Photo 7: The north wall east of the window opening was approximately $4\frac{3}{16}$ " out of plumb in 4ft.

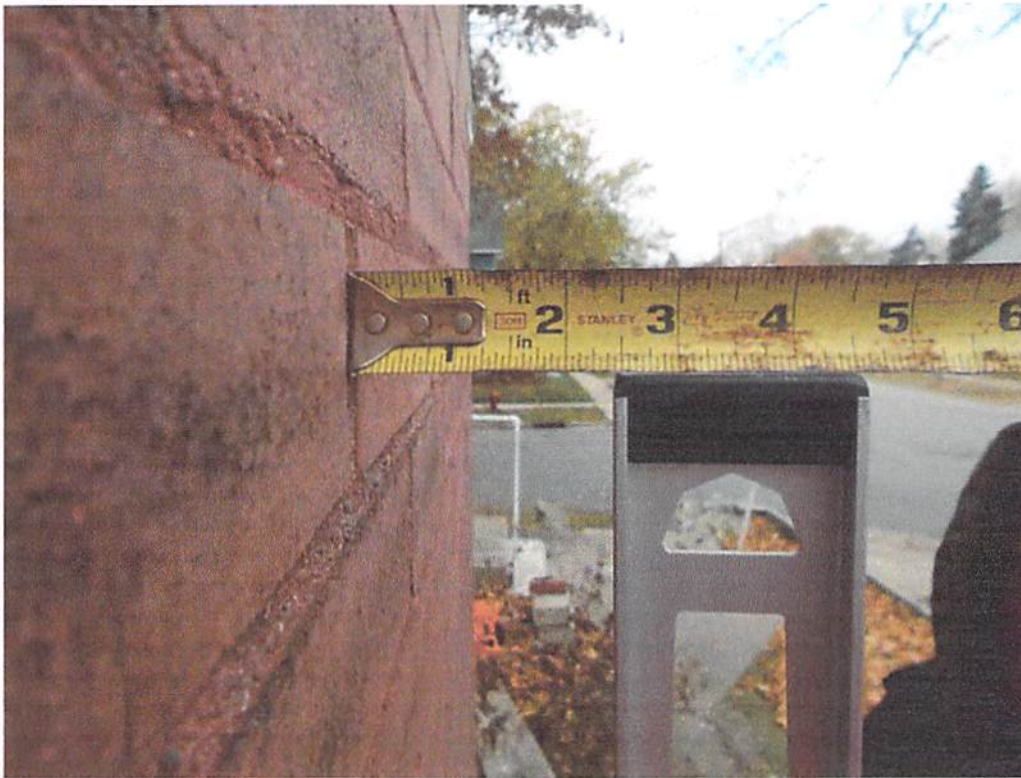
Photo 8: The north wall west of the window opening was approximately 2.5" out of plumb in 4ft.

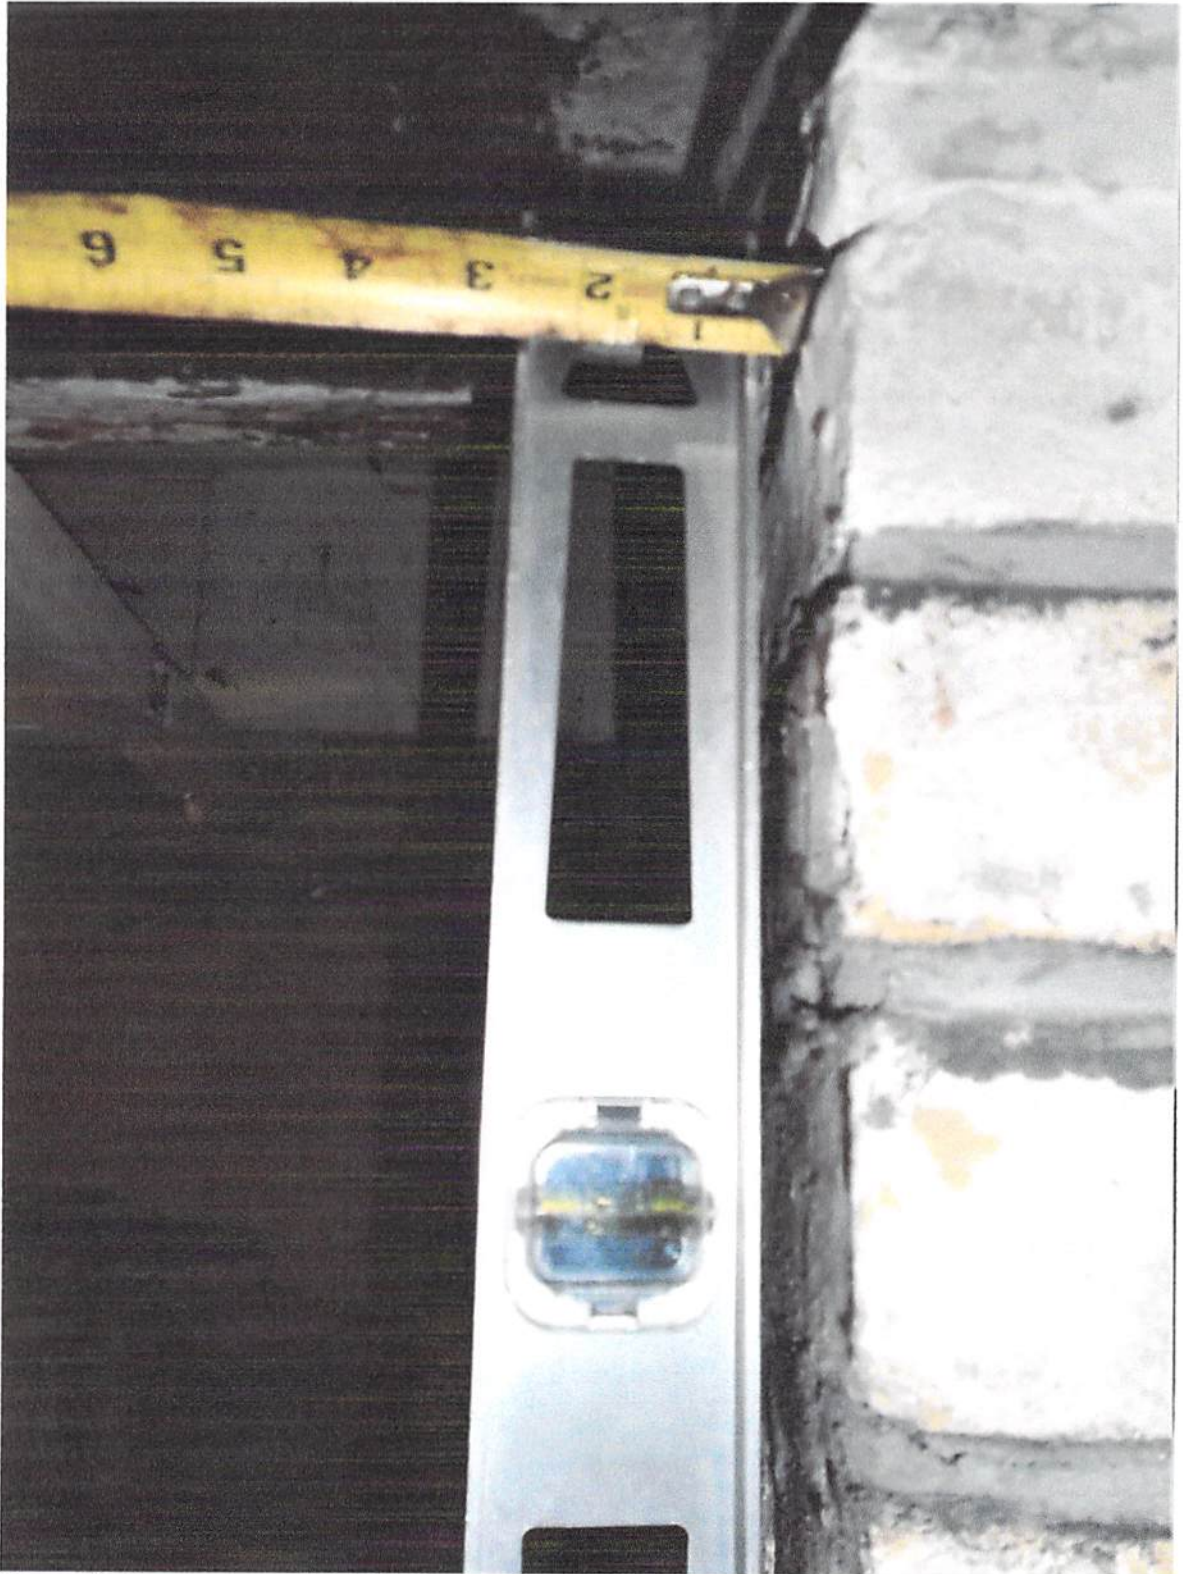
7. The north foundation wall below the two windows above appears to be only 1/2" to 3/4" out of plumb in 4ft (See Photos 9 and 10).

Due to the condition of the north foundation wall, we would suggest that the bowing out of the existing wall on the main level is a result of the condition limited to the façade on the main level of the residence.

Photo 9: Measurement of the plumbness of the foundation wall east of the basement window on the north side of the residence.

Photo 10: Measurement of the plumbness of the foundation wall west of the basement window on the north side of the residence.

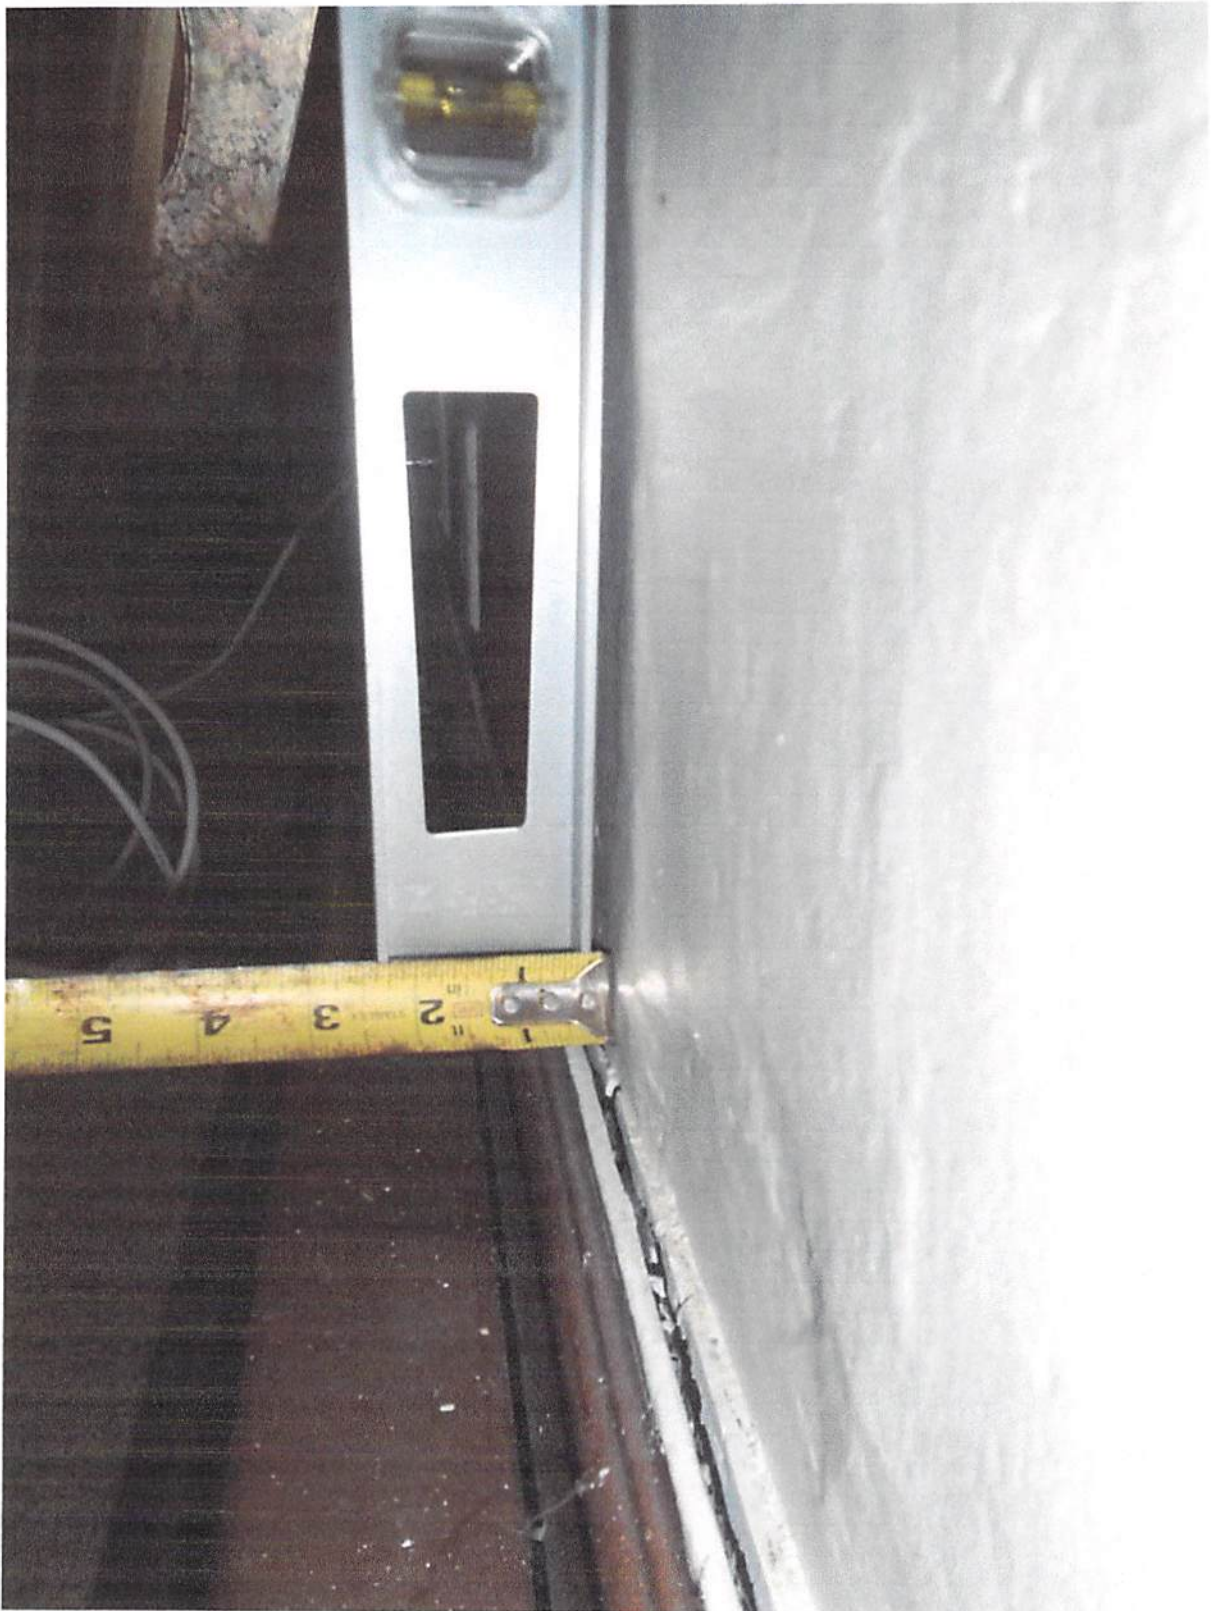
8. The inside face of the interior wall behind the brick façade along the north wall was out of plumb at an approximate rate of $\frac{1}{4}$ " in 4ft (See Photo 11).
9. The wood framing around the perimeter of the basement appears to be a little soft.

Photo 11: Inside face of interior wall behind the brick façade along the north wall was out of plumb a little less than $\frac{1}{4}$ " in 4ft.
