**Becklin & Whitney**  
*Consulting Engineers, Inc.*  
**139 1<sup>ST</sup> AVE. E, SUITE 100**  
**P. O. BOX 471**  
**CAMBRIDGE, MN 55008**  
**PHONE (763) 689-5631 FAX (763) 552-5631**

April 17, 2019

RE: Vehicle Impact  
377 Maryland Ave. W  
St Paul, MN

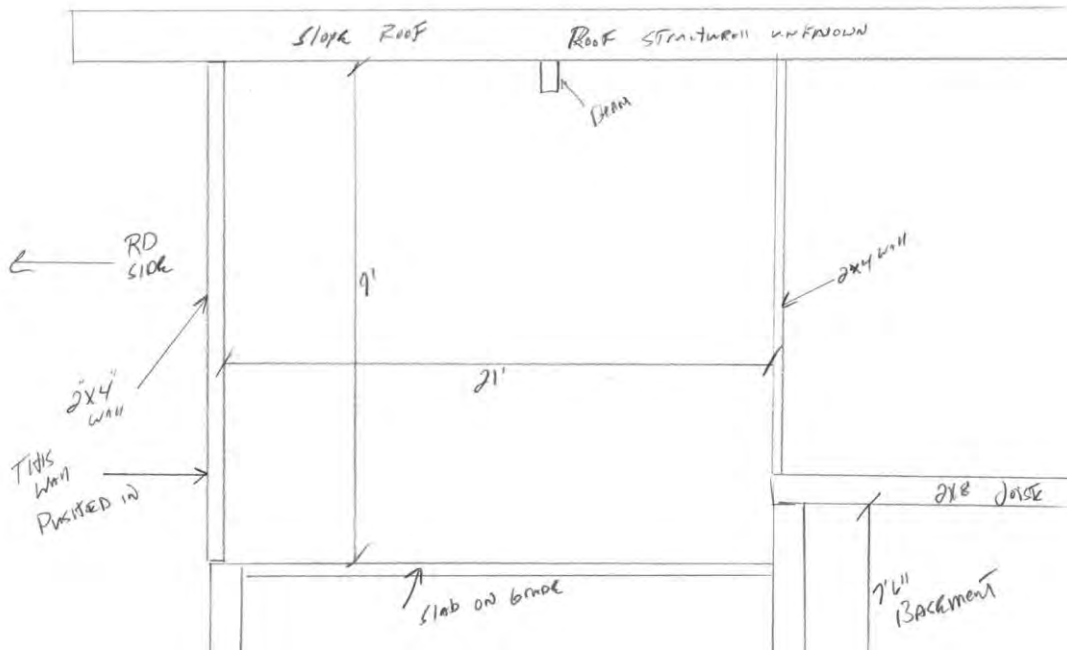
Section  
Looking West

The south 21 feet of the home is damaged along with the party wall. The south 21 feet of home which is the garage and breezeway needs to have interior and exterior finishes and ceiling finishes removed. Framing can then be checked and repaired. The party wall between home and breezeway also needs to be stripped so framing can be checked and repaired.

Ceiling beams have shifted and need to be reframed to support the roof structure. The beams appear to be undamaged but need to be moved back into position and supported by a minimum of four (4) studs.

Remove all interior, exterior and ceiling finishes from the south 21 feet (garage & breezeway) of the home. Repair the foundation on the east side of home. Repair or replace framing as needed in attached garage and breezeway. Check framing anchorage to foundation, anchor bolts are required at 6 feet o.c. Move beams back into location and support with (4) studs at each end.

All walls need to be anchored to roof joist with (3) toenails for A35 clips.
