525 Ohio St.
St. Paul, MN 551067
EA761612
651-222-8744

Inspection Report for: 188 Acker St. E Saint Paul, MN

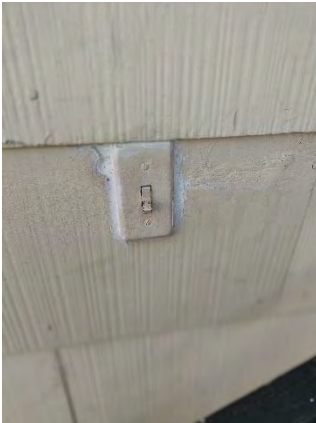
7. Switch is not rated for outdoor/wet location new cover listed for use in wet location required.
