## 1657 MINNEHAHA ST. PAUL

### Structural Observations and Report

1657 Minnehaha Ave,  
St. Paul, MN

August 15, 2022

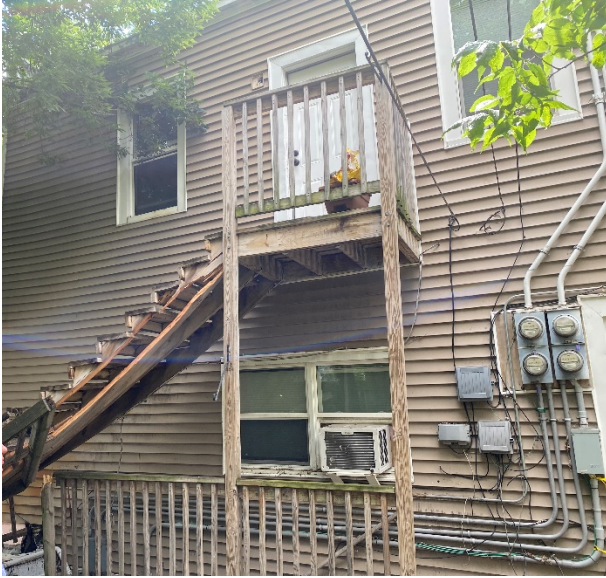
The stairs and landing were also affected by the vehicle impact. Damage to the stairs and landing was significant and they will need to be replaced.

Stairs were  
significantly  
damaged.

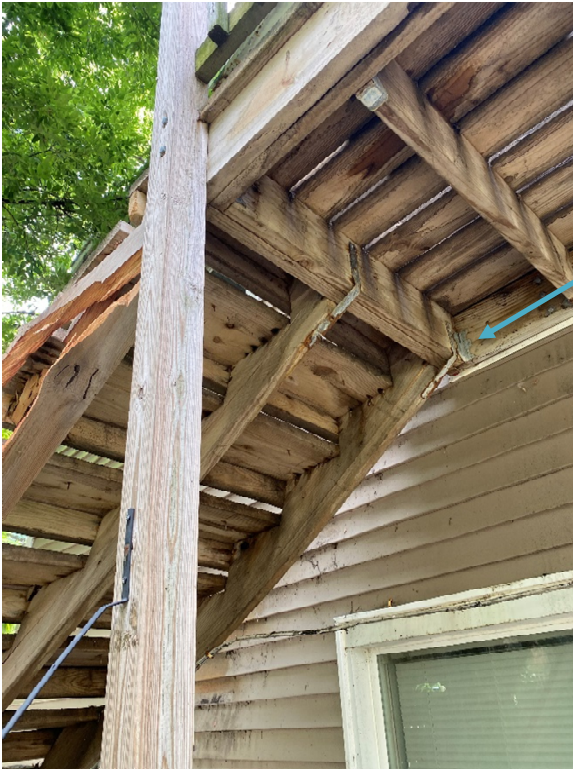
Landing pulled away from  
the second floor and should  
be re-placed
