**Appeal of the Department Determination for  
934, 938, & 942 Ashland Avenue**

**Appellants' Exhibit 1**

## **Expert Report of John Trostle**

### **Violations of the Covenant of Habitability, Including Conditions that are Hazardous for Tenants' Health and Safety, at 934/938/942 Ashland Avenue**

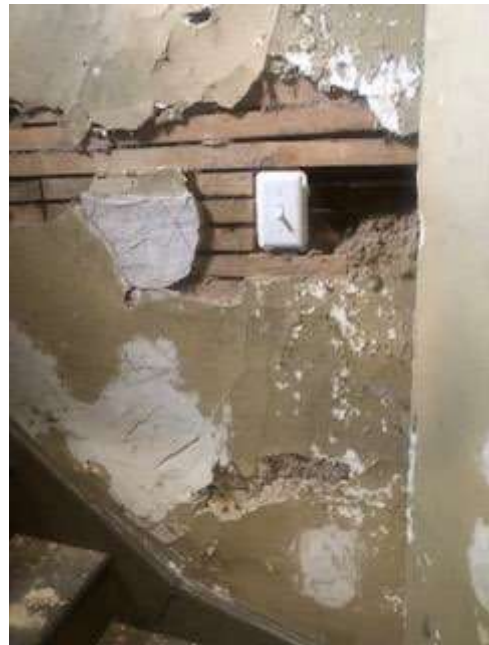
In other common areas, I observed bulging and cracking of various walls and ceilings in the halls and stairways (see picture 21). There is also general damage, staining, and paint wear in these areas that have been left unrepaired (see picture 22). The holes such as that shown in picture 21 may allow rodents and other pests to enter the building.

22: Wall deterioration at stairway

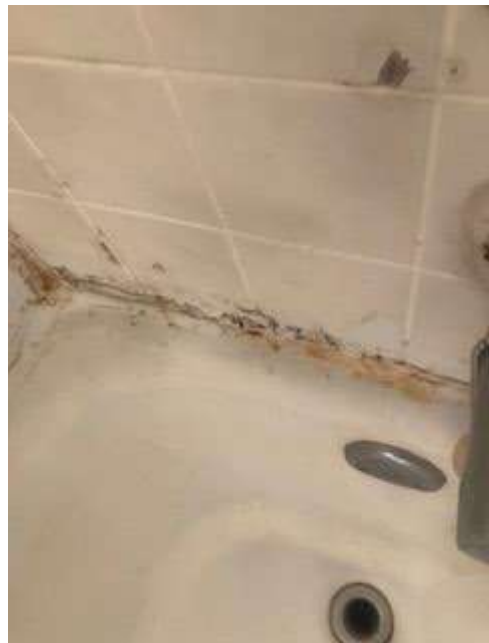
Tenant units accessed in all buildings have various problems related to their walls and ceilings. For one, I observed multiple instances of mold inside units, including on baseboards and in unit showers (see pictures 23-26). There are also many settling cracks and bulging within units, likely due to the buildings' foundation problems (see pictures 27-29). I observed other instances of neglect like peeling paint and staining. I also discovered loose wall panels in tenant units in areas like behind the stove, in bedroom closets, and in shower tubs.

24: Mold and deterioration in unit shower

With specific regard to the mold issue, it is my professional opinion that the Ashland Apartments will remain in their current dangerous condition without moisture/mold testing in all exterior wall cavities as well as significant abatement efforts for all visible mold in tenant units and common areas like the laundry rooms. I do not believe that this pervasive issue will be resolved without such property-wide efforts by a qualified professional.

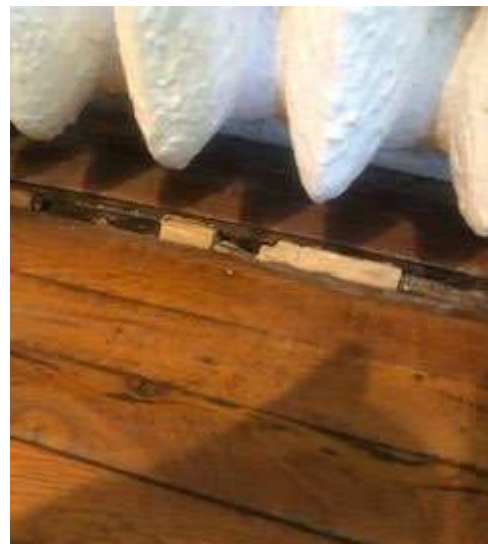
My inspection revealed problems with the flooring in all observable units. Specifically, I found flooring that was significantly damaged, settled, cracked, or completely missing in some corners (see pictures 30-32). There are also instances of shoddy repairs using duct tape (see picture 33), and loose hardwood flooring in all units. Additionally, there are loose and damaged kitchen floor tiles present in Unit 6 within Building #938.

31: Crack in floor under radiator in tenant unit

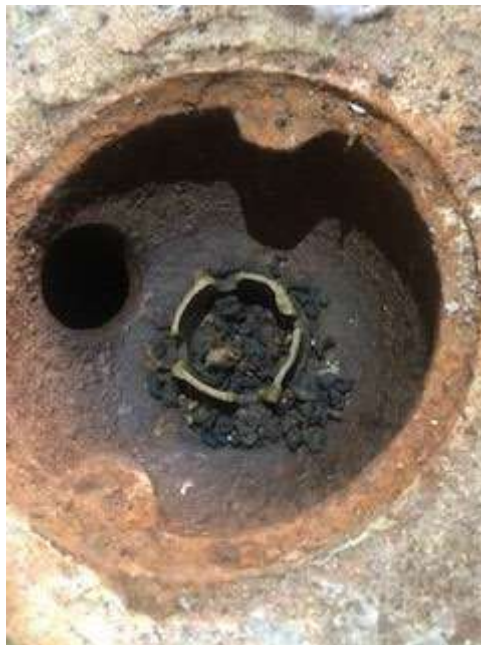
The floor drain in the basement area of Building #934 (which serves as a storage and gym area for Unit 5, seen above with flooding in picture 12) has another clogged floor drain with missing clean-out plug (see picture 40). Again, the lack of a clean-out plug allows sewer gas and smells to enter the space, posing a risk to the health of the Unit 5 tenant who regularly uses this area and has children. I also observed an uncapped plumbing vent pipe sealed with a rag in this room.

40: Unit 5 storage area floor drain missing clean-out plug
