PARKING RAMP EVALUATION REPORT

Best Western Plus Como Park Hotel Parking Ramp
1015 Bandana Boulevard East
Saint Paul, Minnesota 55105

Encompass Project #: 22-8144-000

Re: Best Western - 2022 Parking Ramp Review
1015 Bandana Boulevard East
Saint Paul, Minnesota 55105

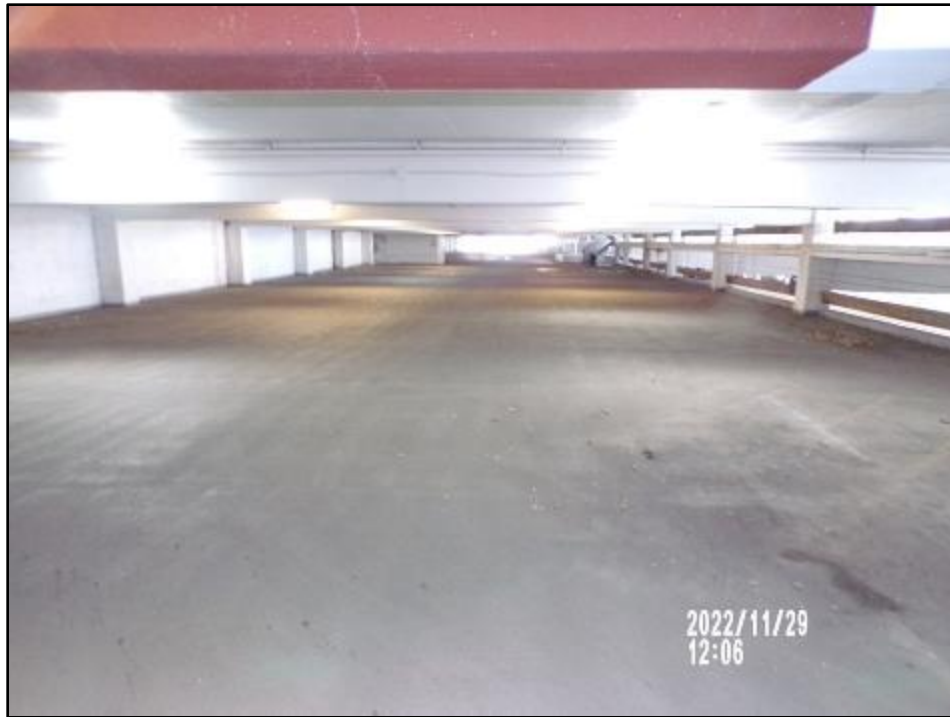
Level 2 looking south

2.3.2.1 Deteriorated traffic coating was observed on level 2 with large tears and missing sections found. The detailing near expansion joints was found to be in the worst condition.

2.3.4.1 The visible traffic coating on Level 2 was in poor condition and the Google aerial image of Level 3.5 shows a severely deteriorated traffic coating present.

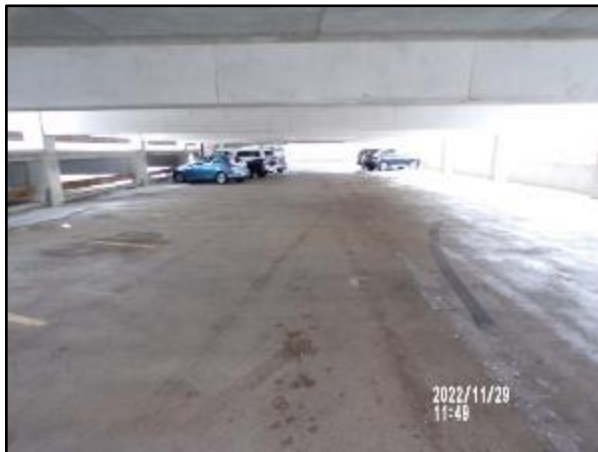
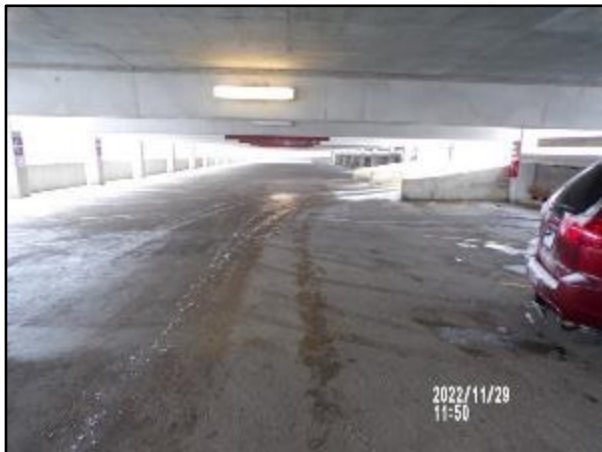
Level 2.5

2.3.2.3 The PT slab surfaces had varying levels of roughness with the first covered level (level 2.5) having aggregate pops (pockmarks in the slab) with a higher occurrence of pop outs near the ramps.

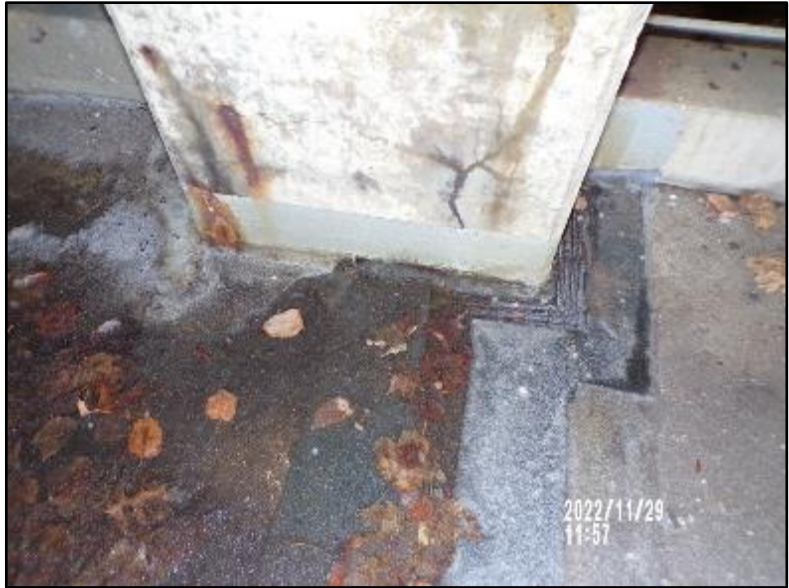
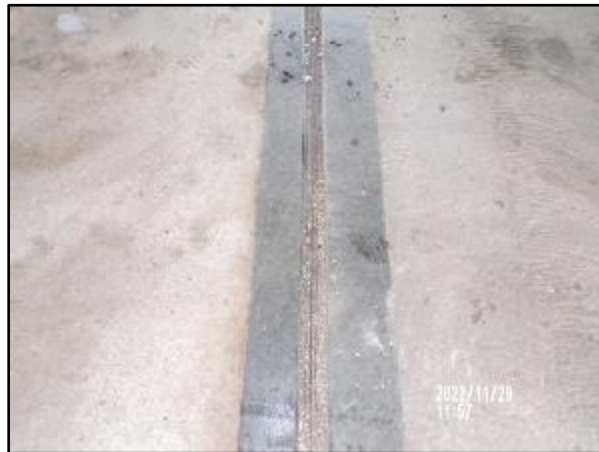
Expansion Joint Top

2.4.1.2 The expansion joints in poor condition had visible tears and debonding of the top horizontal wings (legs) at various points along the joint.

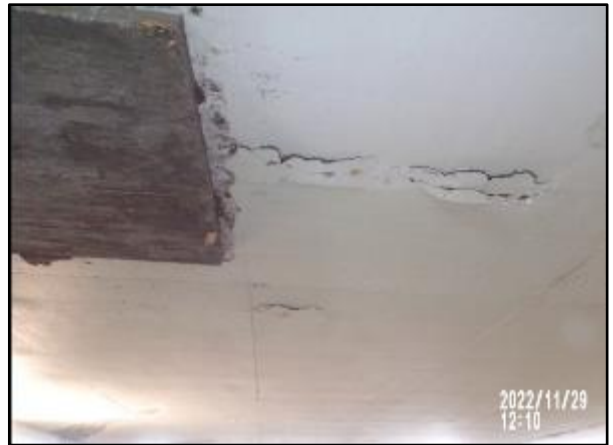
2.5.6.1 One location had several concrete patches that extended 1-2 inches below the formed bottom surface of the slab.

Left: Previous bottom of slab patch was formed lower than original bottom of slab. Right – Continued spalling next to patch.

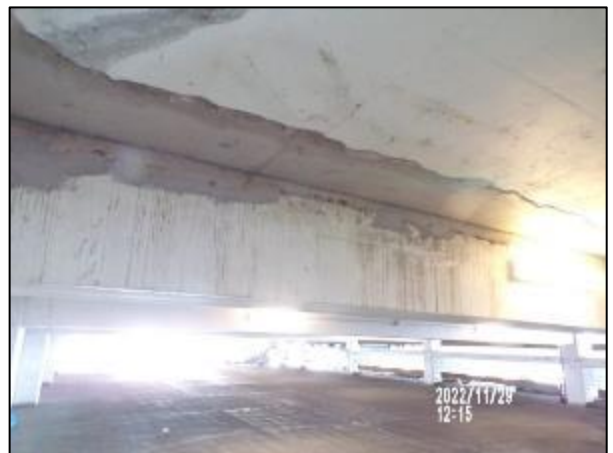
Previous patch full length of beams.

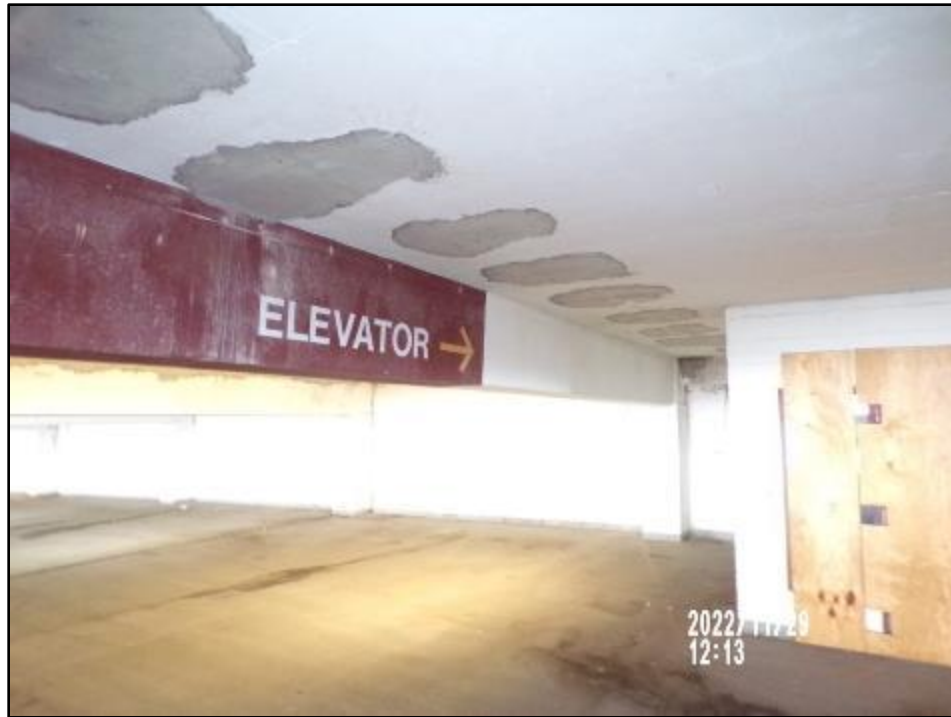
2.5.5 Locations on Levels 1.5 and 2.5 had four uniformly spaced holes drilled through the entire depth of the PT slab.

2.5.5.2 Some locations had threaded rods with square washers and nuts in the holes while other locations were open.

Previous bollard through bolt patching under Level 3.

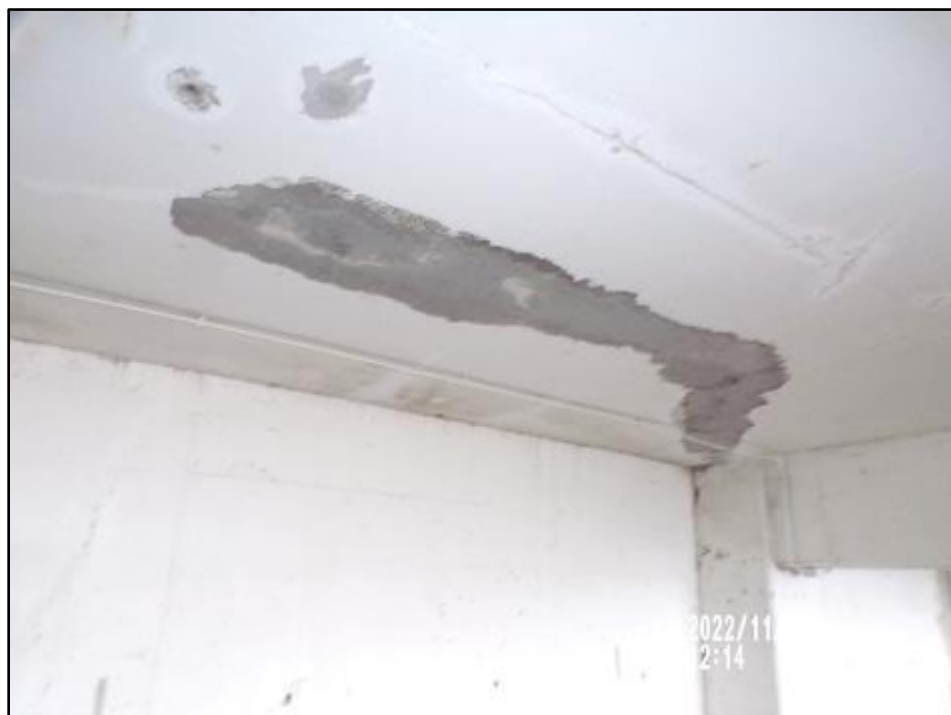
Bottom of slab cracks intersecting beam-column connection at foundation wall.

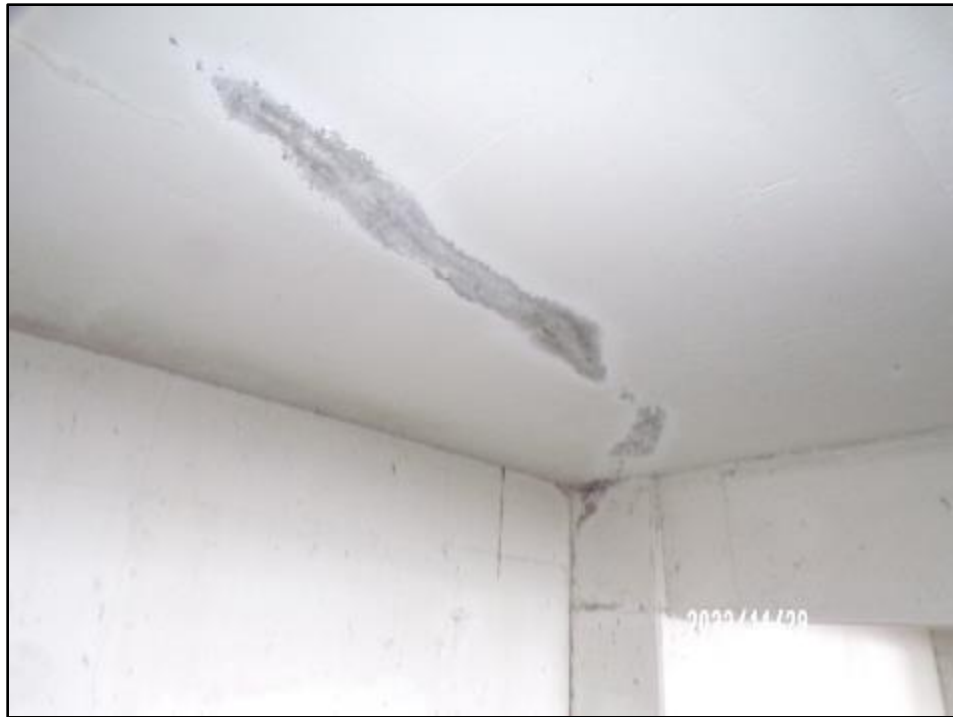
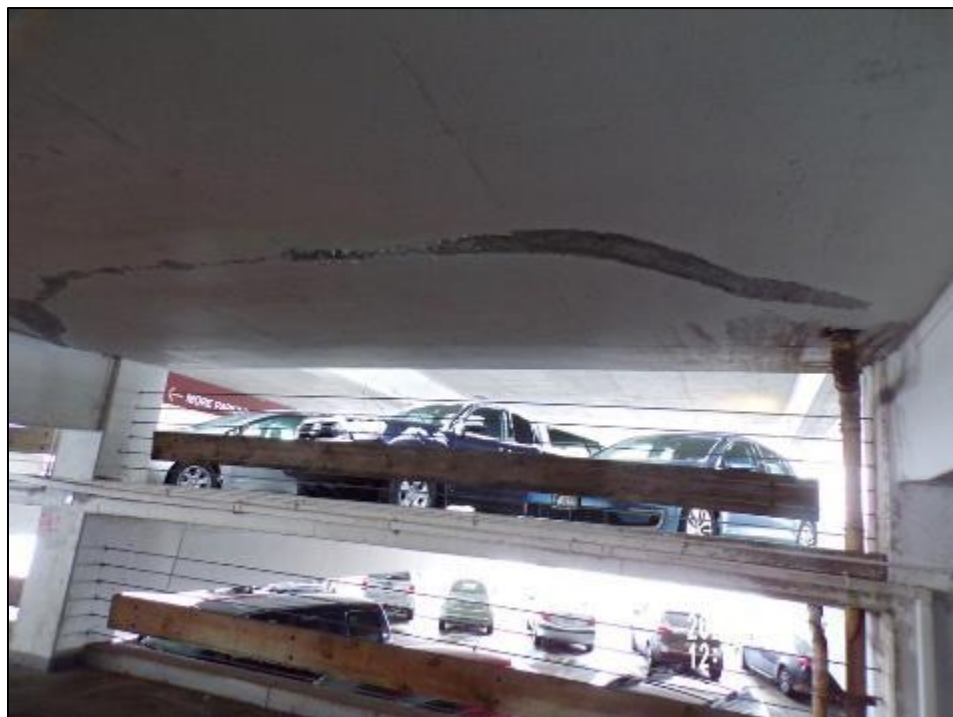
Bottom of slab cracks intersecting beam-column connection at foundation wall.

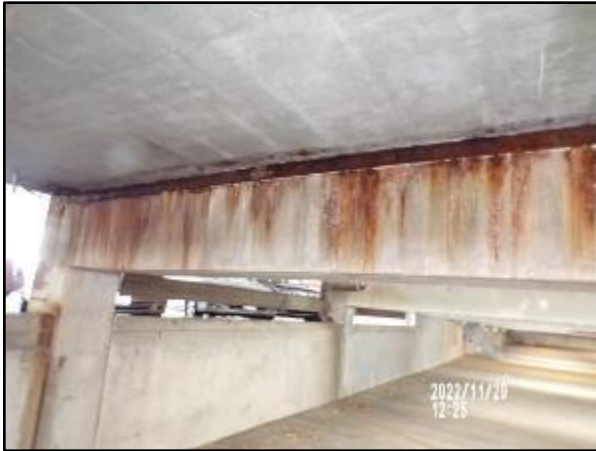
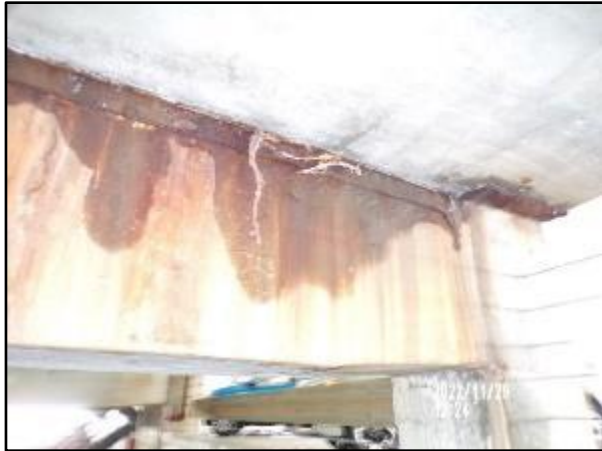
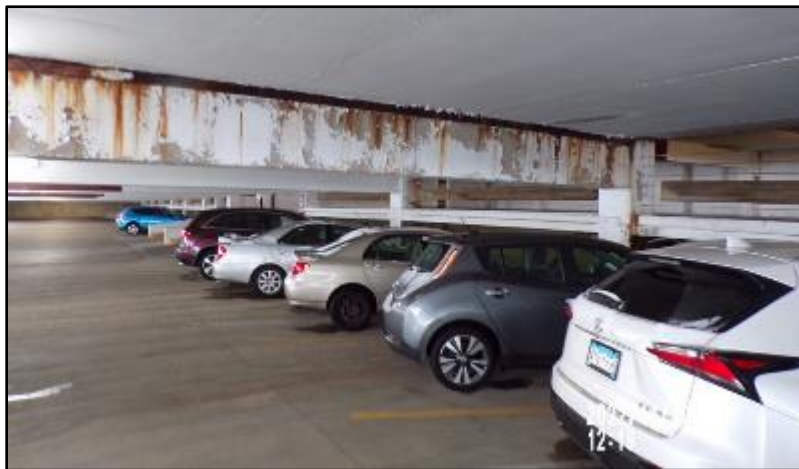
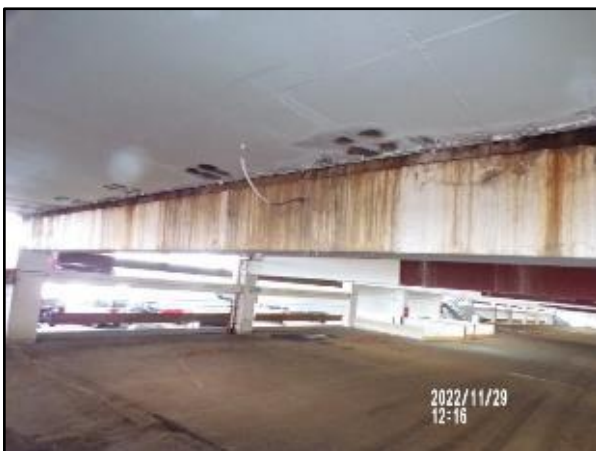
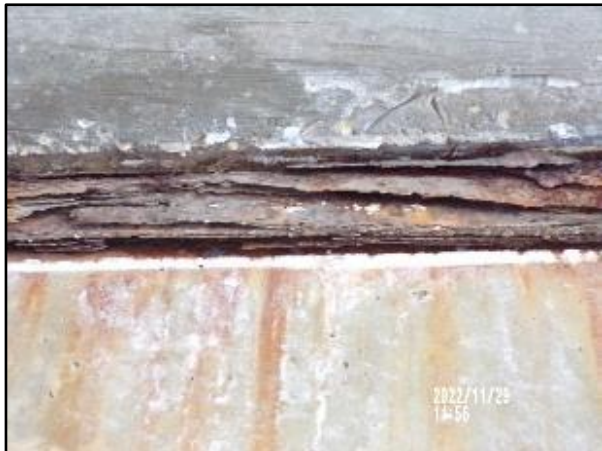
Expansion Joint Bottom

2.6.1 Extensive and severe steel corrosion was present at the steel members, either plates or angles, that were integral in the expansion joint system. The steel angle or bent plate sitting on a PT beam ledge was to allow for a sliding slab condition. The angle is severely corroded all locations.

2.6.1.1 The vertical down leg of the steel angle is completely deteriorated and nonfunctional.

2.6.2 Water intrusion was noted at all expansion joints on bottom of the slabs and beams.

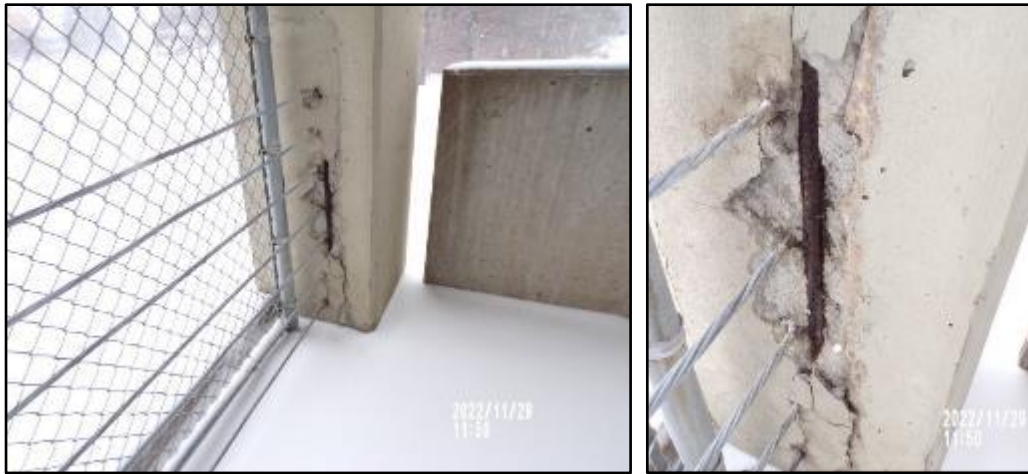
Level 2.5 southwest corner

2.7.1 Most of the exterior columns on Grids A and C observed were significantly cracked with spalled concrete, or otherwise experiencing structural deterioration.

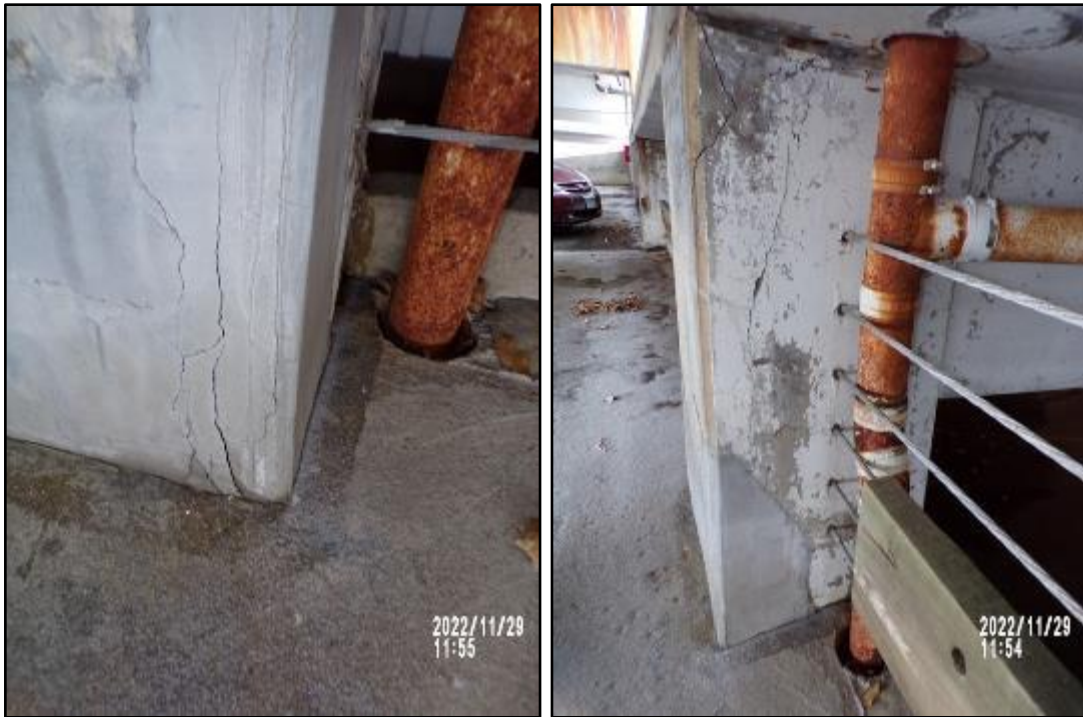
2.7.5.1 Previous repairs were cracking and spalling, similar to the original columns.

Level 2.5 previous column base patching starting to re crack

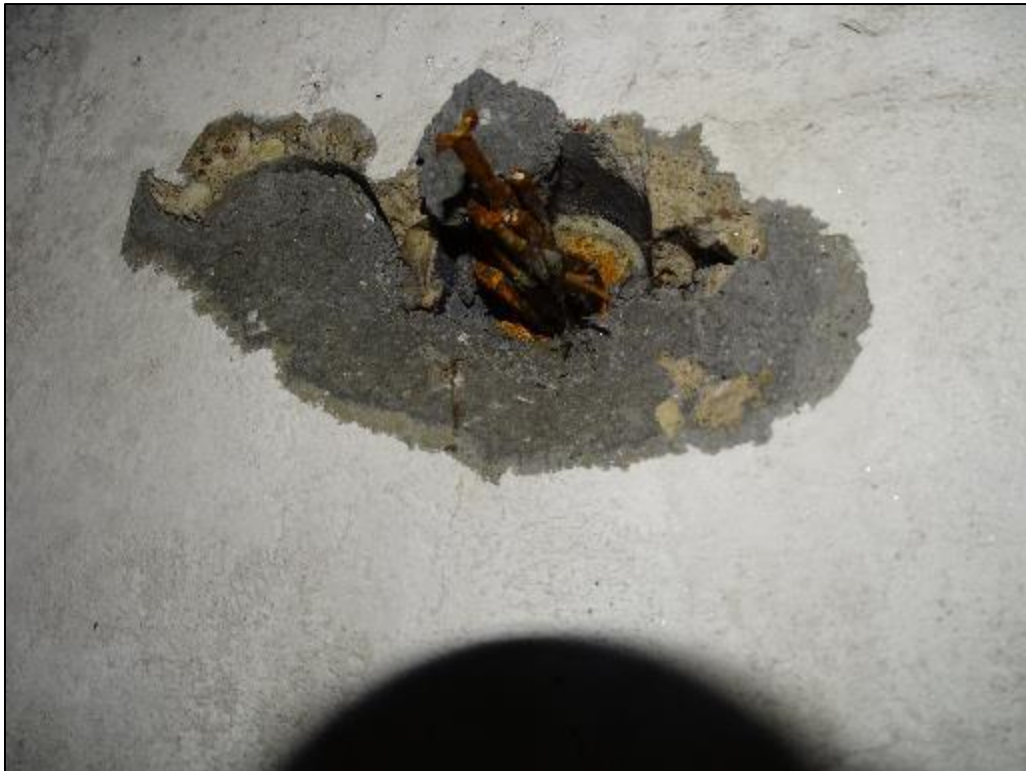
2.7.2.3 One PT beam tendon end was observed to have broken and come out of the column surface. The 7 wire tendon strands were not tightly wound together, and the wedges used to hold the tendon in tension during installation were loose in the grout pocket.

Broken PT Cable at column

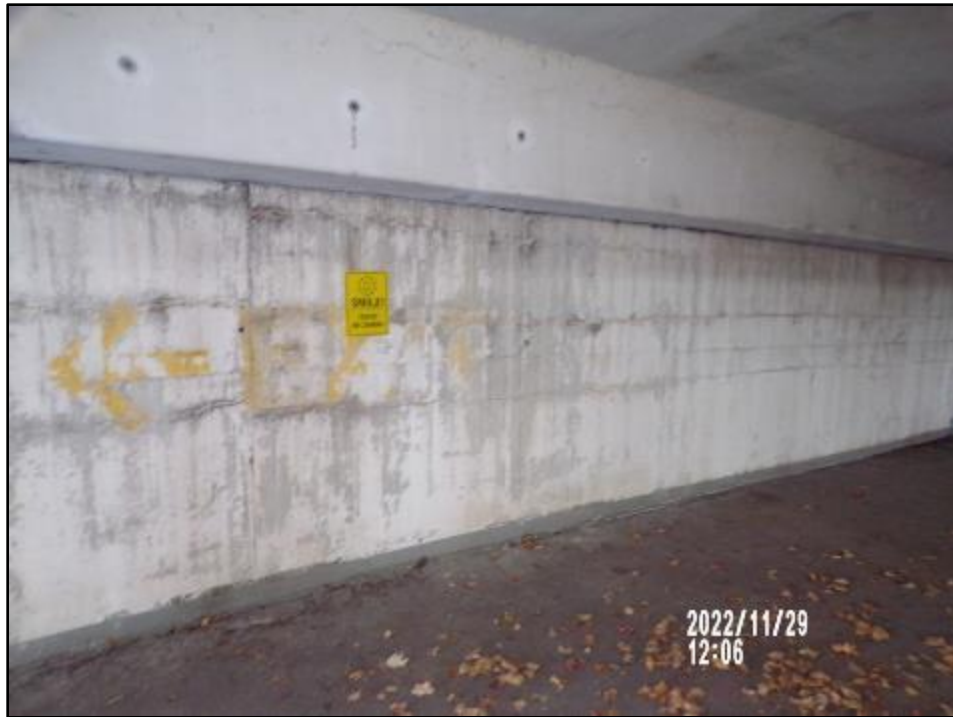
North foundation wall

2.8.1 Foundation walls were in good condition with some cracks and spalls noted.

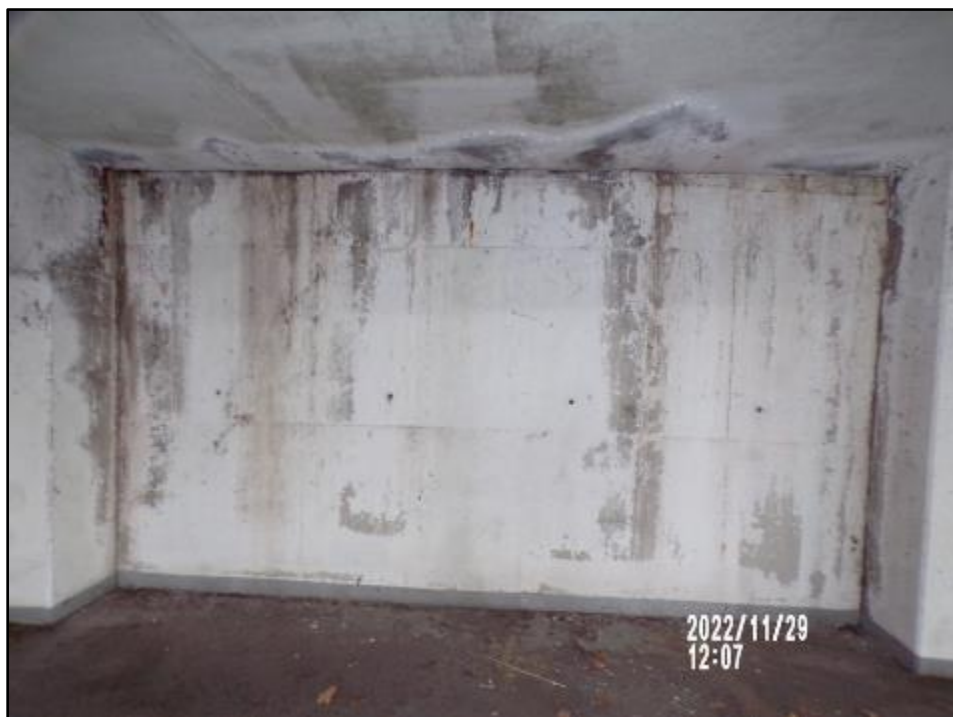
East foundation wall between beam supporting columns Grid C

2.8.4 Vertical shrinkage cracks were noted on most exterior walls.

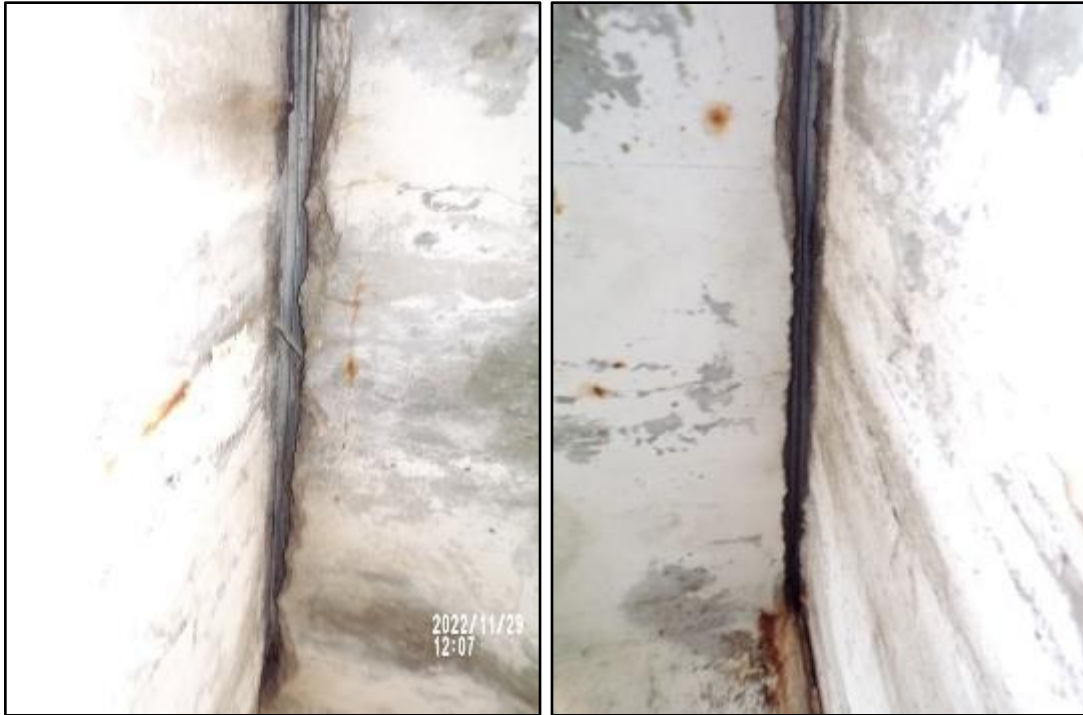
Level 3 Expansion Joint between Grid C east foundation wall on left and PT slab on right.
Photo taken on Level 2

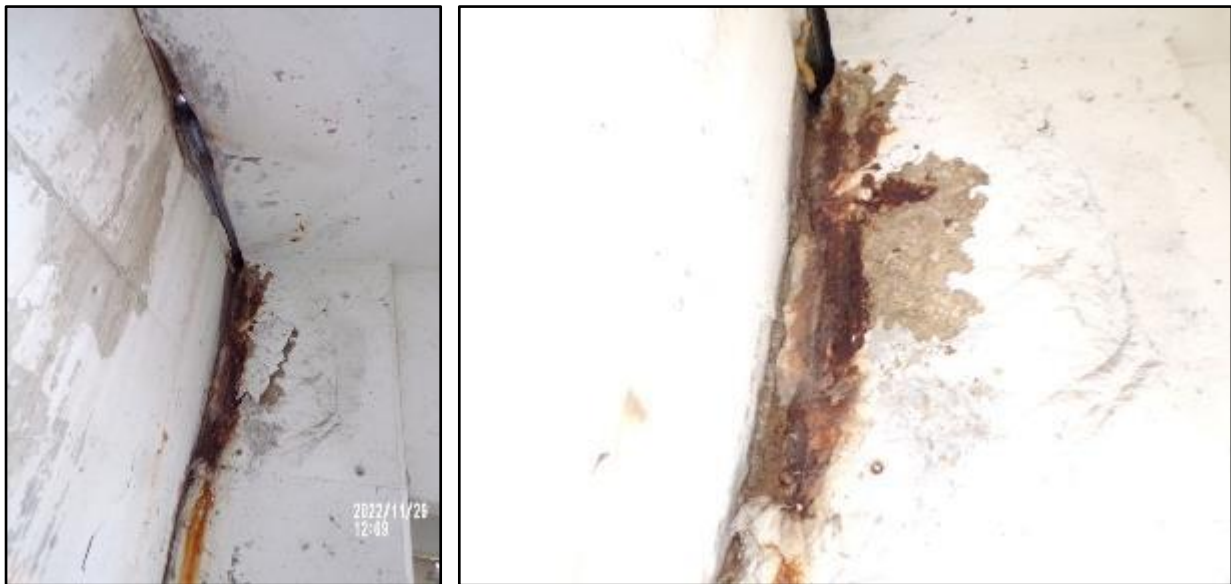
Loose concrete spall (left) removed (right)

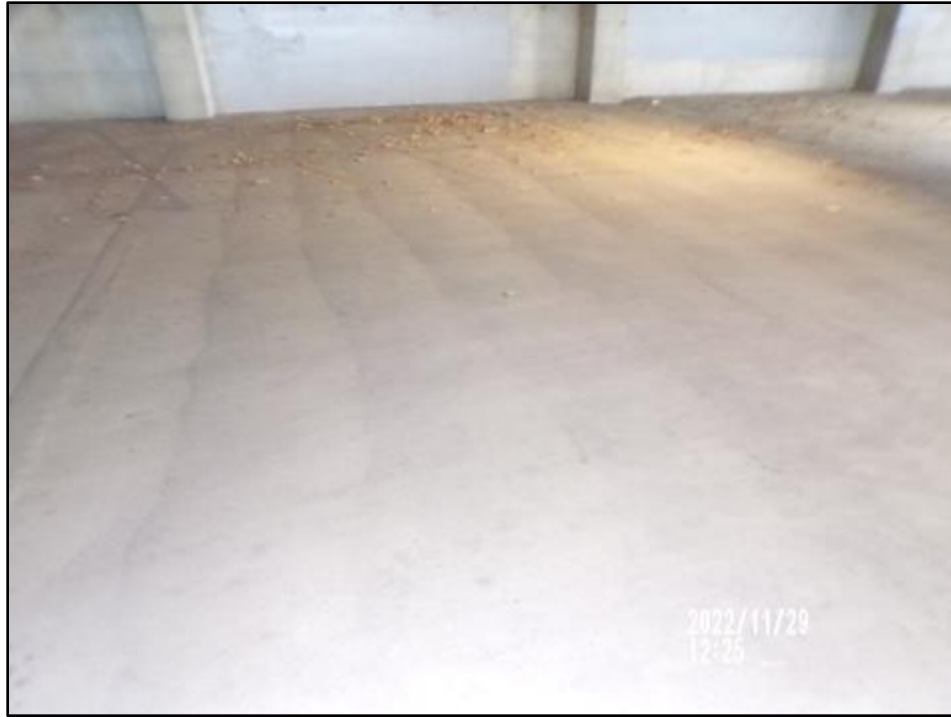
Level 1 slab on grade east side

- 2.9.1 The slabs on grade are in good condition with minimal cracking or settling noted.
- 2.9.2 Most of the cracking and settling occurred at the column/slab intersection point.
- 2.9.3 The finish on the slab on grade was a rough nonslip texture and appears to be original from finishing of the concrete.

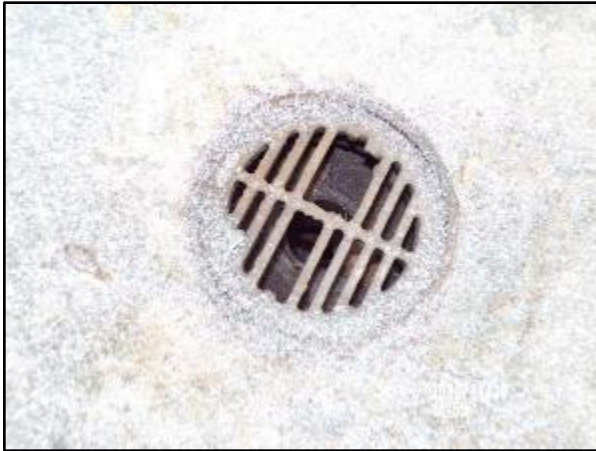
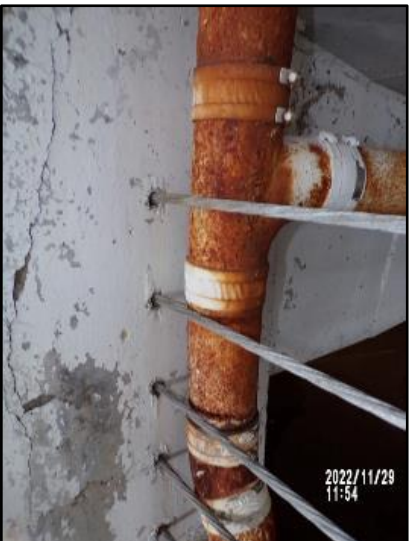
Slotted Drain Covers and Cast Iron Pipe Corrosion

- 2.10.1 The cast iron or ductile steel drainpipes are in poor condition with corrosion and evidence of water leaks at the fittings.
- 2.10.2 Some locations were missing portions of the pipe.
- 2.10.3 The drain covers were generally in good condition with only minor corrosion and damage observed.

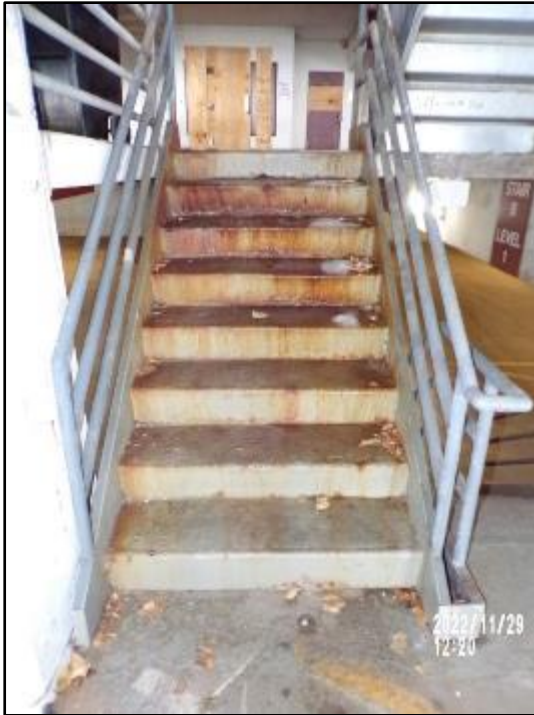
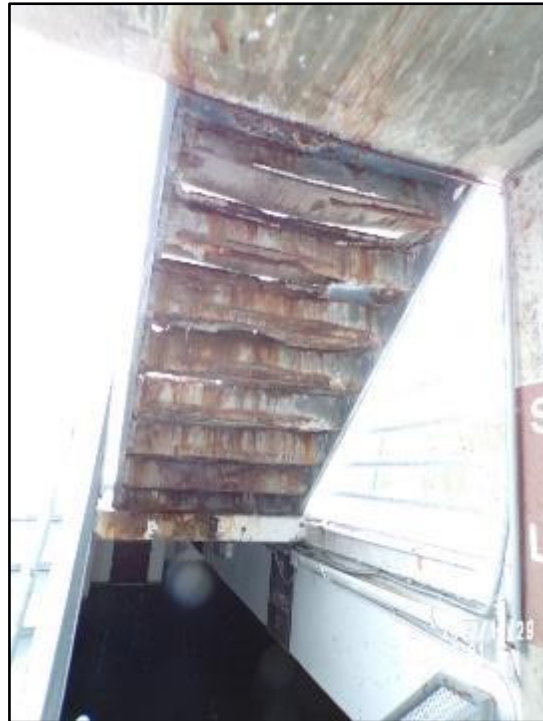
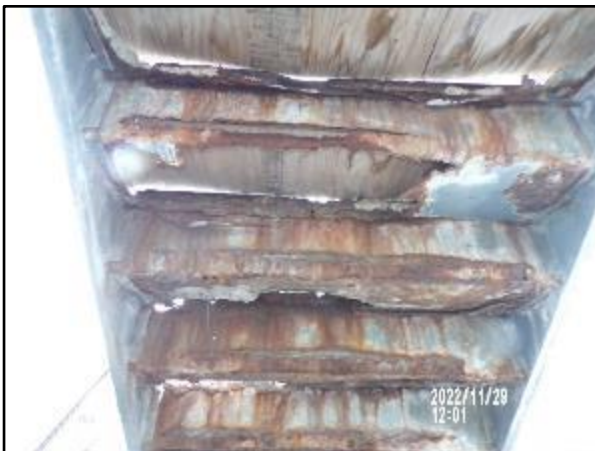
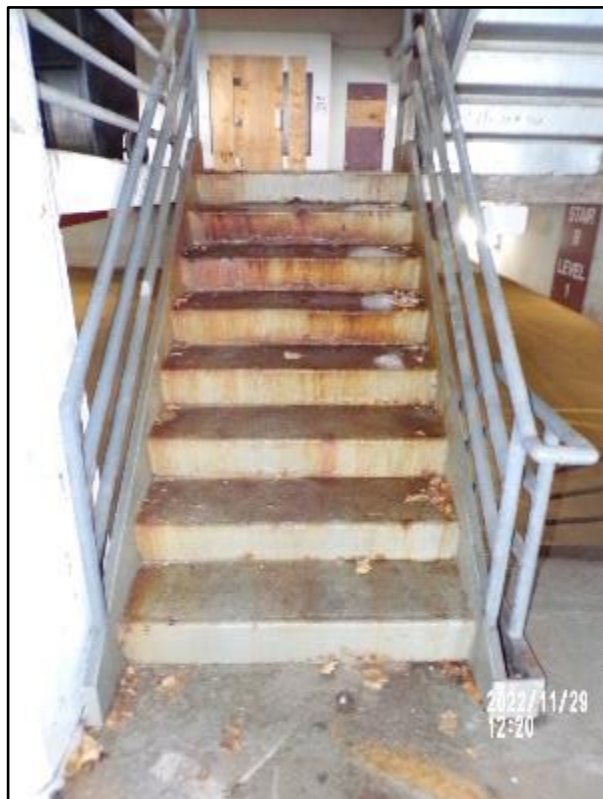
Metal Stairs

- 2.12.1 The metal stairs at the top levels of the parking ramp were in significantly corroded condition with some steel riser pan forms disintegrated and the filler concrete in the pan was missing.
- 2.12.2 These stairs had plywood placed over the damaged risers trying to make them accessible and able to be used.
- 2.12.3 The remaining stairs down to the lower levels were in varied condition but all of the stairs present showed signs of moderate to significant corrosion, water intrusion through them, and varied levels of deterioration of the concrete and/or metal structure.

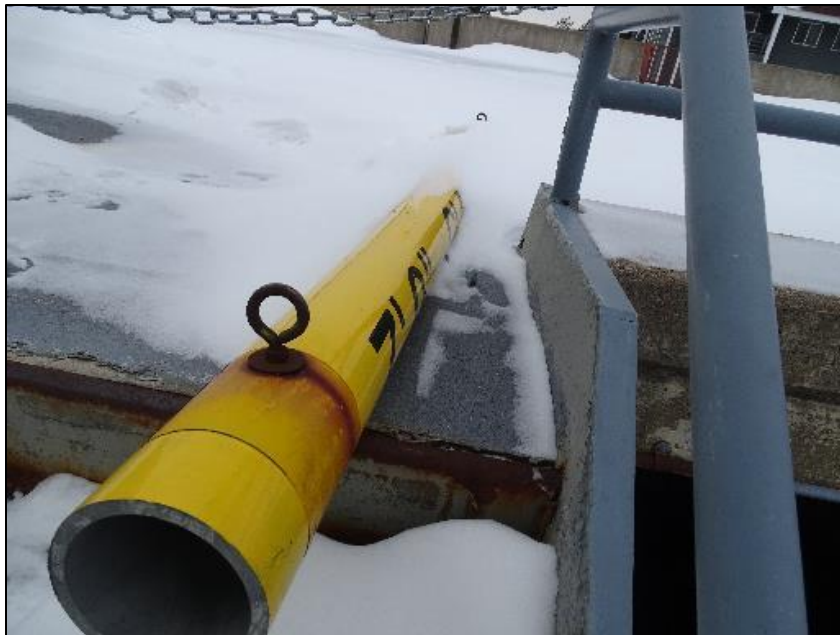
Height warning bar not installed
