PORT AUTHORITY OF THE CITY OF SAINT PAUL  
[Parcels 2 and 6 – Substandard Building and Coverage Findings]

### **Proposed Redevelopment**

*Former St. Paul, MN 3M Corp Campus  
(Beacon Bluff Redevelopment)*

August 5, 2011

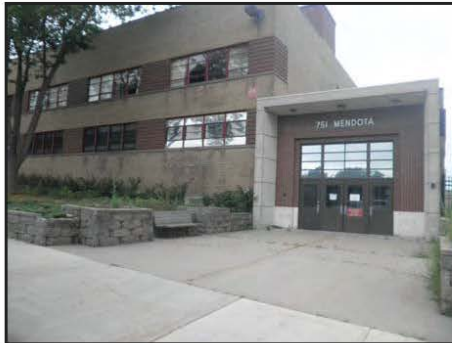
Overview

Defects in exterior building shell Deteriorating and rotting wood structure at column and floor points, masonry foundation wall and bearing points show evidence of settlement cracks, mortar joints missing/loose voids in brick grout, cracks settling in concrete at various locations.

Chipped and/or damaged drywall in a few locations. Numerous tripping hazards and lack of guard rails at floor openings. Layout exhibits obsolescence.

Defects in exterior building shell: window frames need paint, glazing broken or missing: deteriorating brick and block: roof leakage problem exists: water-damaged ceiling areas need to be replaced: rusted exterior metal doors. Asbestos and lead hazards have been identified and is considered critical level in various locations.

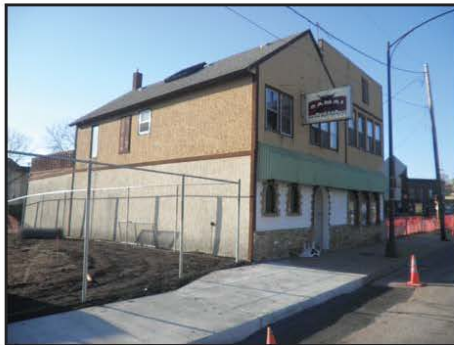
Overview

Satisfies Conditions Test for Structurally Substandard Building: Y
