SUBSURFACE GEOTECHNICAL ASSESSMENT

Solid Rock Construction

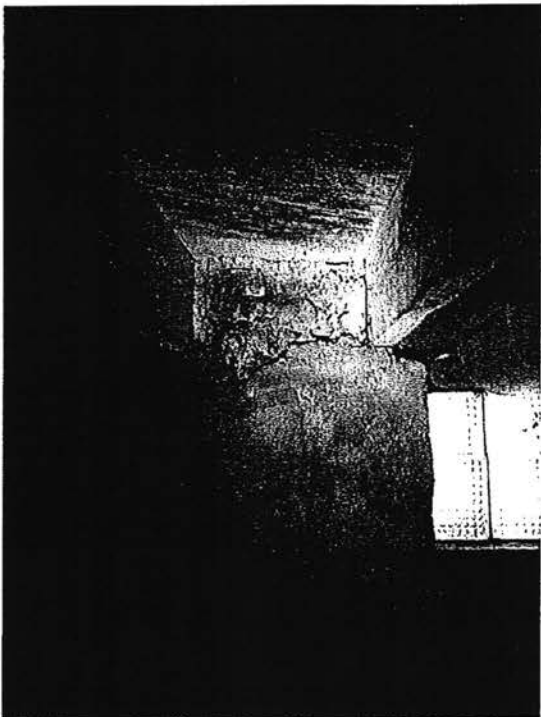
Photo 3 – Damaged/Rotted Wood Floor Joists

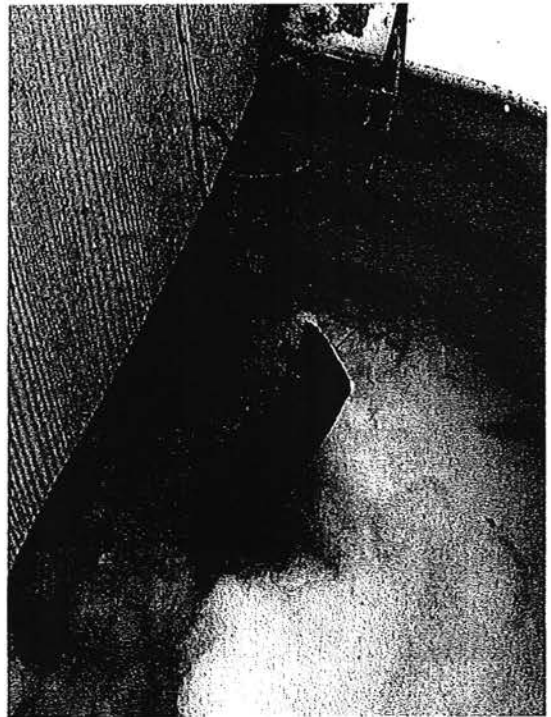
Photo 4 – Window Well with High Interior Grade Level

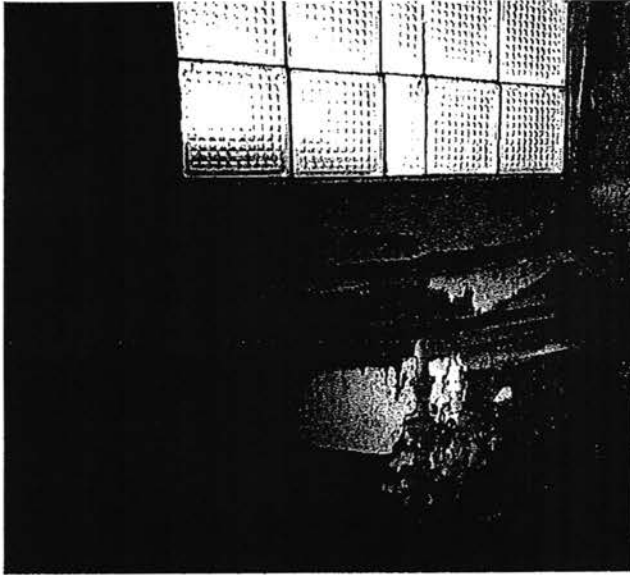
Photo 5 – Low Window Sill Allowing Moisture Infiltration

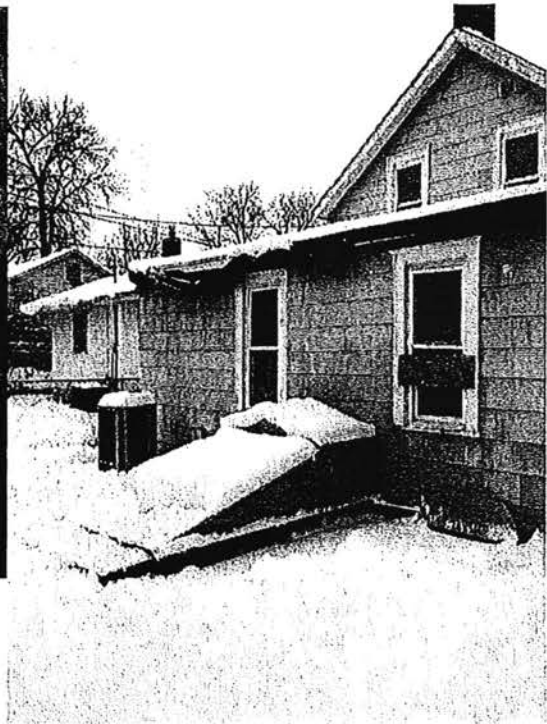
Photo 6 – Uninsulated, Unprotected Exterior Stair Access

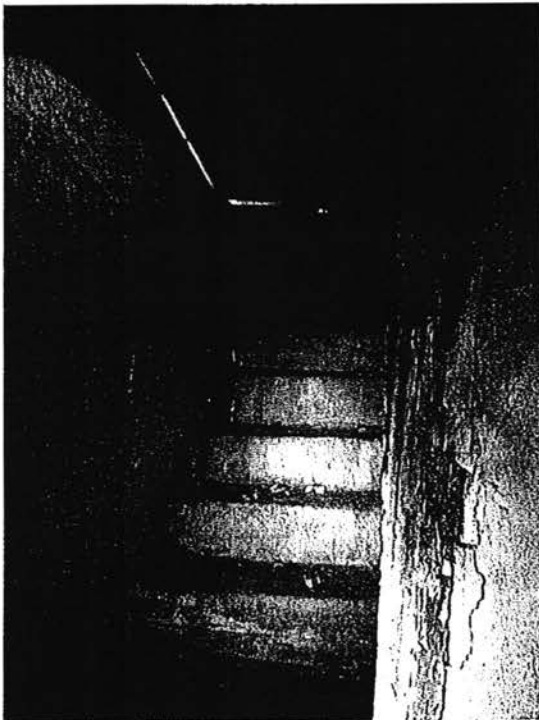
Photo 7 – Stair Access Allowing Moisture Infiltration

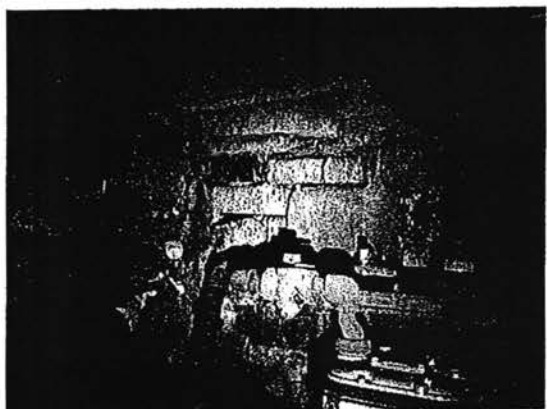
Photo 8 – Cracked, Settling Stone/Brick Foundation Wall

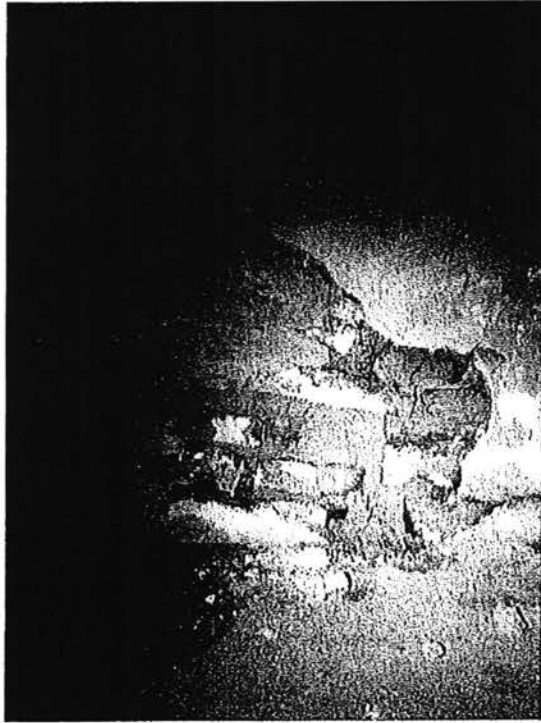
Photo 9 – Damaged Parge Coat and Crumbling Foundation Wall

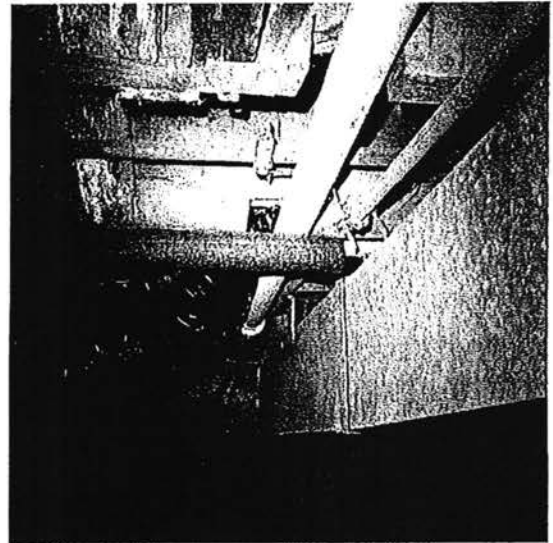
Photo 10 – Notched Floor Joists

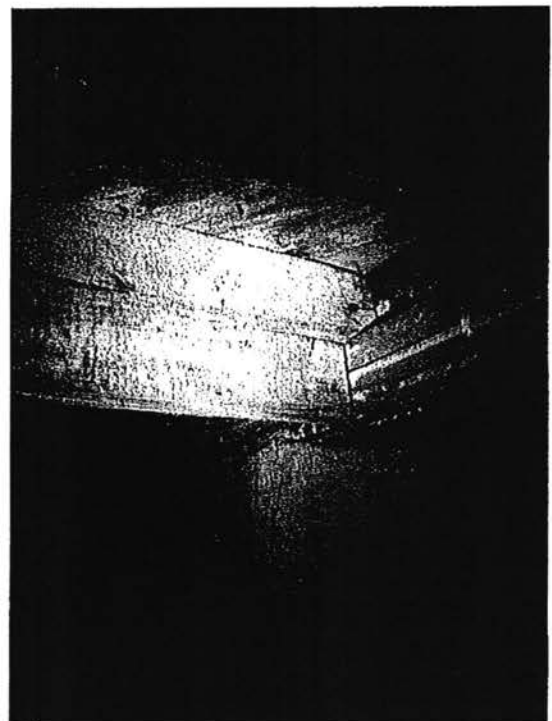
Photo 12 – Notch and Cracked Floor Joist
