**Appeal documentation for 461 McKnight.**  
**Owners: Patty McDonald & Carl Anderson**

**Fire Inspection Correction Notice lists:**

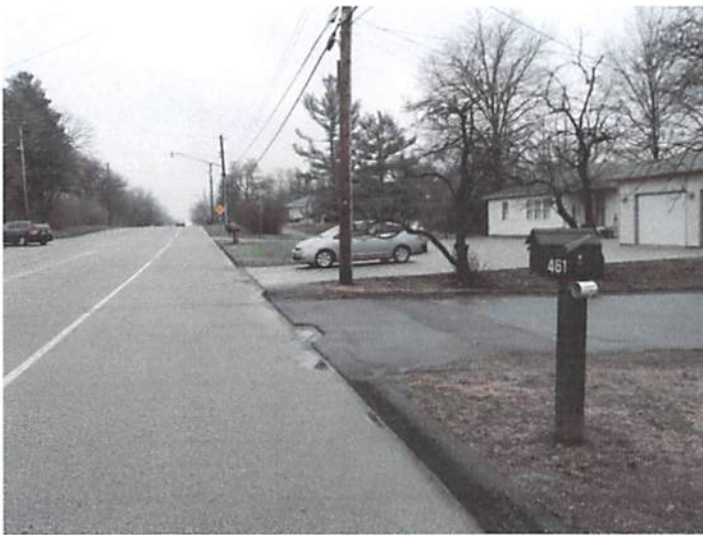
*Photo 4: You can see Mailand Road is just past 475 McKnight and the fire hydrant, which is 45 yards away from the driveway at 461 McKnight.*

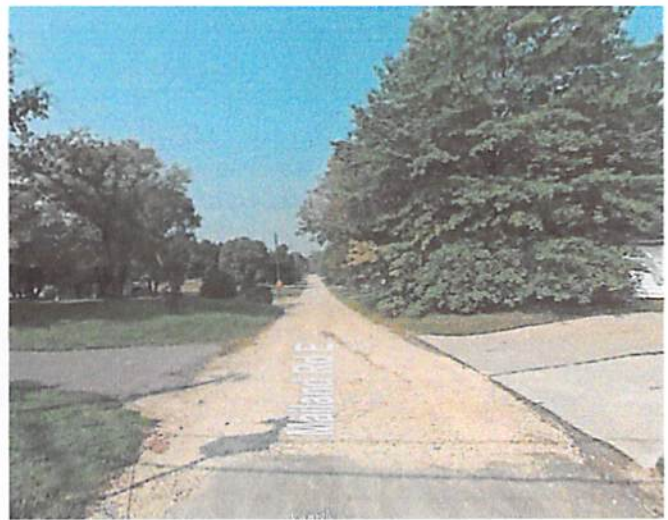
*Photo 5: Mailand Road. The road just down the street 45 yards.*

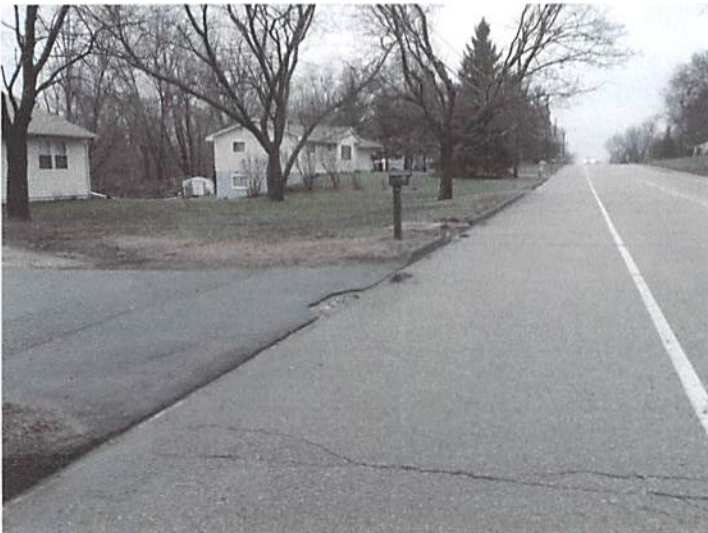
*Photo 6: Another view of the storm sewer run off drain near the driveway at 461 McKnight.*

The street drains in front of 461 McKnight are part of this system--which means the water on the street backs up to the point of least resistance and flows down that path. That path is the driveway at 461 McKnight. (see Photo 6)

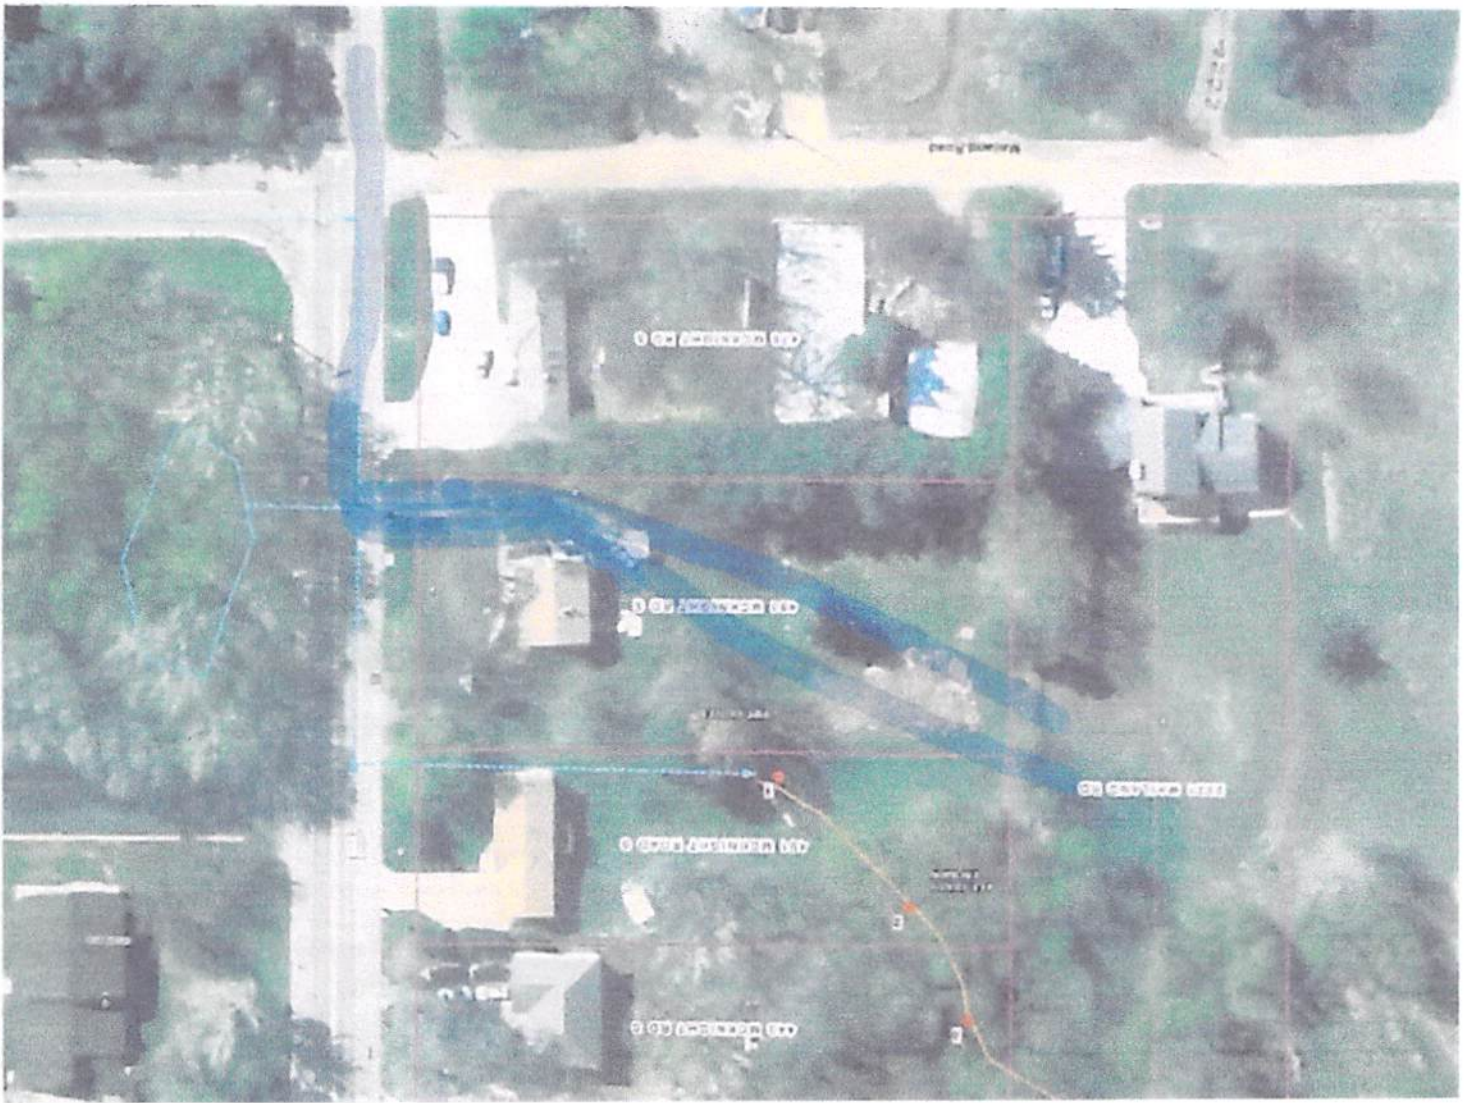
This has been an ongoing issue for years. Before the garage was there the water flowed straight down into and across the backyard. The flow was of such high volume and with such force that it washed away the new septic field. (*Diagram 1*) It was so severe that the city made the owners hook up to the city sewer—which involved installing a small pumping station to pump the septic sewage the 50+ yards to the where the septic ends two houses down.

Brown area under flow is the septic field, or what was the septic field.

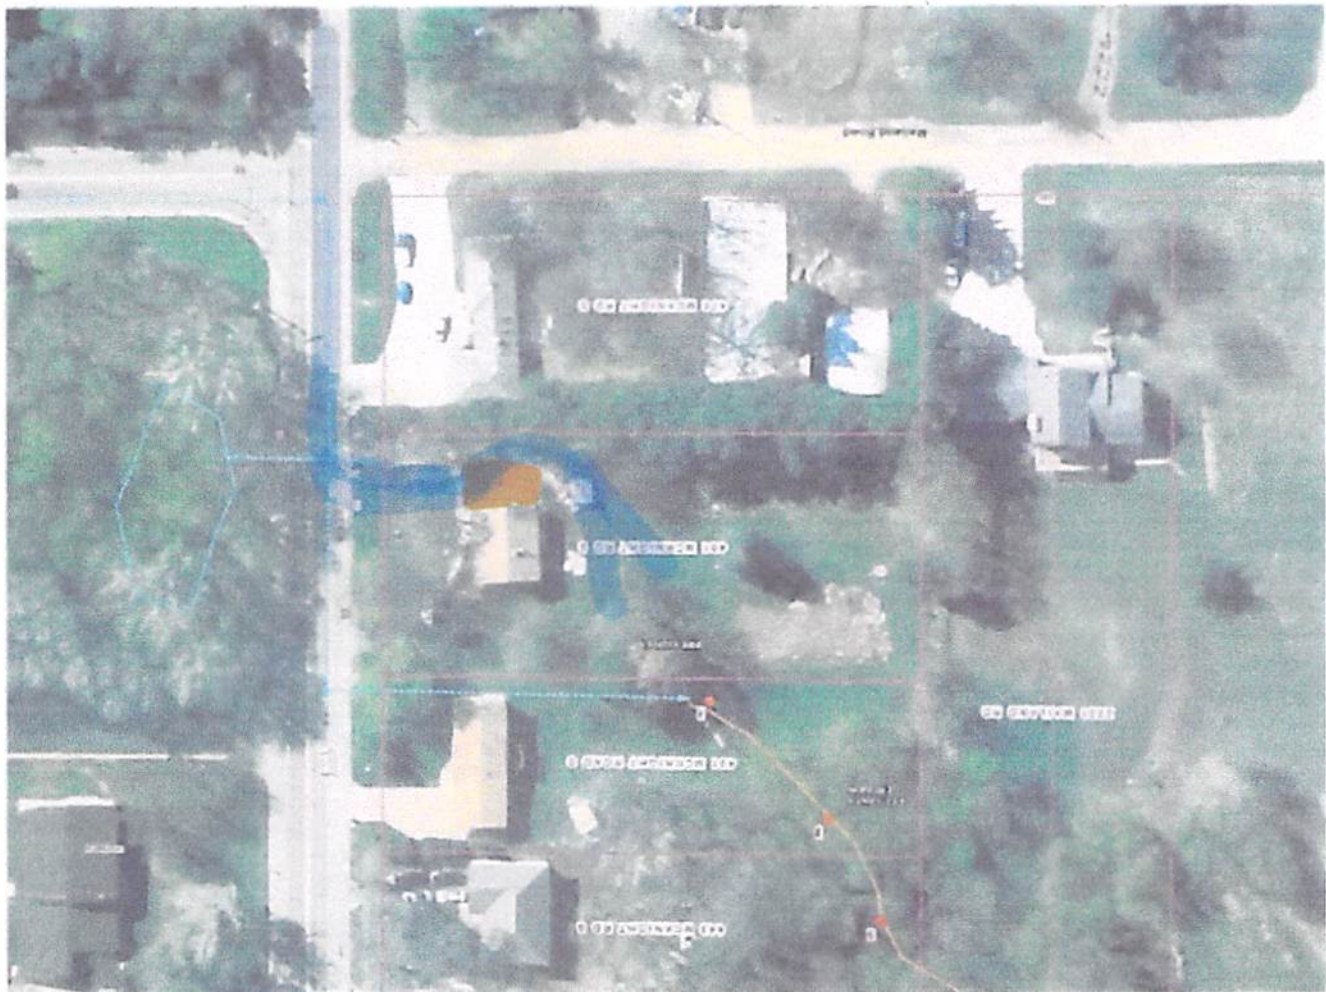
### Diagram 2: water flow after garage

The next phase of the water issue was that the water would go around the back and across the backyard—taking mud across the patio and yard (*Diagram 2*). We have worked on that (with landscaping, berms and directing water flow) and now have the water flowing only to the side of the yard and into a green space where the water percolates down—eventually. (*Diagram 3*)

Water flow cuts into earth along the wall of the south side of the garage creating a mud flow that covers the patio and part of the yard.

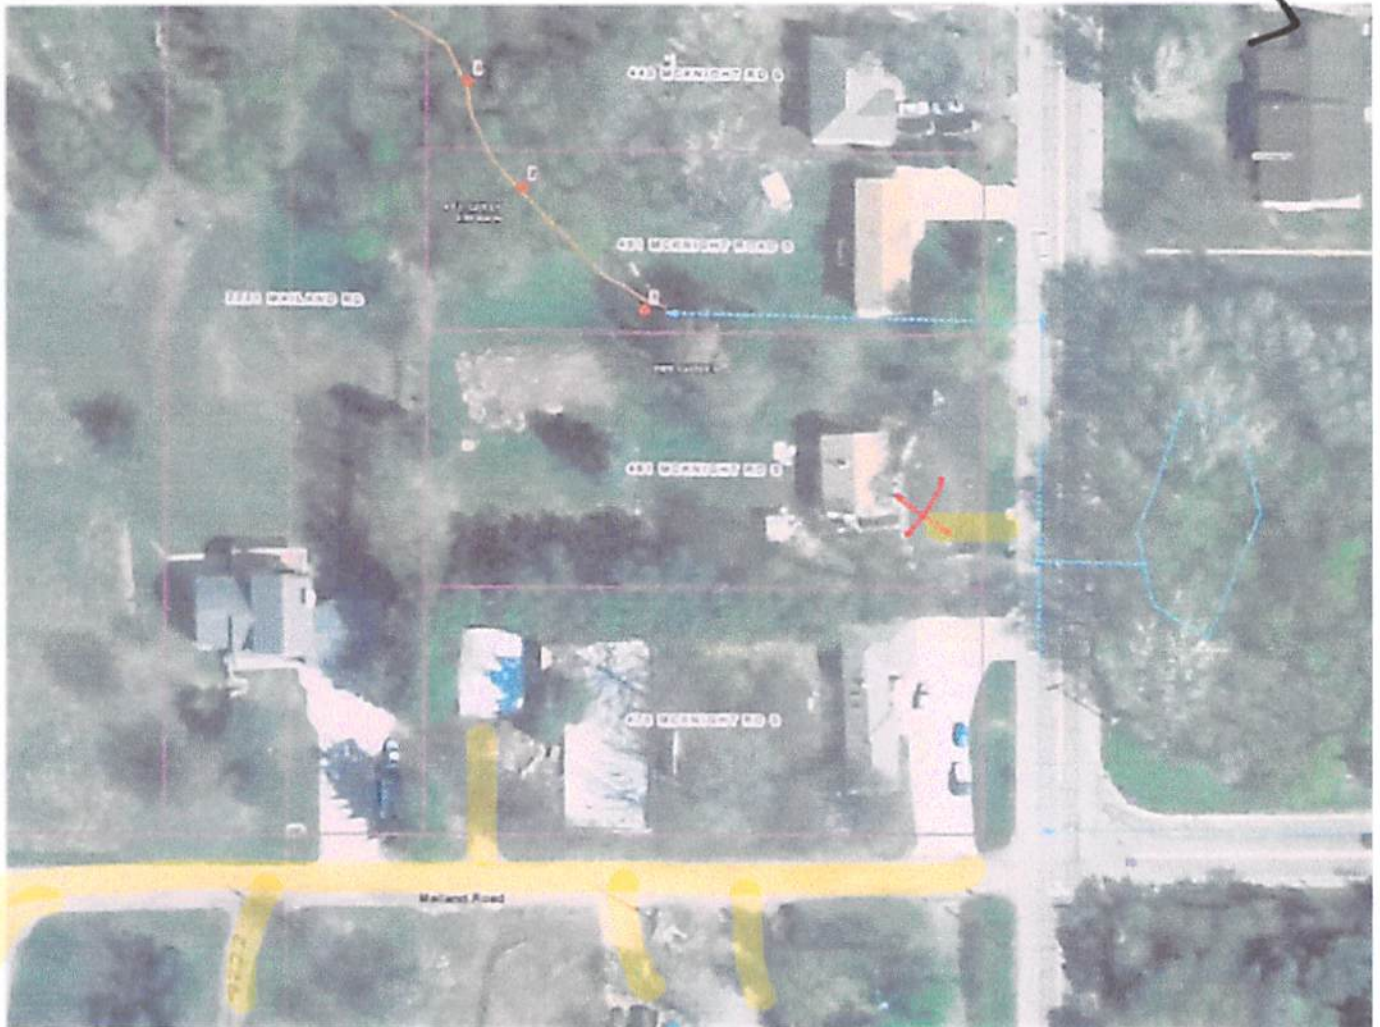
Diagram 5: class 5 road & neighbors

Class 5 road and driveways
