Date: June 23, 2010 File #: 10 - 511807 Folder Name: 755 ANDREW ST PIN: 082822410090

South and east sides

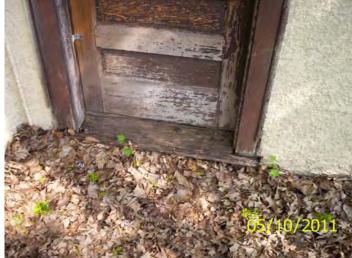
Rot damaged door trim, threshold, framing

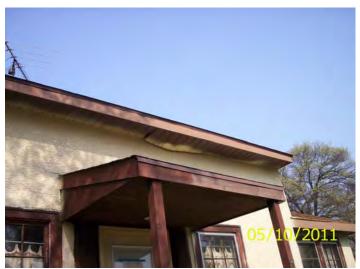
Deteriorated eave covering

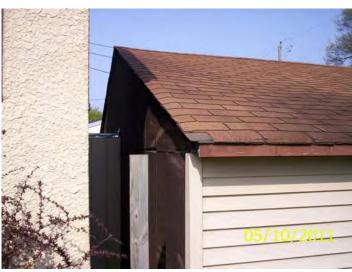
Missing siding, open wall

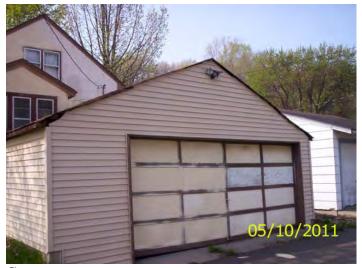
Date: May 10, 2011
File #: 10 - 511807
Folder Name: 755 ANDREW ST
PIN: 082822410090

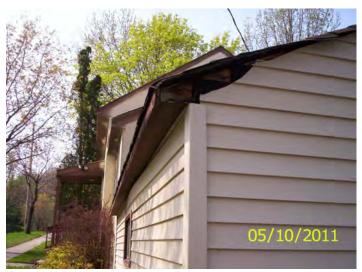
Open siding, deteriorated siding, water damaged open eave

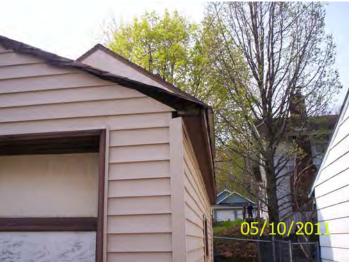
Open siding, water damaged open eave
