July 23, 2023

I am writing to respectfully request that the Department of Safety and Inspections (DSI) grant me the certificate of occupancy to my 733 Fairview Ave. N., Saint Paul Home for the reasons I will illustrate.

Re: 733 Fairview Ave N
File#: 14 325587 VB2

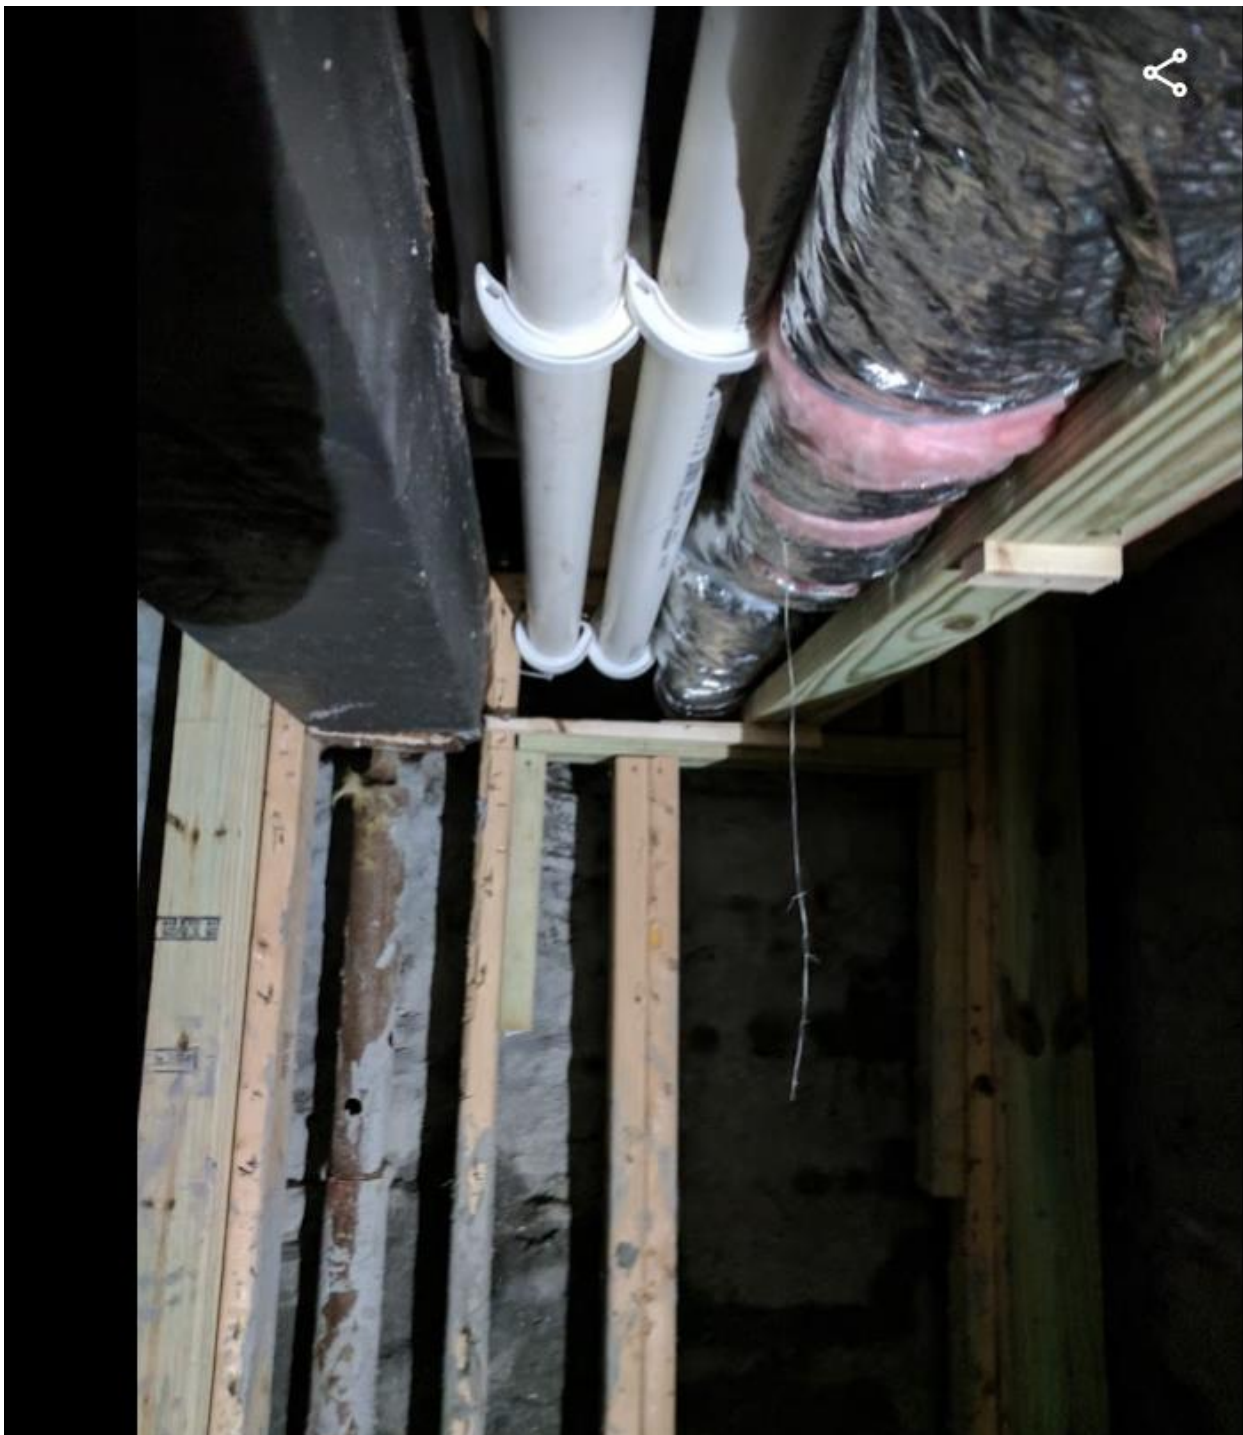
2015

The aforementioned is duplicitous because the following photo of the (white) PVC water heater gas vent piping is precisely what the Plumbing Inspector, Jim Kaufer observed in 2015. As such, there is no need to destroy and open a finished ceiling and walls so you can see the piping again. There were no issues with these gas venting pipes at that time, and accordingly, there should not be any new issues today.

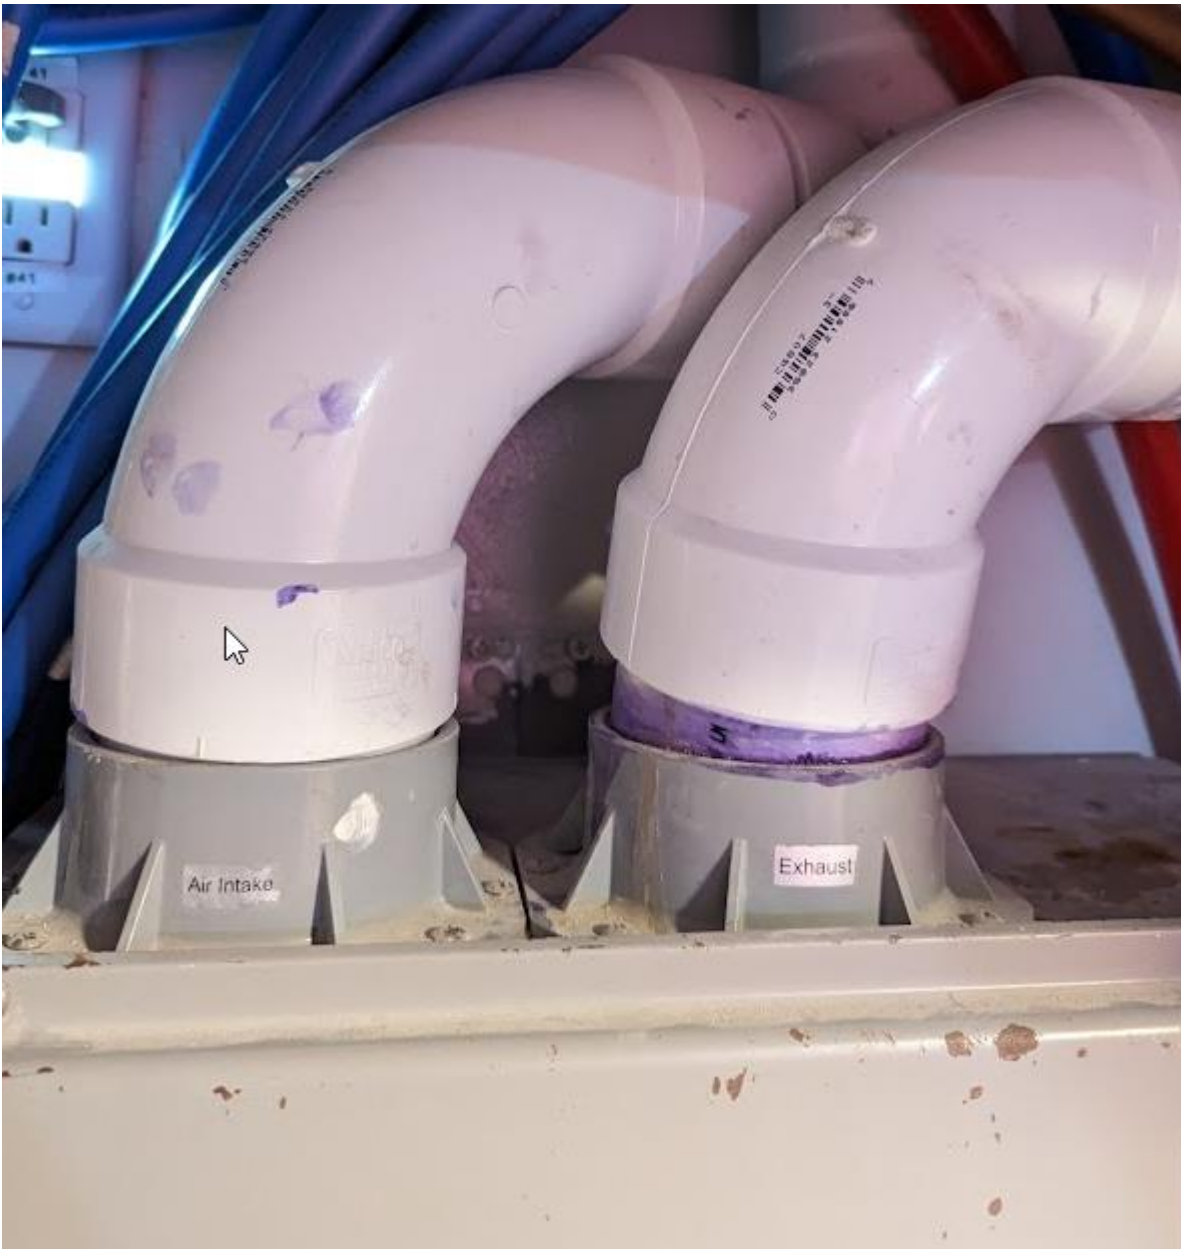
Water Heater Mounted to wall

To illustrate: in 2015, the plumbing inspector, Jim Kaufer observed the tankless water heater mounted on the wall, but not yet connected with water or electricity. He also observed/inspected the (white) PVC venting pipes mounted and leading to the Water Heater and leading straight

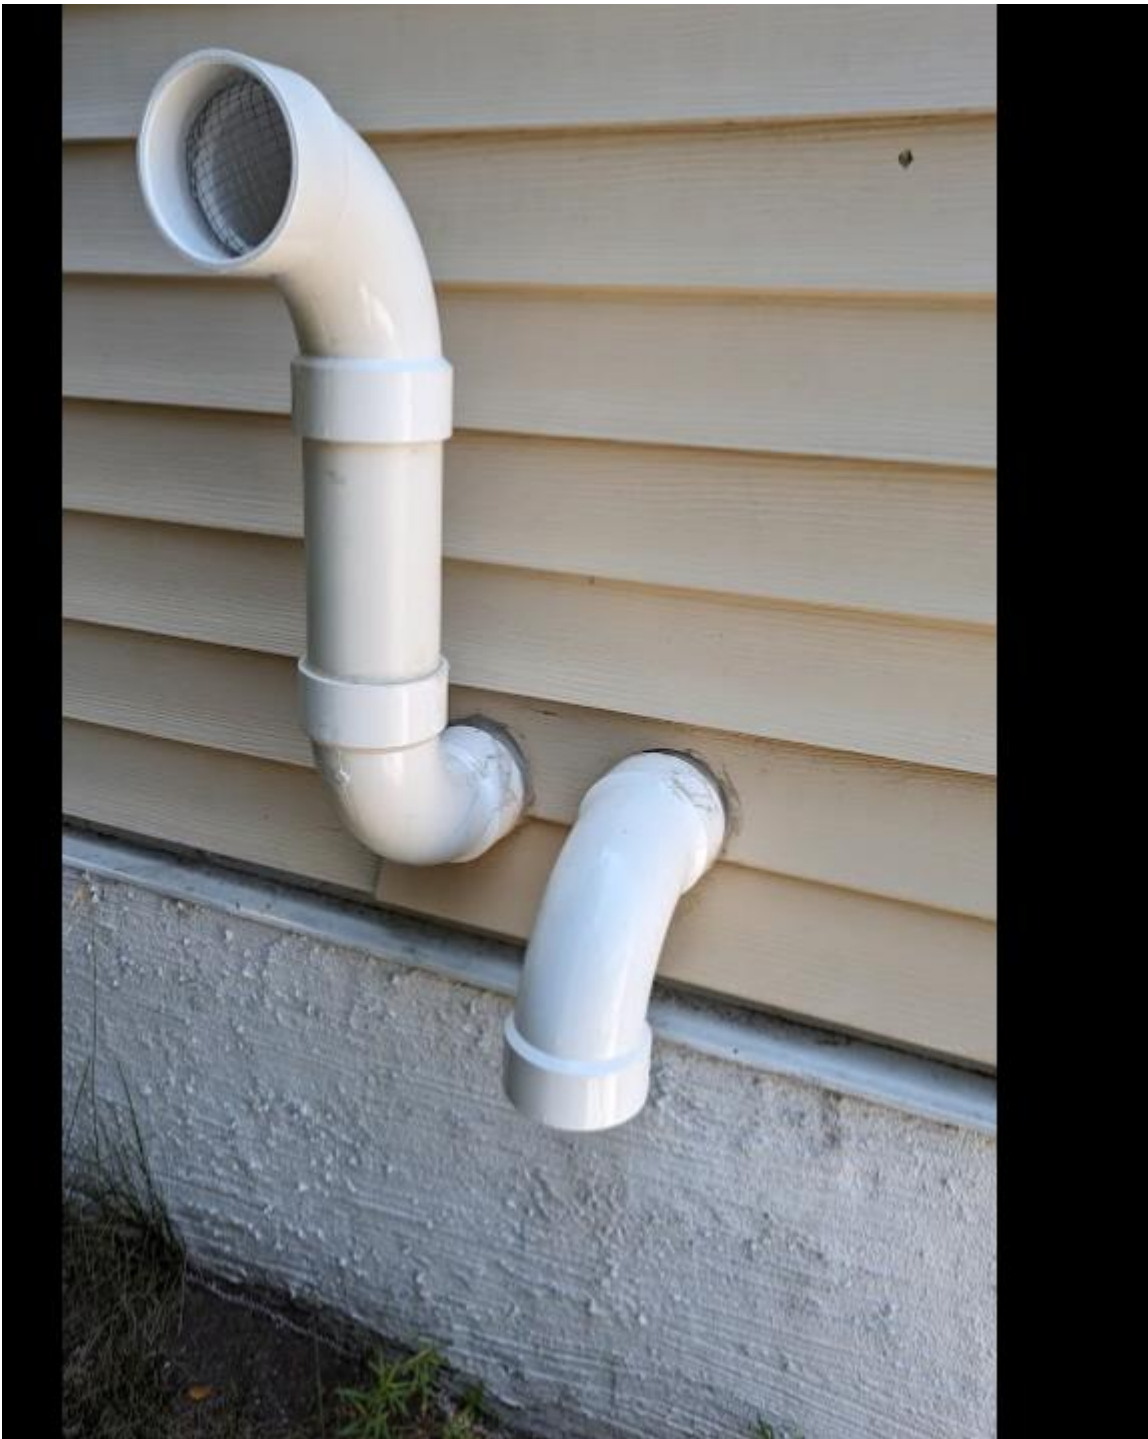
March 2023

The aforementioned was corrected and the elbows were secured, but that does not warrant a new directive in 2023 for the Plumbing Inspector, Jim Kaufer, who has already seen and inspected the PVC gas venting pipes in 2015 – to require the homeowner to open up the sheetrock of an already finished basement for the inspector to re-inspect what he already himself inspected and passed in 2015-2016. It should be noted, still, into the first half of 2021, the basement ceilings remained open (not sheetrocked) and the gas venting was still exposed and visible. Thus, for the homeowner to now be required as of June 2023 for **“The walls/ceiling will need to be opened**

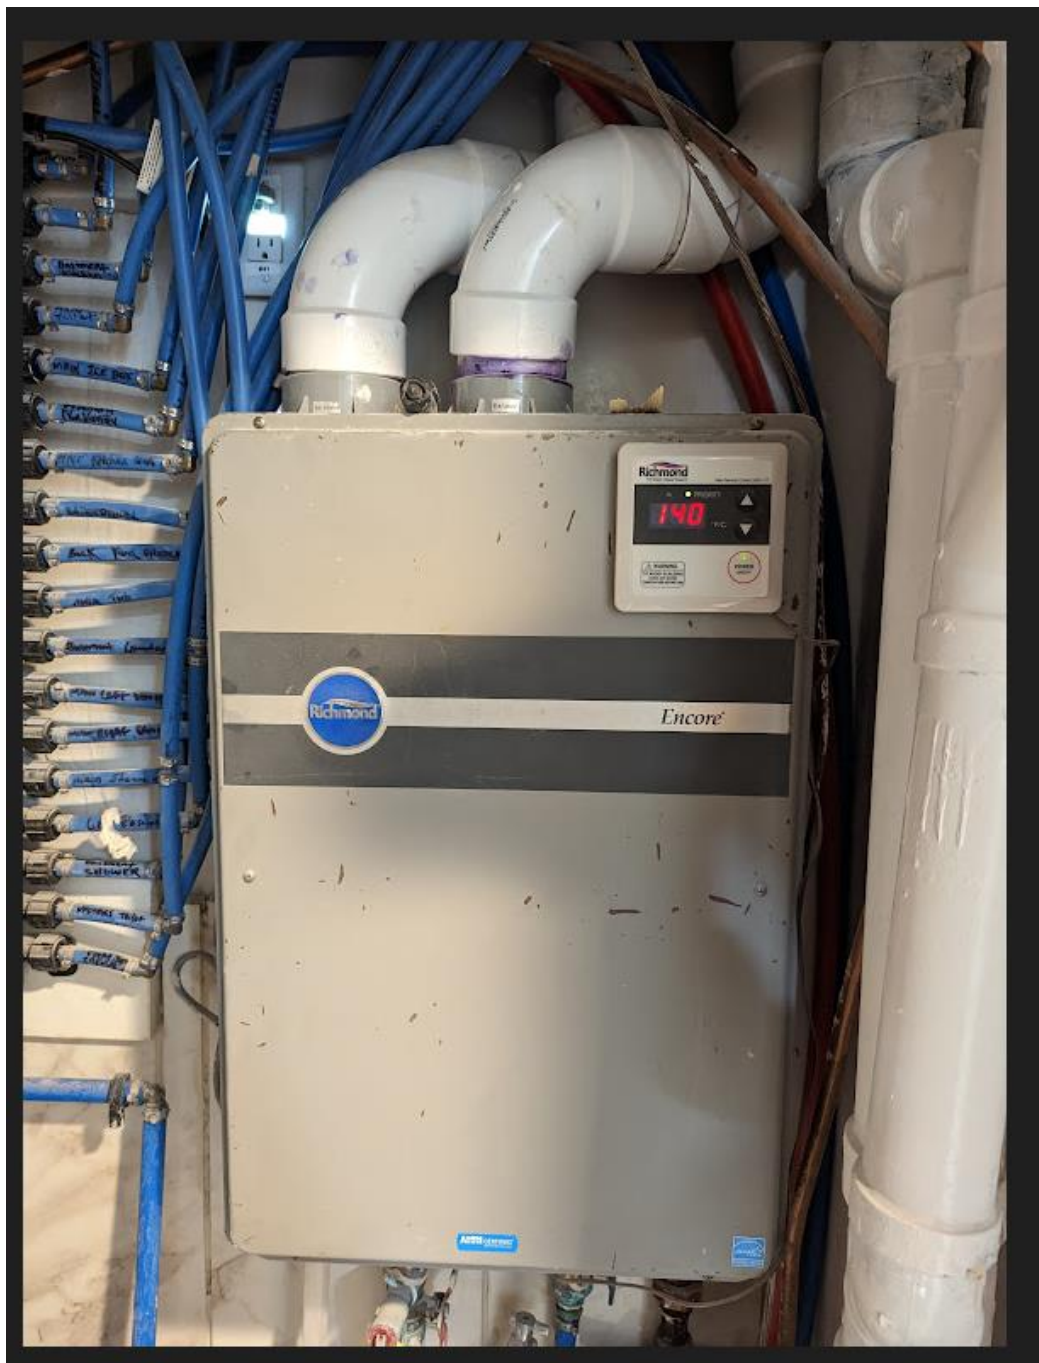
2023

up to inspect the water heater venting” is unreasonable, counterproductive, onerous, but also arbitrary and capricious.

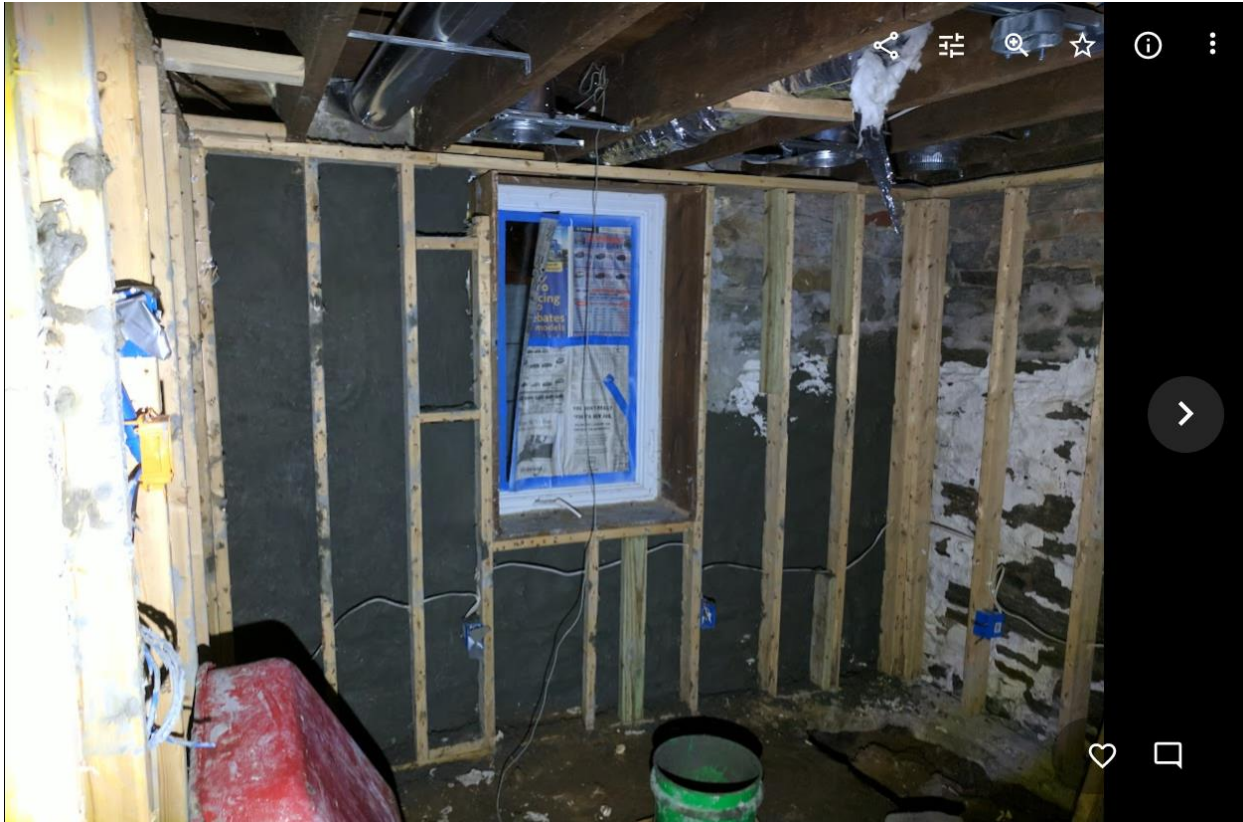
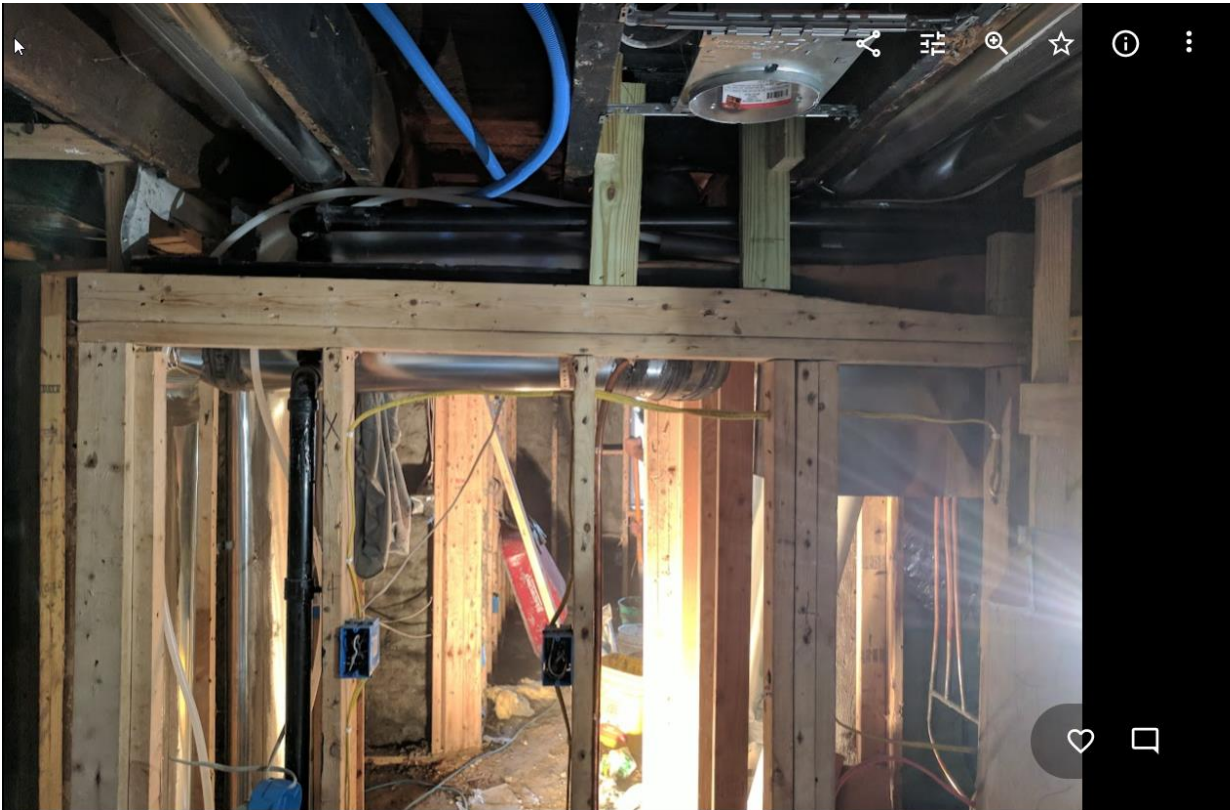
To this end, just like the white PVC gas venting piping in the walls and ceiling, the AC/HVAC Venting ductwork is also visible in these photos and appropriately, was also inspected – **but by a different** Heating Inspector, Erik Witt, **and not the June 2023 inspector**. The only comment about the new ductwork in 2021 is mentioned in #5: “Clean all supply and return ducts.” Accordingly, it is unnecessary that in 2023, the Warm Air Inspector, Chris Wiskur (a

different inspector than even the previous two inspectors), alleges that the “ducts were installed and covered up without permit or inspection”. This is patently untrue, sloppy, and if he had reviewed the previous two reports, possibly requested in bad faith. Irrespective, the demand would be extremely onerous to the homeowner, is unwarranted and redundant. The work was done years earlier as is visible in the photos, with a permit and the work inspected years earlier, soon after the work was completed.

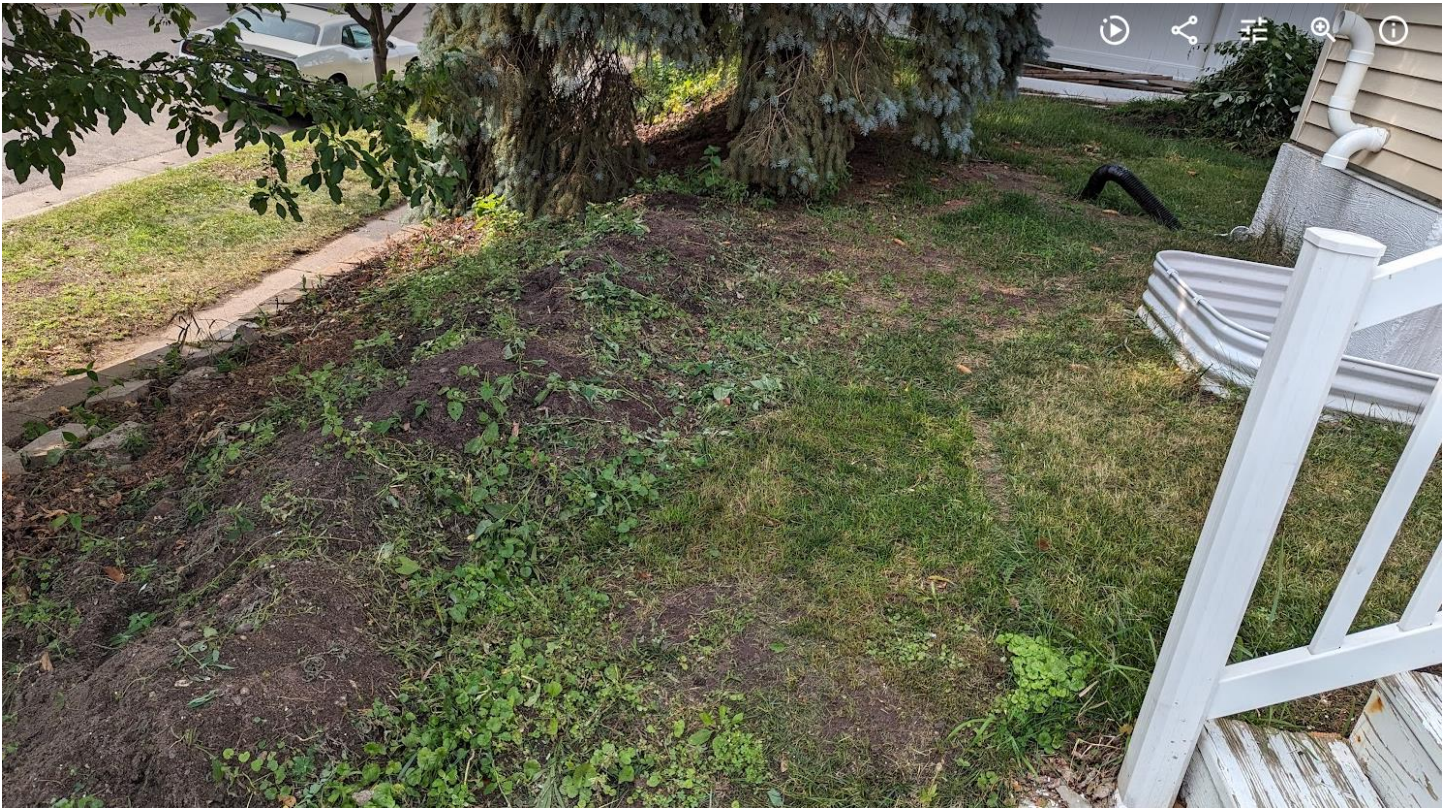
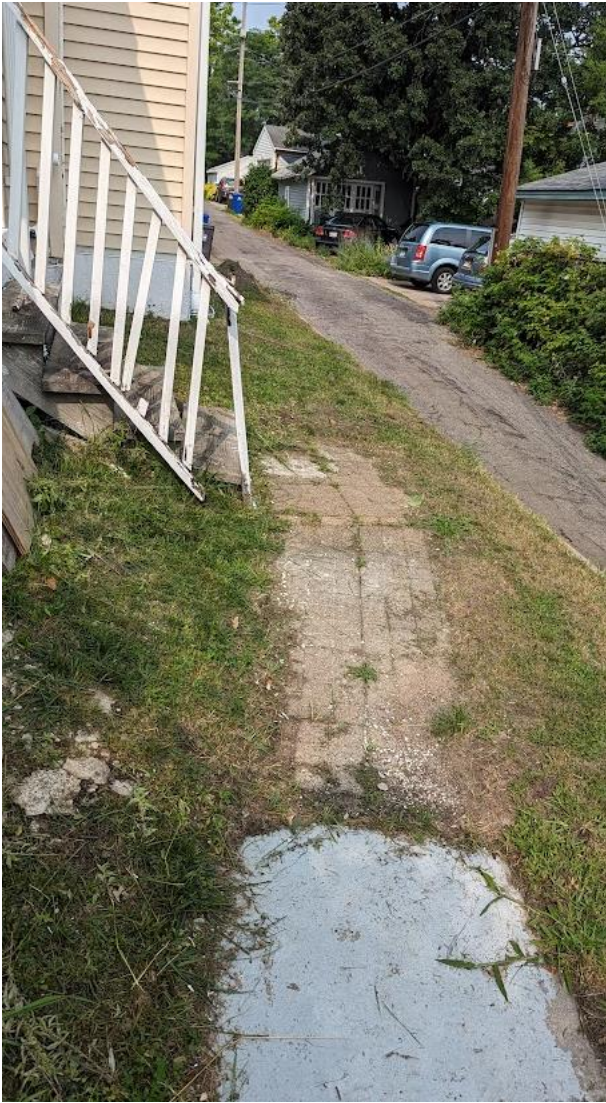
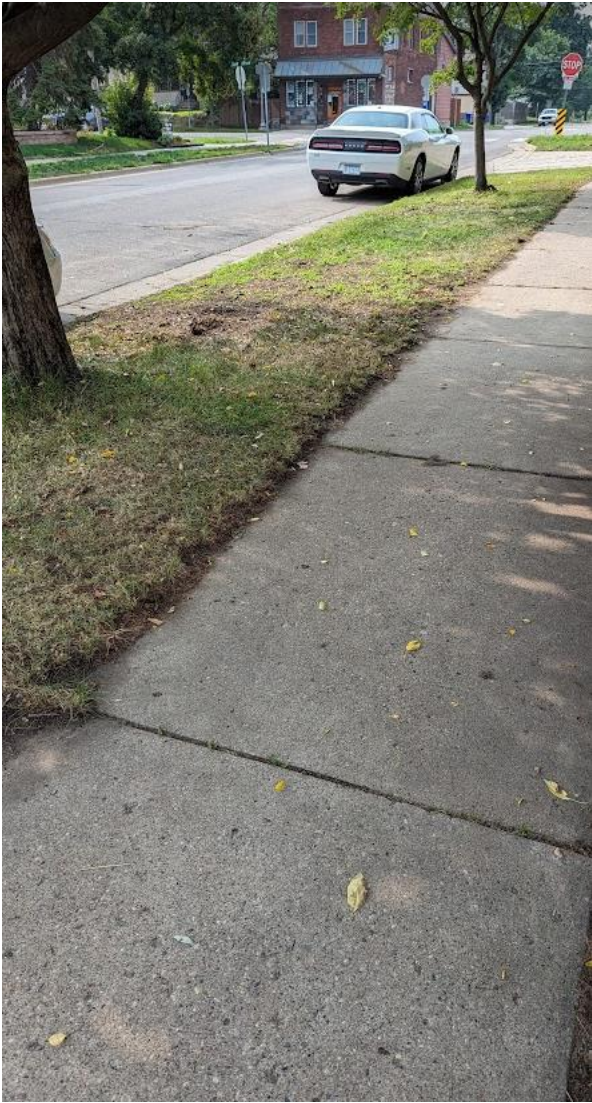
As of this writing, July 23, 2023, all tall grass, weeds and rank plant growth from the yard, boulevard and even my neighbors' boulevard and alley areas have been cut.
