## St. Paul Heritage Preservation Commission

### August 27, 2015 Public Hearing/Design Review

# Central Presbyterian Church

500 Cedar Street Individual Heritage Preservation Site

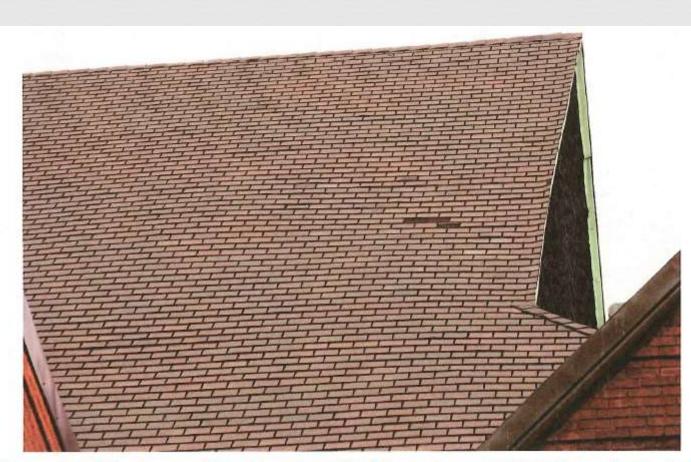
Figure 7 Detail of current portion of south side eastern end of main roof showing missing shingles 7/27/15

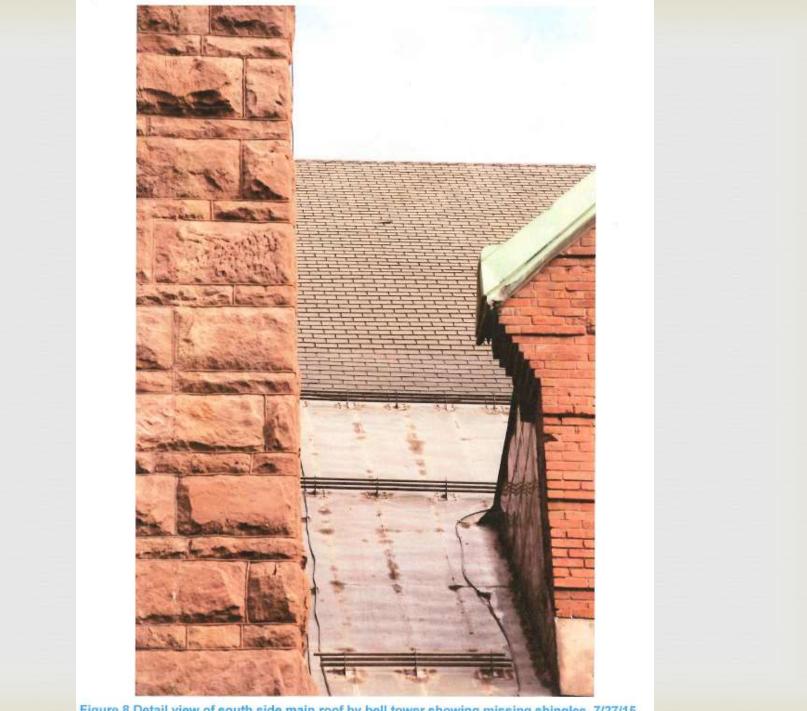
Figure 8 Detail view of south side main roof by bell tower showing missing shingles 7/27/15

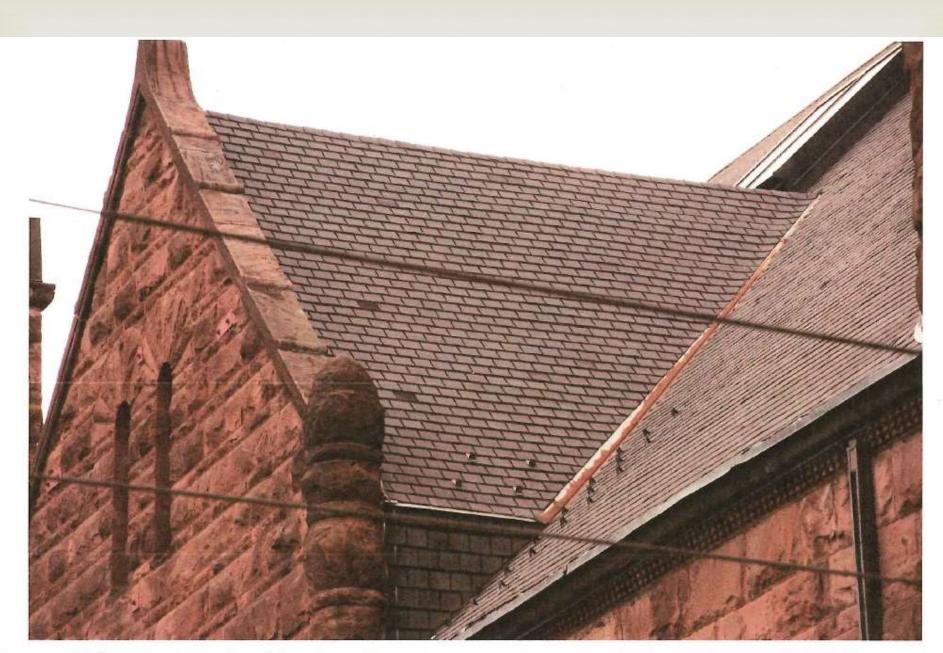
Figure 12 Detail view of gable of northeast corner showing missing shingles 7/27/15
