### HERITAGE PRESERVATION COMMISSION DESIGN REVIEW APPLICATION

Demolition of 700 4th Street East

Project No.:15538.00Re:Structural Condition Review of the building at 700 4th St. E.

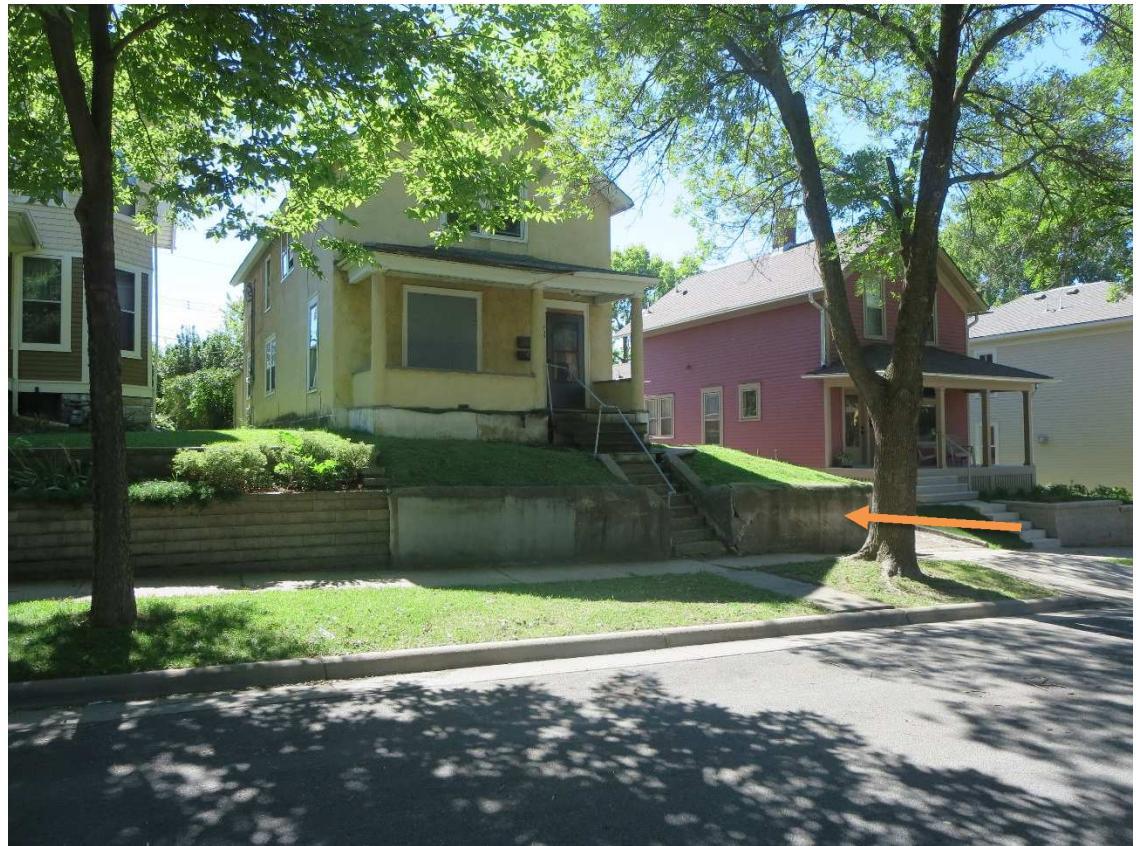
The retaining wall at the front of the house is cracking and needs to be replaced. Picture 1 shows an overall view of the front retaining wall. Picture 2 shows the portion of the retaining wall that is showing the most cracking. A portion of the retaining wall has tipped. As the retaining wall continues along the southern side of the building its deflection increases. Picture 3 shows the wall, as seen from 4<sup>th</sup> street. There are also cracks that appear to go through the wall. Picture 4 shows one such crack.

Picture 1 – Front Retaining Wall

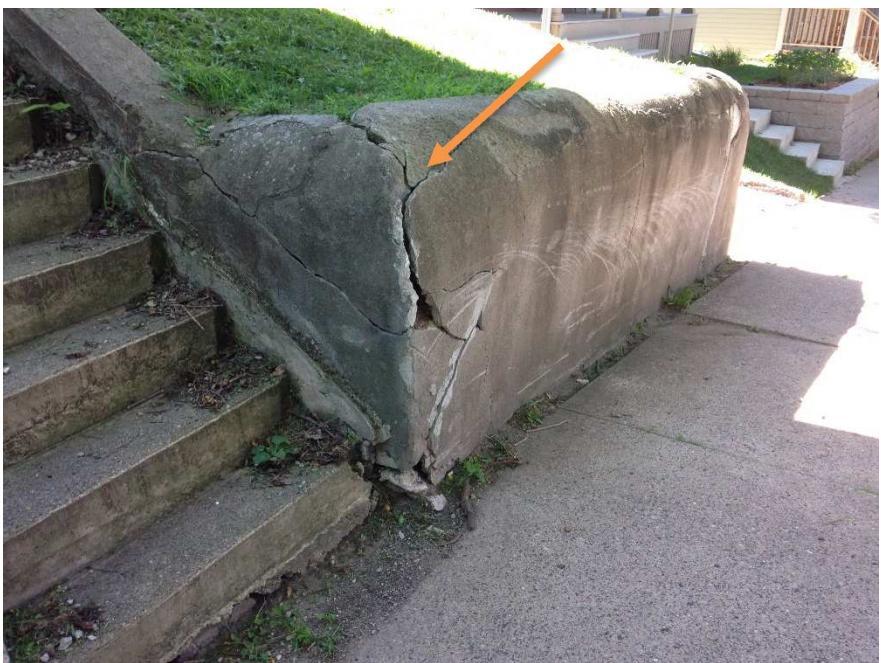
Picture 2 – Front Retaining Wall

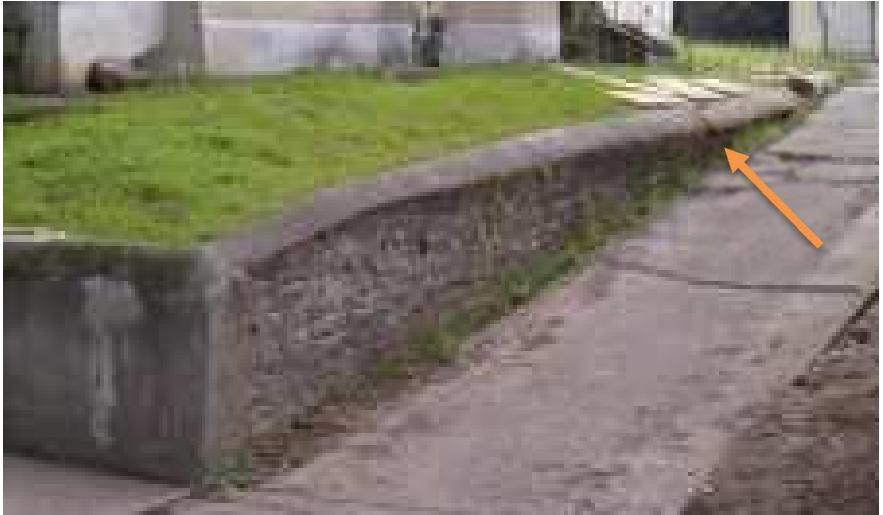
Picture 3 – South Retaining Wall

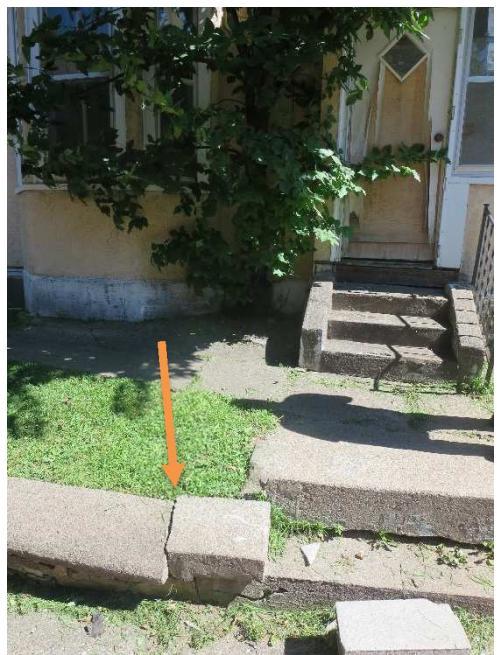
Picture 4 – Crack at South Retaining Wall

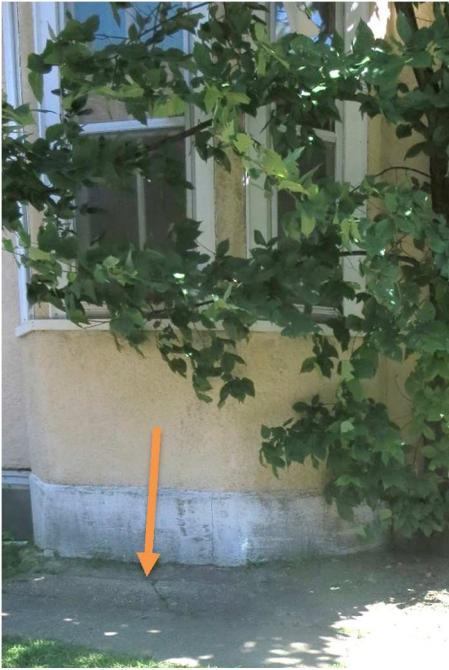
The bay along the south wall of the house appears to have settled. Picture 5 shows the bay and a crack that has occurred next to it. There is a tree that is growing just east of the bay. Its trunk is adjacent to the foundation wall. The tree is likely one cause of the settlement of the bay and could be the cause of other problems in the house. Picture 6 shows the base of the tree and the foundation wall. The background of Picture 4 shows the bay along with the tree as well.

Picture 5 – Bay at South Wall

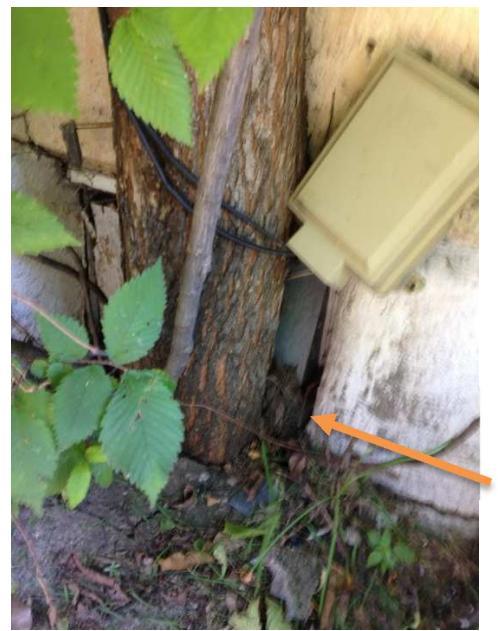
Picture 6 – Tree Growing Next to House

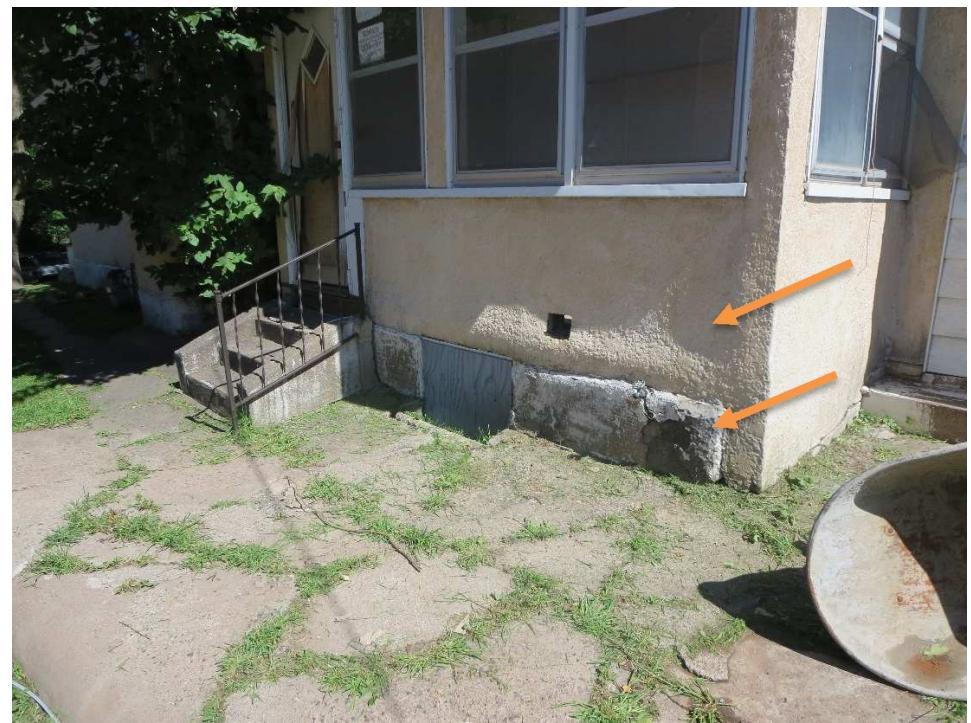
There is some water damage to the house. The eastern section of the south foundation wall showed signs of damage and rot. Picture 7 shows some of the rot that has occurred as well as spalling of the finish material along the foundation and bulging of the stucco on the wall. Water damage effects were found in the floor of the second story of the house. Picture 8 shows some of the damage. It is likely that there is damage that allows water to leak. The roof was observed from the outside to be sagging slightly (not pictured). It is likely that there is some damage to the roof, which is causing water to enter the house.

Picture 7 – Water Damage at Southern Foundation Wall

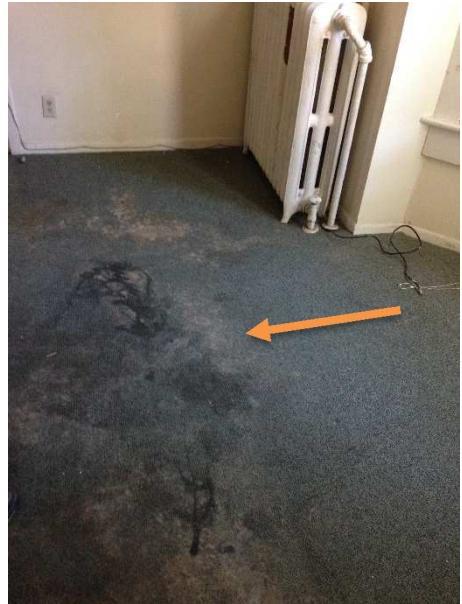
Picture 8 – Water Damage in 2<sup>nd</sup> Floor

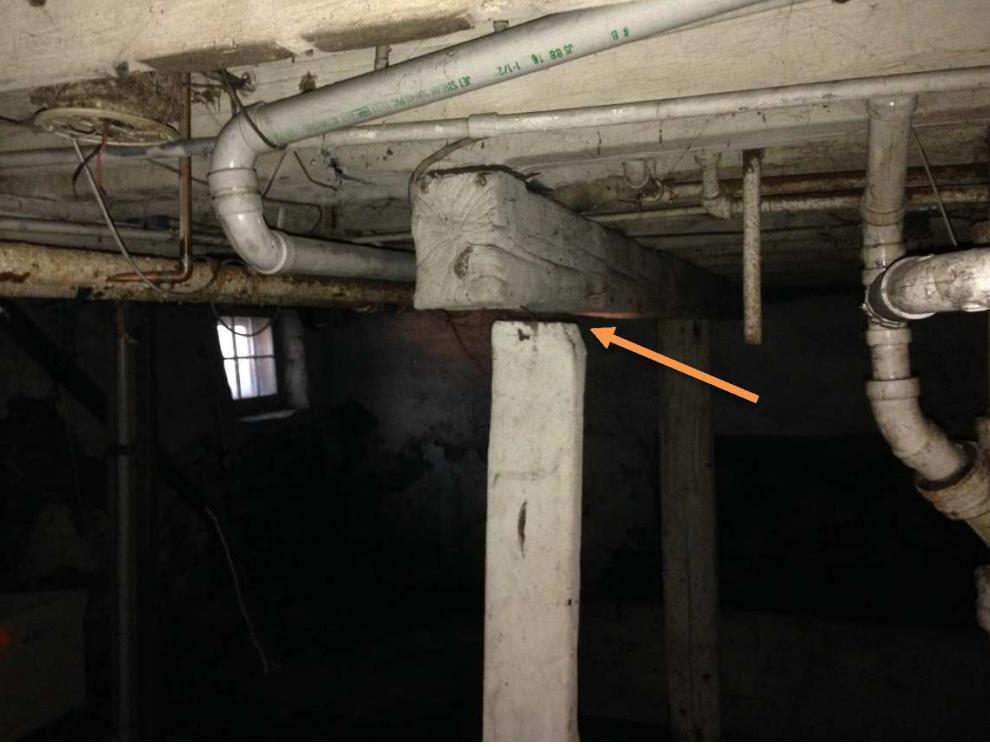
There are framing issues in the basement. There is a beam that does not rest on the column as it was originally designed. Picture 9 shows the beam as well as the column. The gap between the beam and the column is approximately 1 inch. The gap between the beam and column can be seen in the picture.

Picture 9 – Beam Above Column in Basement
