SUBSURFACE GEOTECHNICAL ASSESSMENT

Project 2016.001

RE: Foundation Assessment 956 Geranium Ave E St. Paul, Minnesota

Foundation Assessment - 16052.00

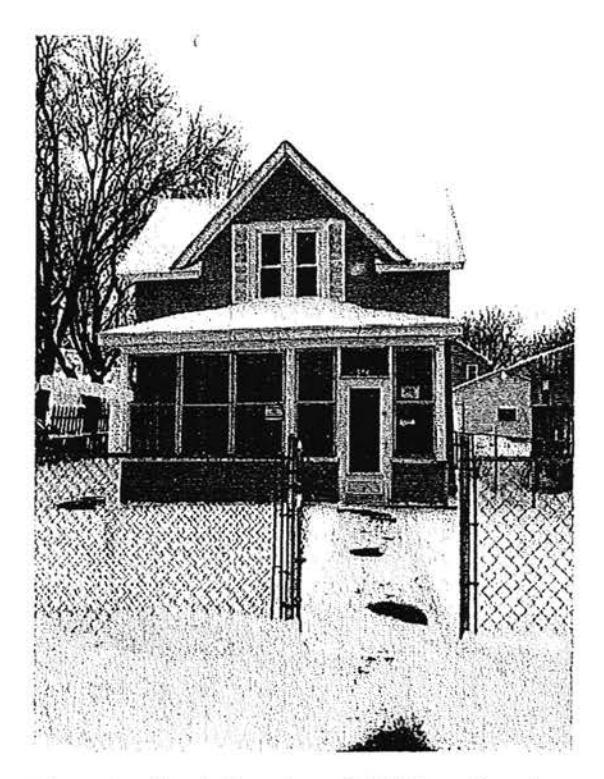
As requested, I visited the above referenced site to assess the condition of the residential foundation. The home is currently vacant and on the market for sale. The 1 1/2 story, single family residence (see Photo 1) sits atop a foundation system of exterior stone walls and interior heavy timber support beams. My review was limited to the main level structure and the foundation area below. No lighting was available in the lower level, so my review was limited to those areas I could illuminate with a flash light.

Photo 1 - North Elevation of 956 Geranium Ave

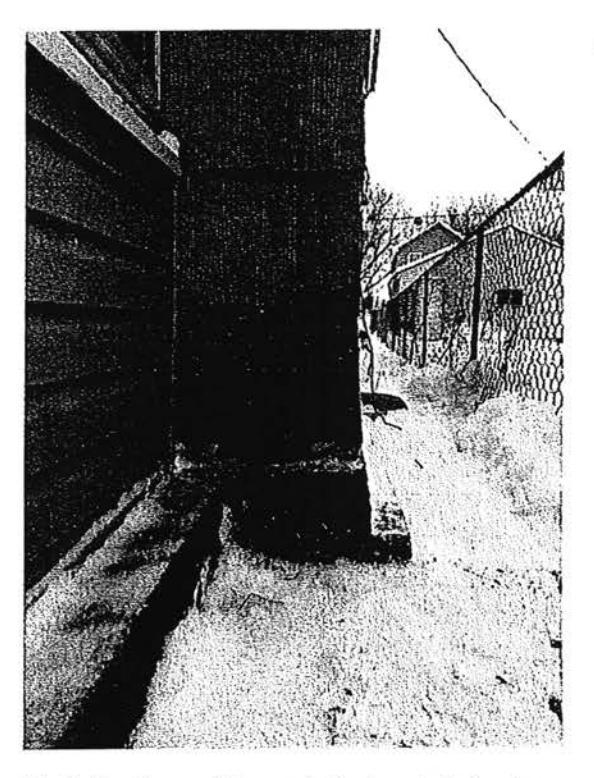
Along the perimeter of the house, a poured concrete ledge was visible, projecting out from the face of the exterior wall (see Photo 2). This ledge is a source of standing water which has been allowed to enter the rim joist and main floor framing members. The water intrusion appears to have resulted in damage/rot throughout the perimeter of the house (see Photo 3).

Photo 2 - Poured Concrete Ledge at Perimeter

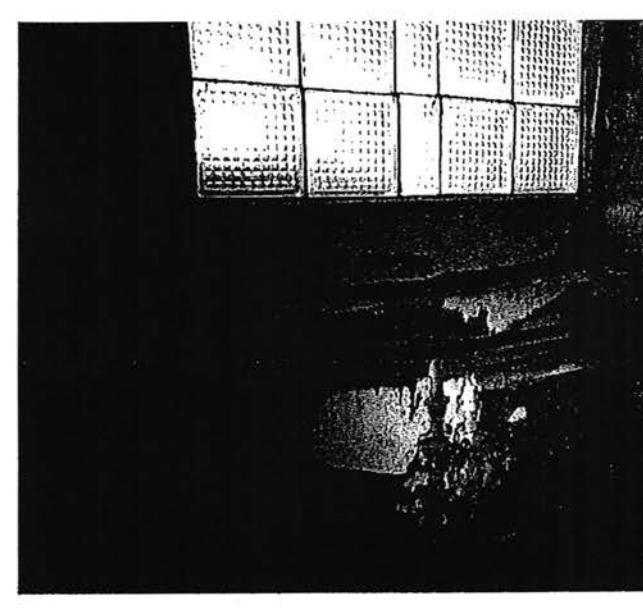
Other areas were noted as locations where water has been allowed to penetrate the foundation system. Poorly constructed window wells (see Photo 4), window sills located near exterior grade level (see Photo 5), and an exterior stair providing access to the lower level (see Photos 6 &7) have all contributed to the moisture problem. In addition, the lower level stair structure did not appear to have adequate frost coverage at the foundation, so heave/settlement due to frost effects have also been an issue.

Photo 5 – Low Window Sill Allowing Moisture Infiltration

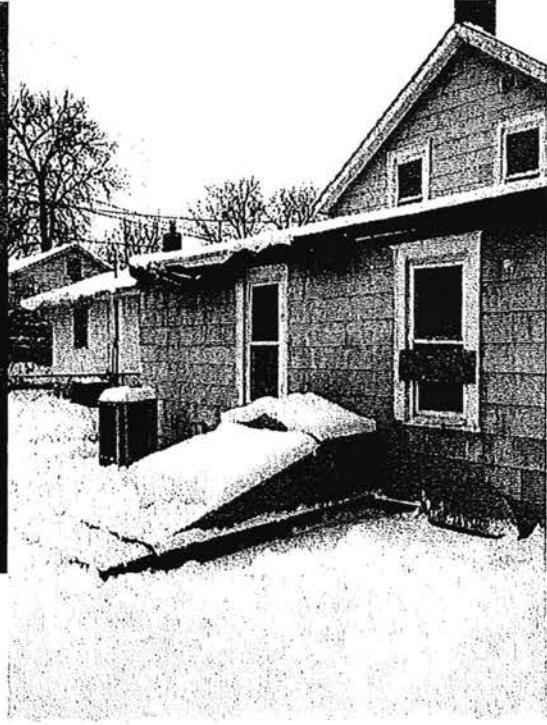
Photo 6 – Uninsulated, Unprotected Exterior Stair Access

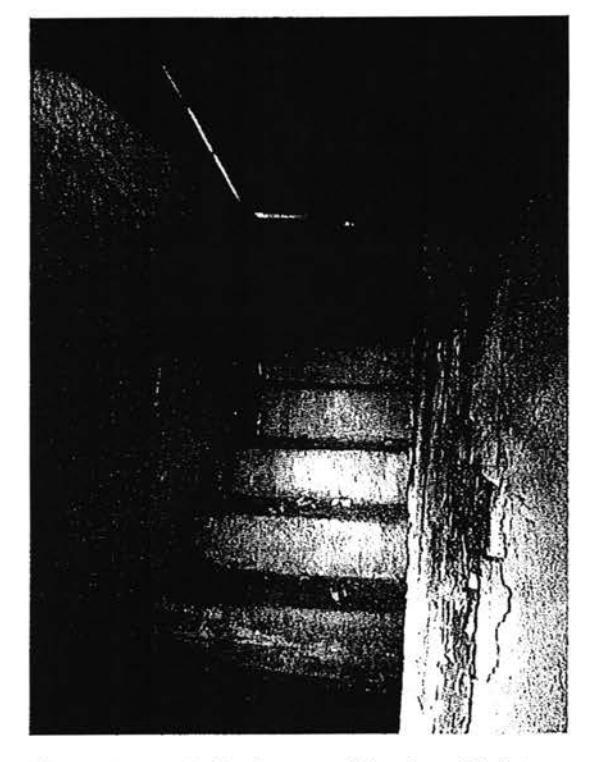
Photo 7 – Stair Access Allowing Moisture Infiltration

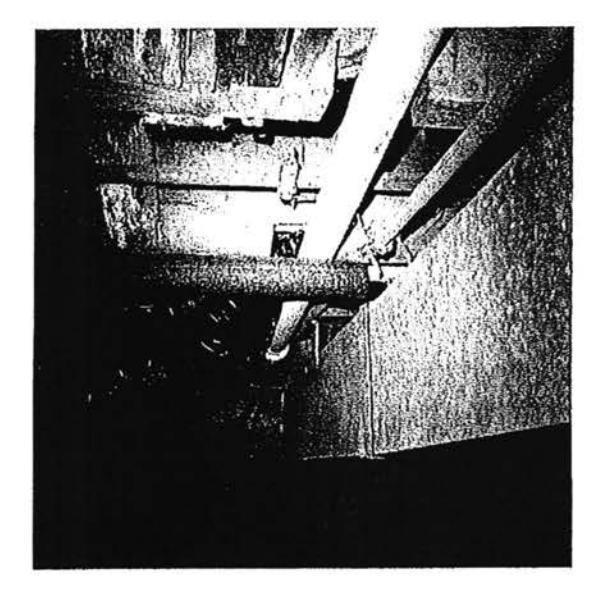
The main floor framing consisted of 2 x 8 floor joists, spaced at 16" o.c. In most areas, the joists were inadequately supported (no joist hangers, insufficient bearing length). Many of the headers over openings were undersized and in many cases, the joists were heavily notched or drilled (see Photos 10, 11 & 12), decreasing their load carrying capacity.

Photo 10 - Notched Floor Joists
