Inspection Report

Date:	05/11/2018
Inspector:	David Eide
License Address:	1202 Dale St N
Licensee/ Violator:	Bee Lee & Tou Yang, d/b/a MC Auto Repair & Tire Services
License Number:	20160000541
Violation:	License Conditions 1, 2, 3, 4, 5, 6, 11, and 17

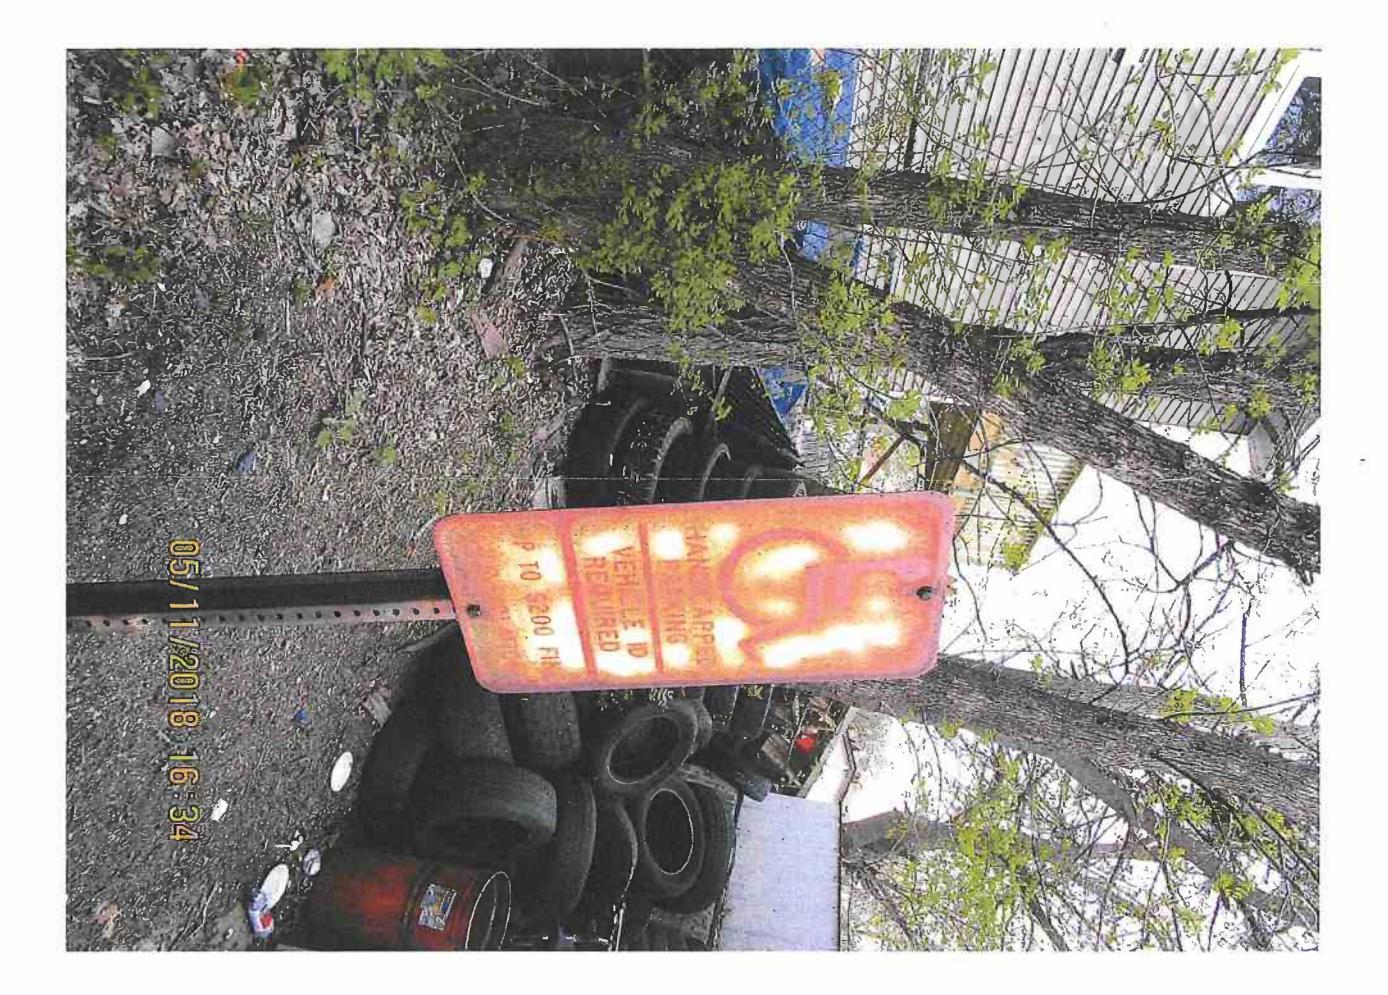
Condition #3: Lot must be striped and landscaped in accordance with 7/13/16 site plan. Four medium sized trees must be installed along Dale and are missing.

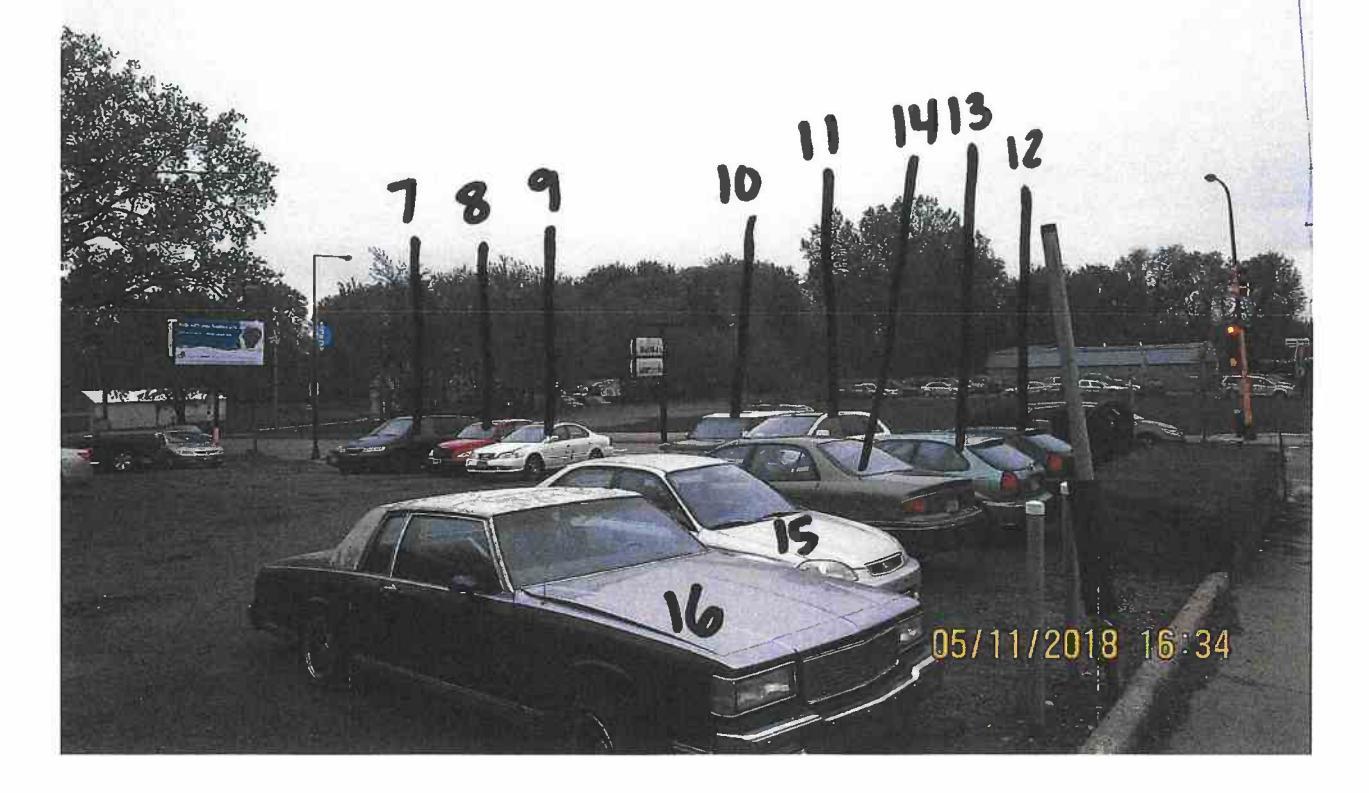
Condition #2: Maneuvering space must be provided. (Driveway blocked with cones and vehicle.)

Condition #3: Lot not striped as indicated in 7/13/16 site plan.

Condition #4: No exterior storage on inoperable vehicles.

Condition #6: All vehicles parked outdoors on the lot must appear to be completely assembled with no major body parts missing.

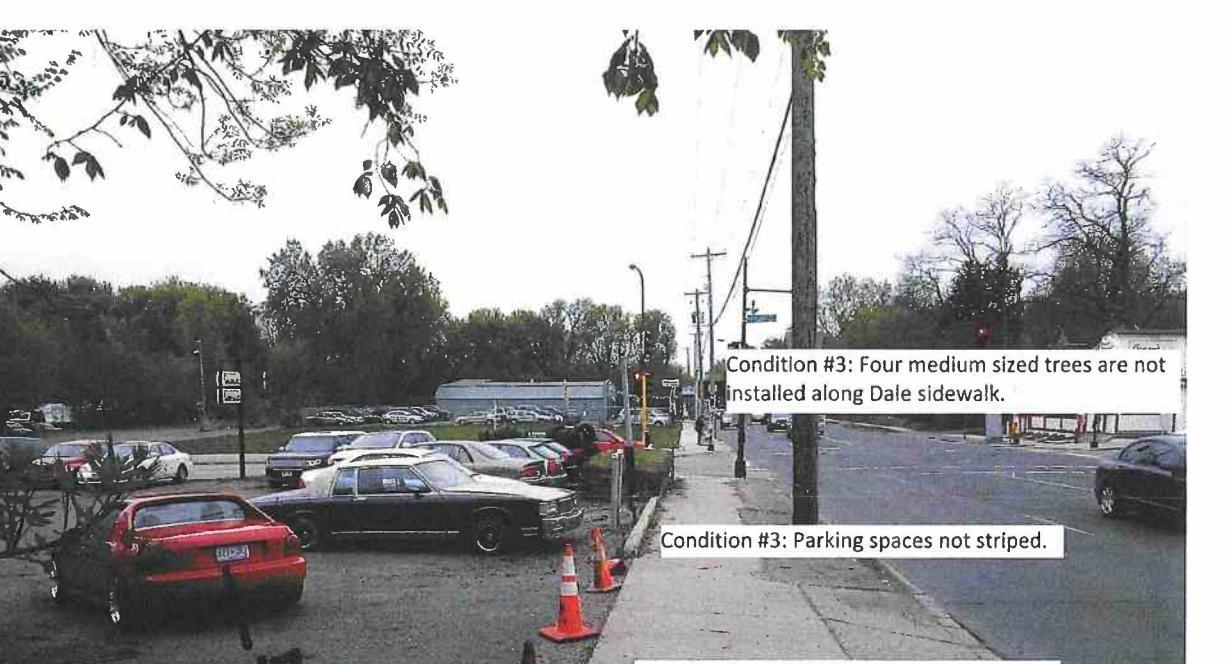
Condition #2: Maneuvering space blocked

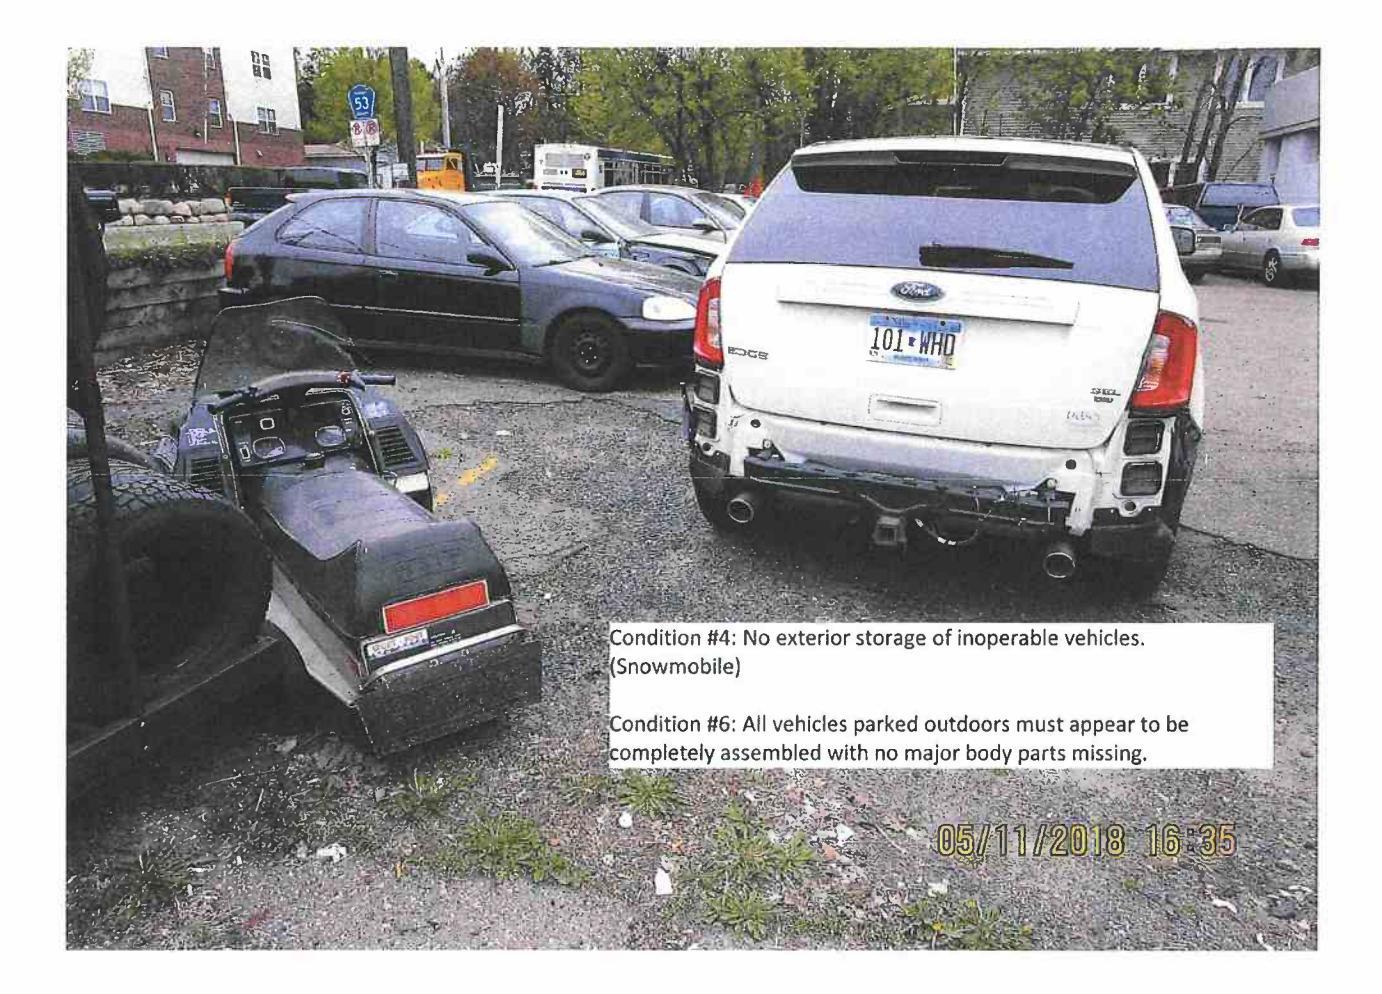
Condition #1: License holder is limited to 18 vehicles parked on exterior. 24 vehicles were on premesis at time of Inspection. Vehicles not parked according to site plan.

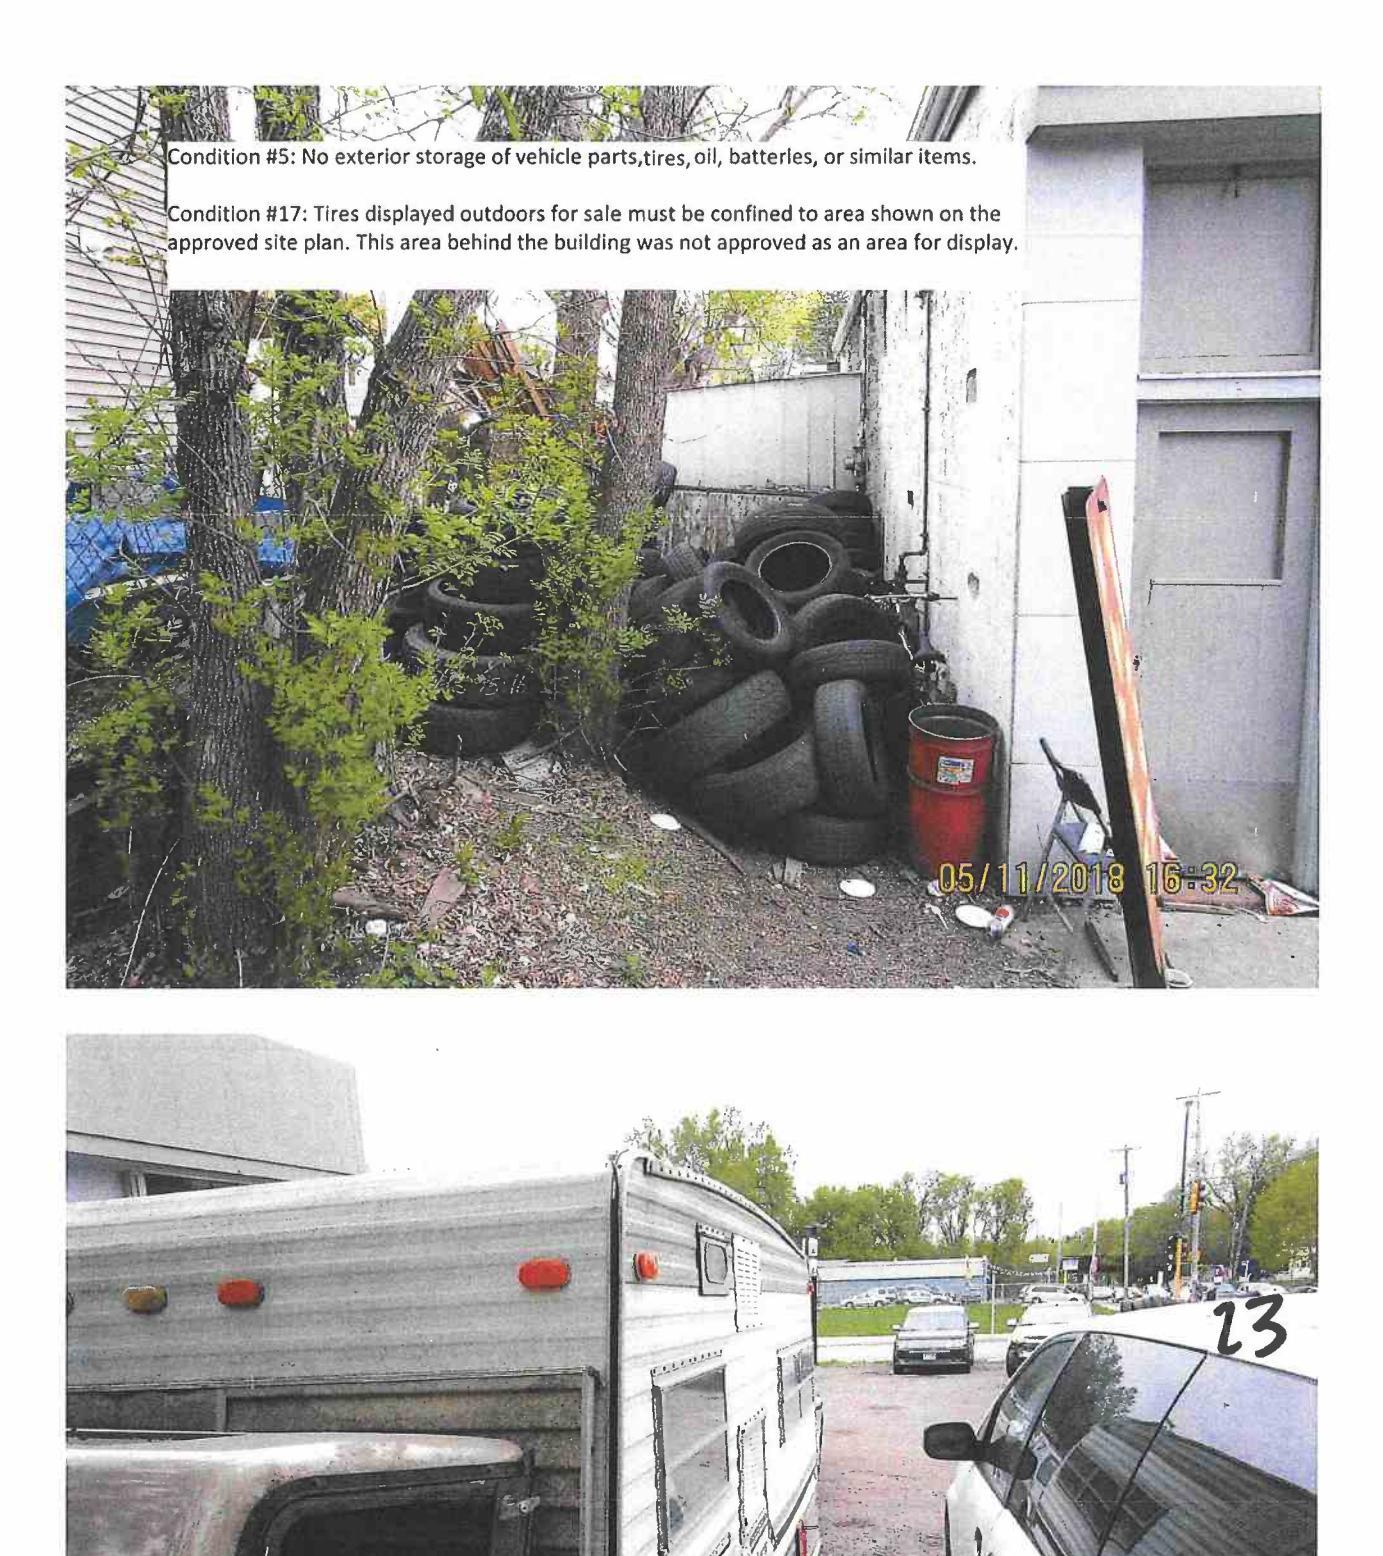
Condition #5: No exterior storage of vehicle parts. 05/11/2018 16:32 Condition #1: Vehicles must be parked according to site plan. Handicap space was blocked in by white vehicle and loading zone was occupied by a camper.

Condition #3: Site plan not striped according to 7/13/2016 site plan. Handicap space not striped, nor loading zone hatched.

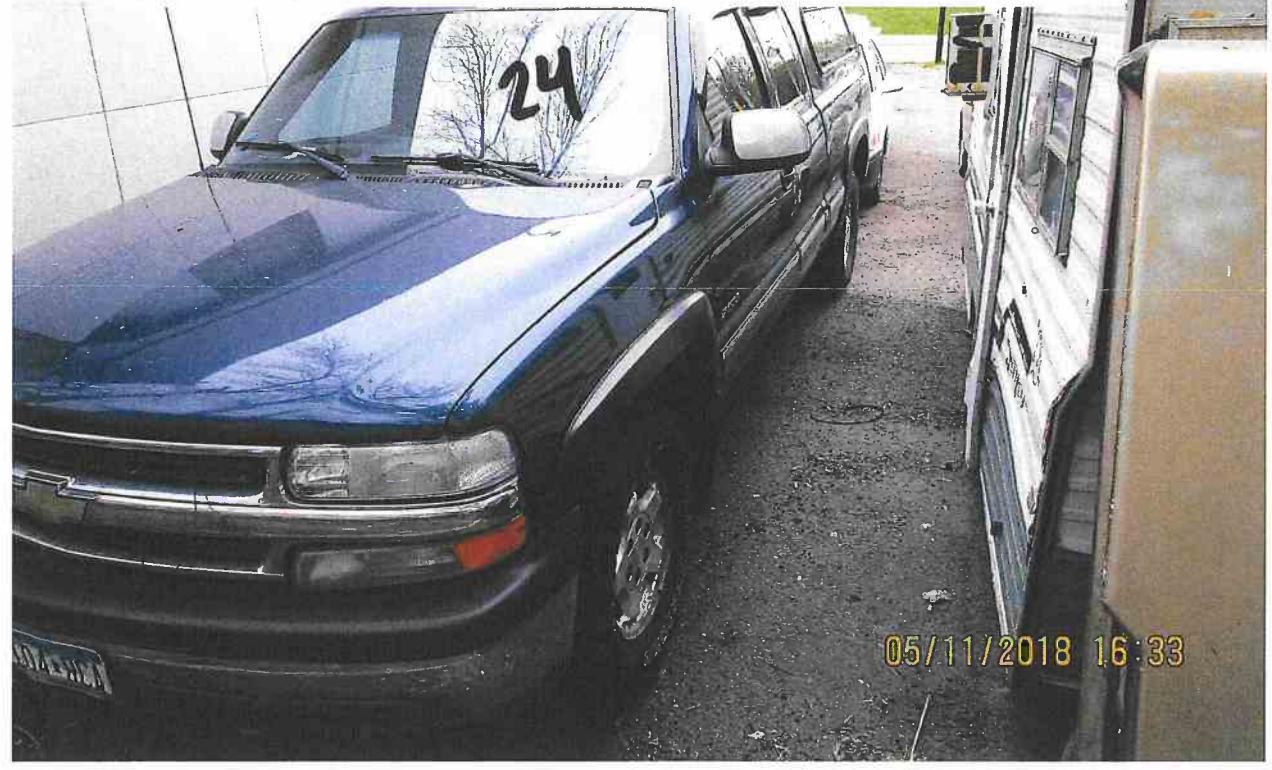
Condition #1: Vehicles not parked according to site plan. (Camper parked in handicap loading zone.) Condition #3: Parking lot not striped according to site plan. (Handicap loading zone must be hashed indicating "no parking.")

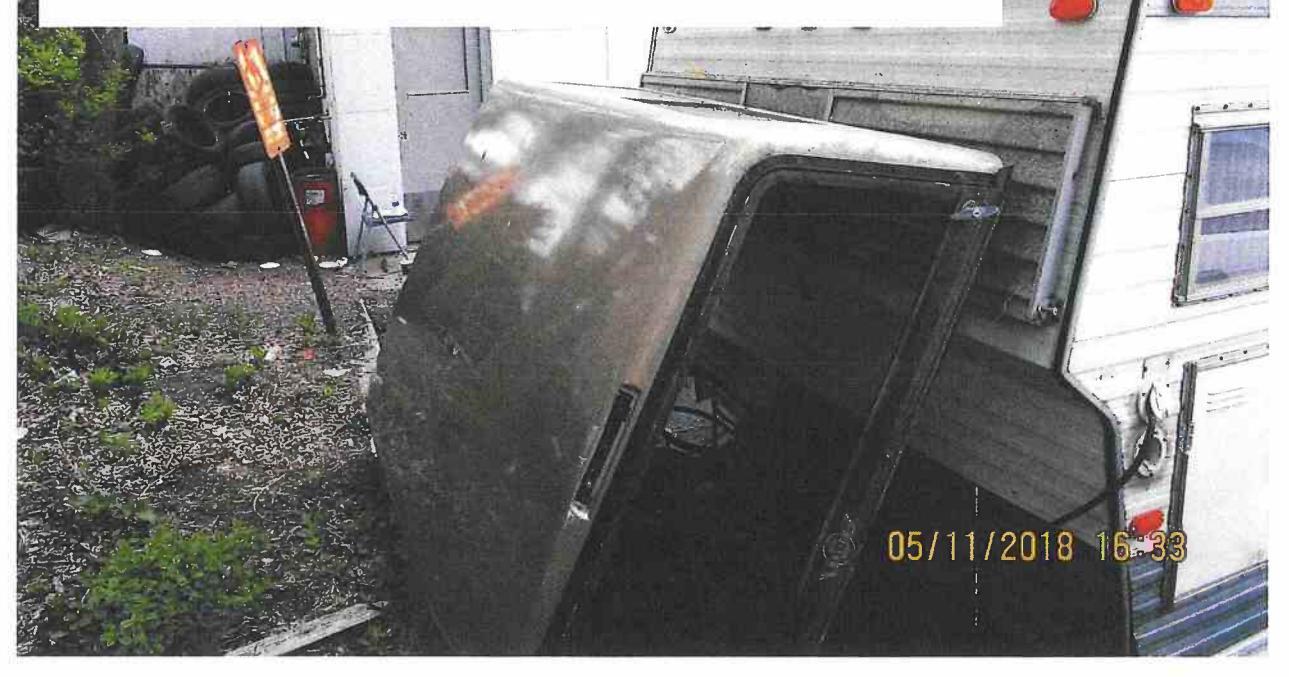
Condition #5: No exterior storage of vehicle parts, tires, or similar. Trash must be in covered dumpster or inside building.

Condition #17: Tires displayed outdoors must be confined to area shown on approved site plan dated 7/13/2016.
