July 23, 2023

I am writing to respectfully request that the Department of Safety and Inspections (DSI) grant me the certificate of occupancy to my 733 Fairview Ave. N., Saint Paul Home for the reasons I will illustrate.

Re: 733 Fairview Ave N  
File#: 14-325587 VB2

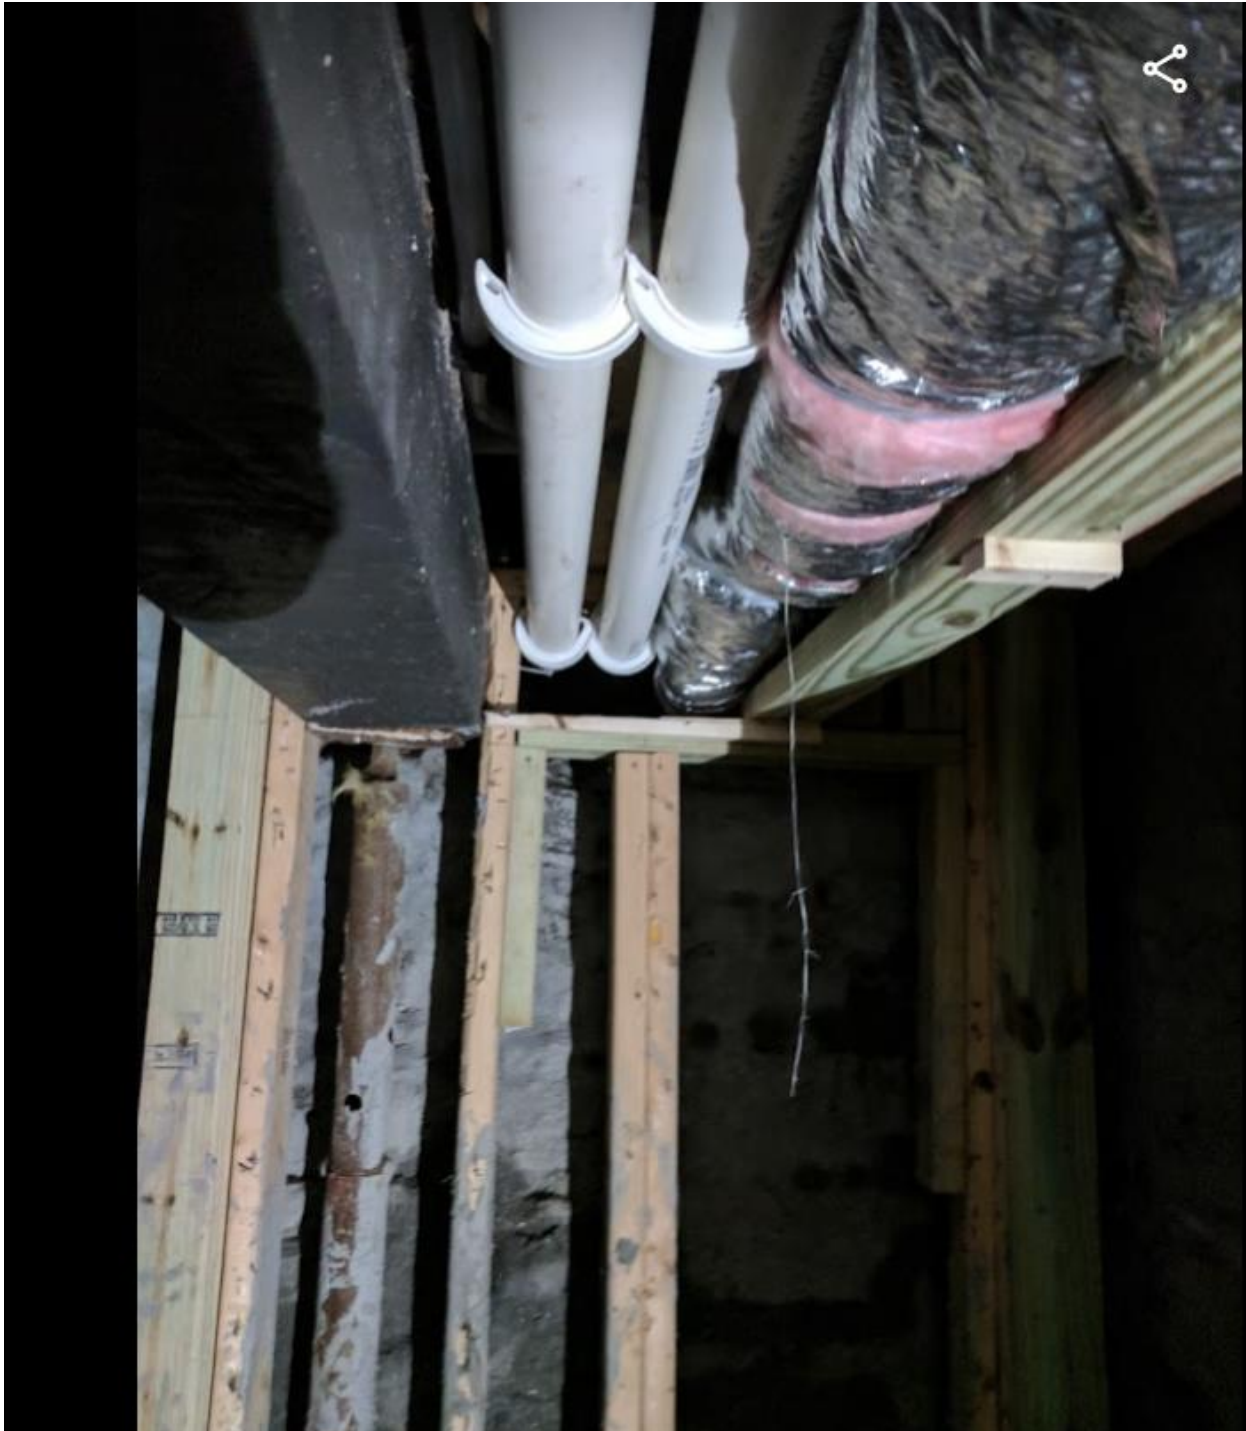
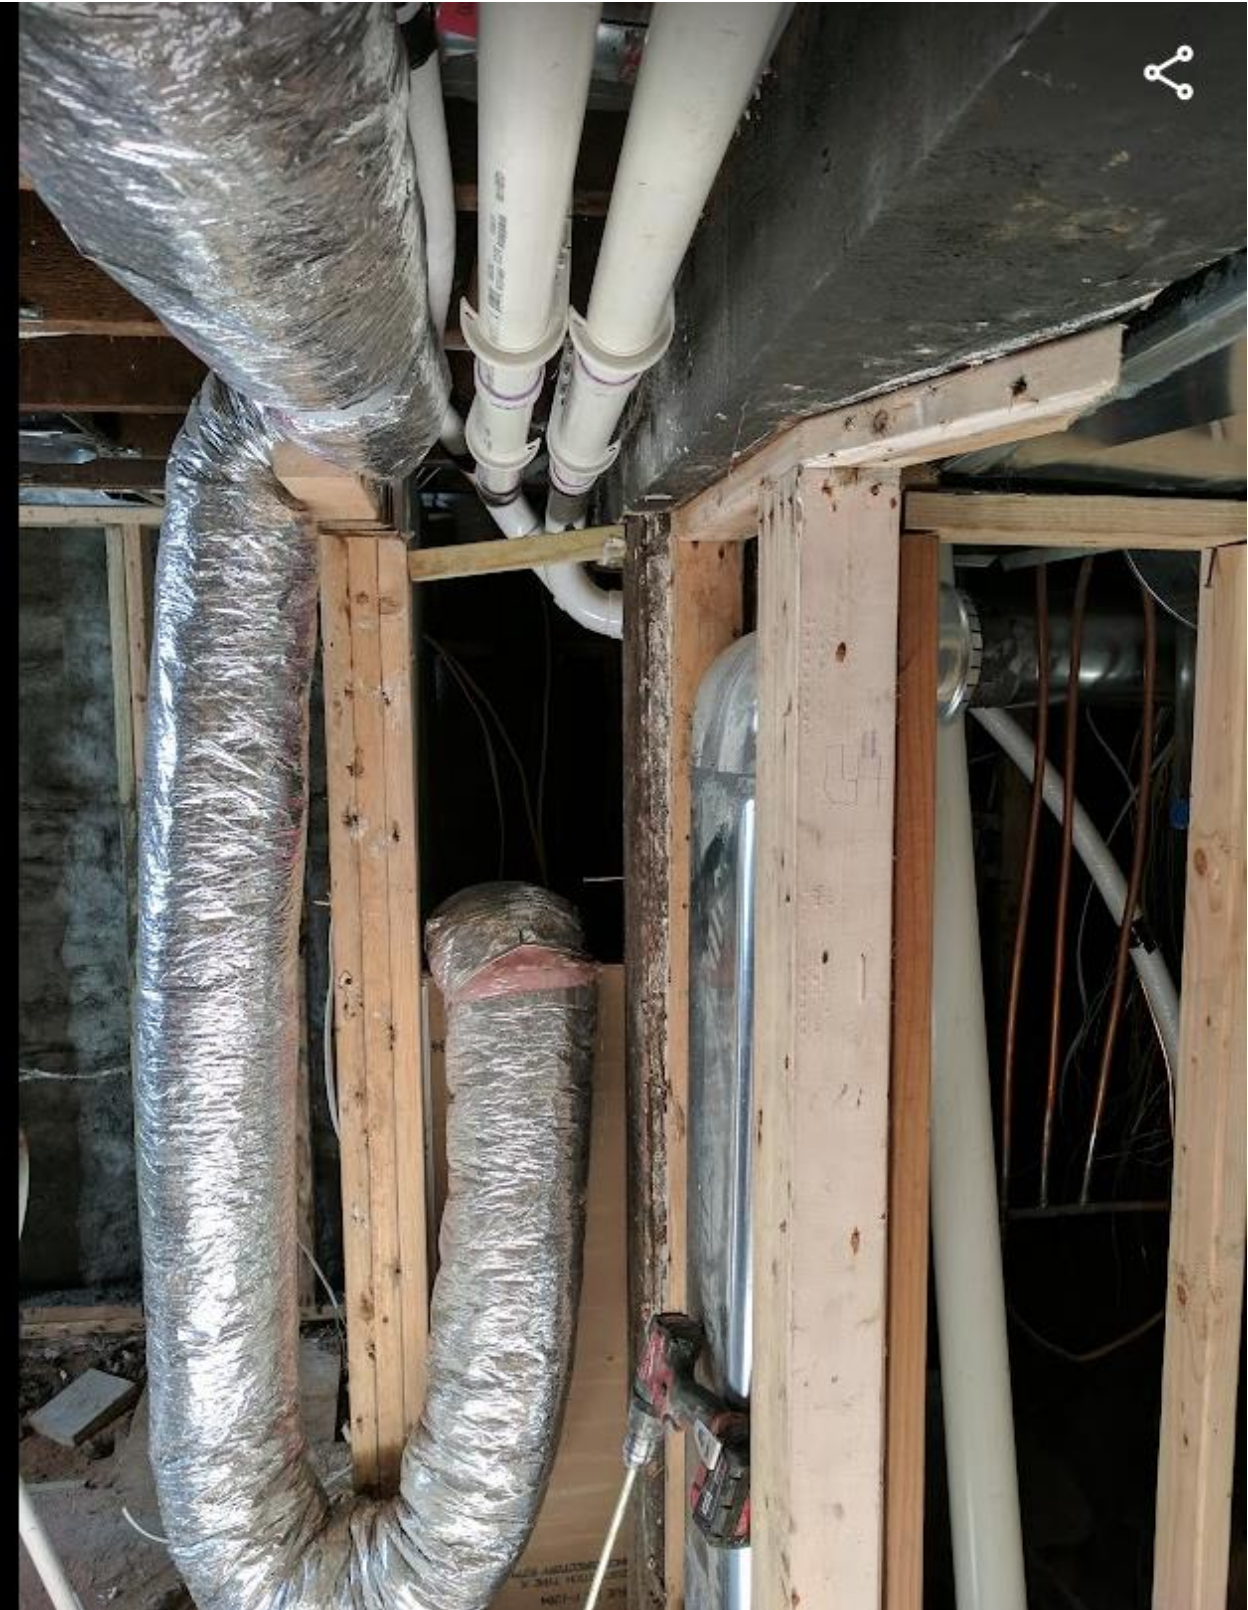
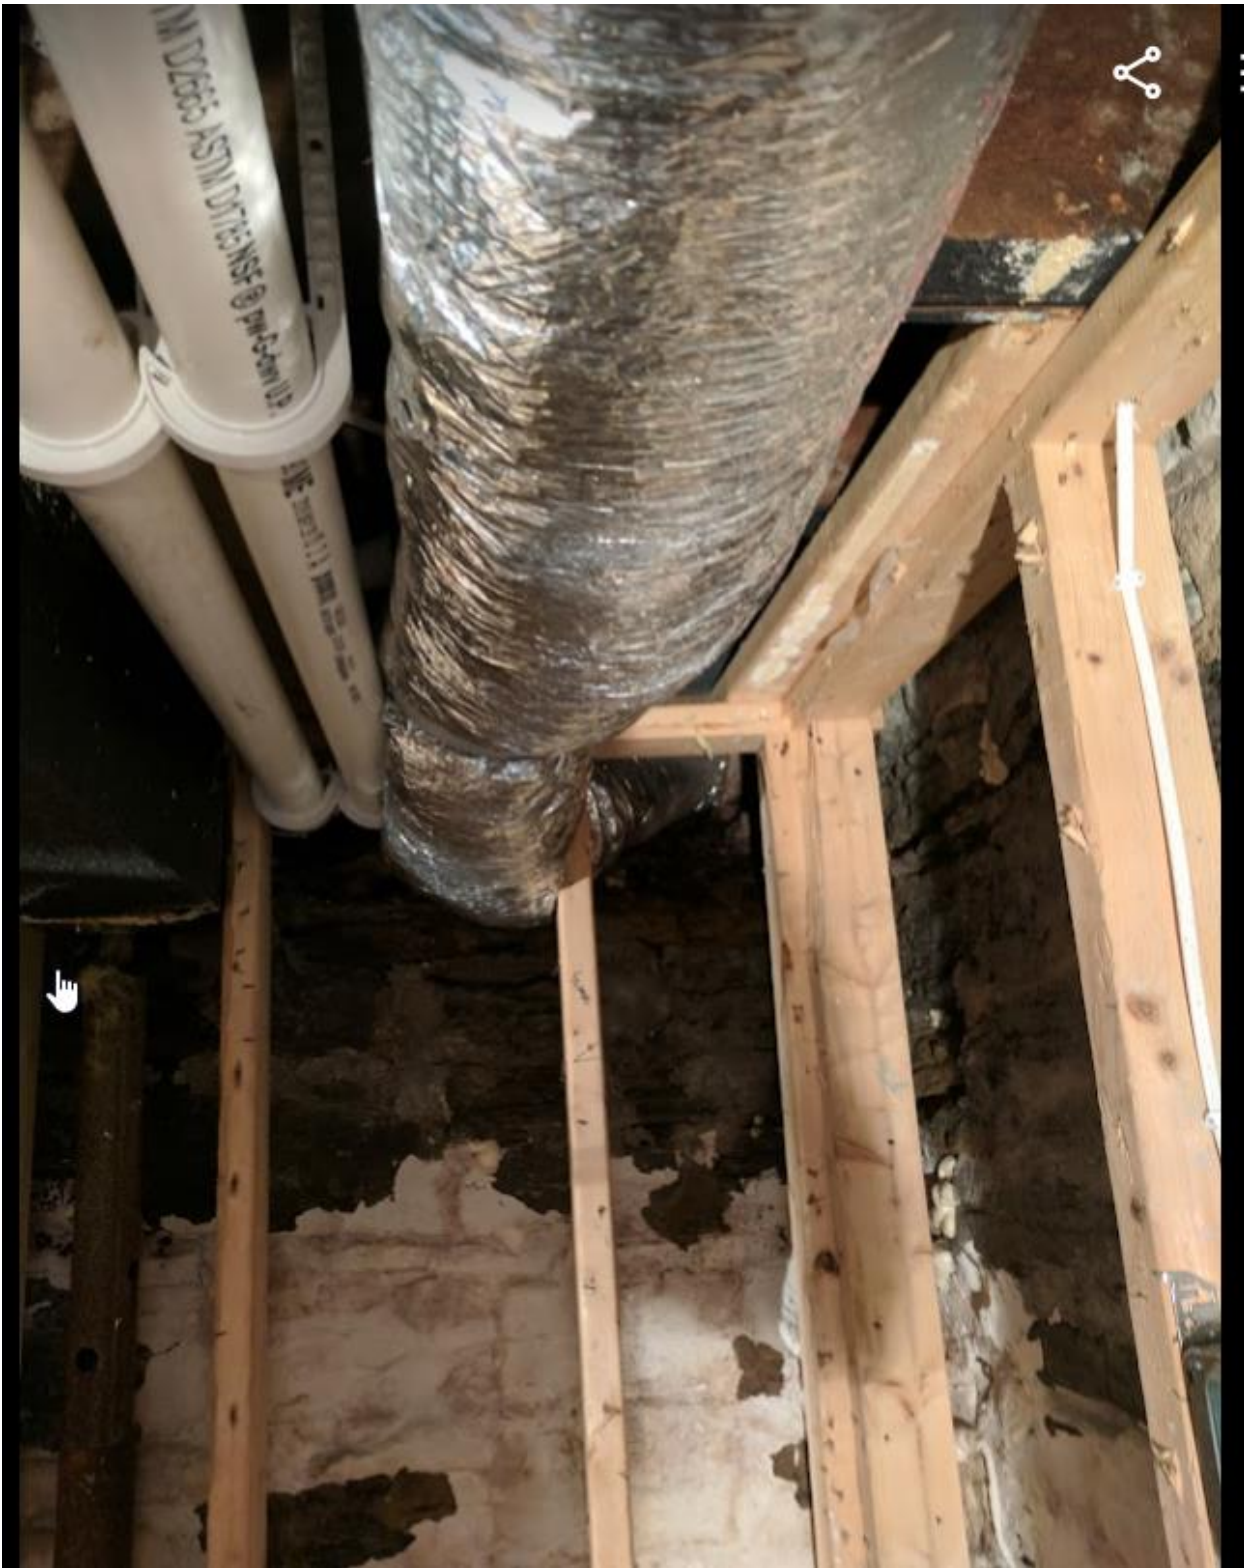
The aforementioned is duplicitous because the following photo of the (white) PVC water heater gas vent piping is precisely what the Plumbing Inspector, Jim Kaufer observed in 2015. As such, there is no need to destroy and open a finished ceiling and walls so you can see the piping again. There were no issues with these gas venting pipes at that time, and accordingly, there should not be any new issues today.

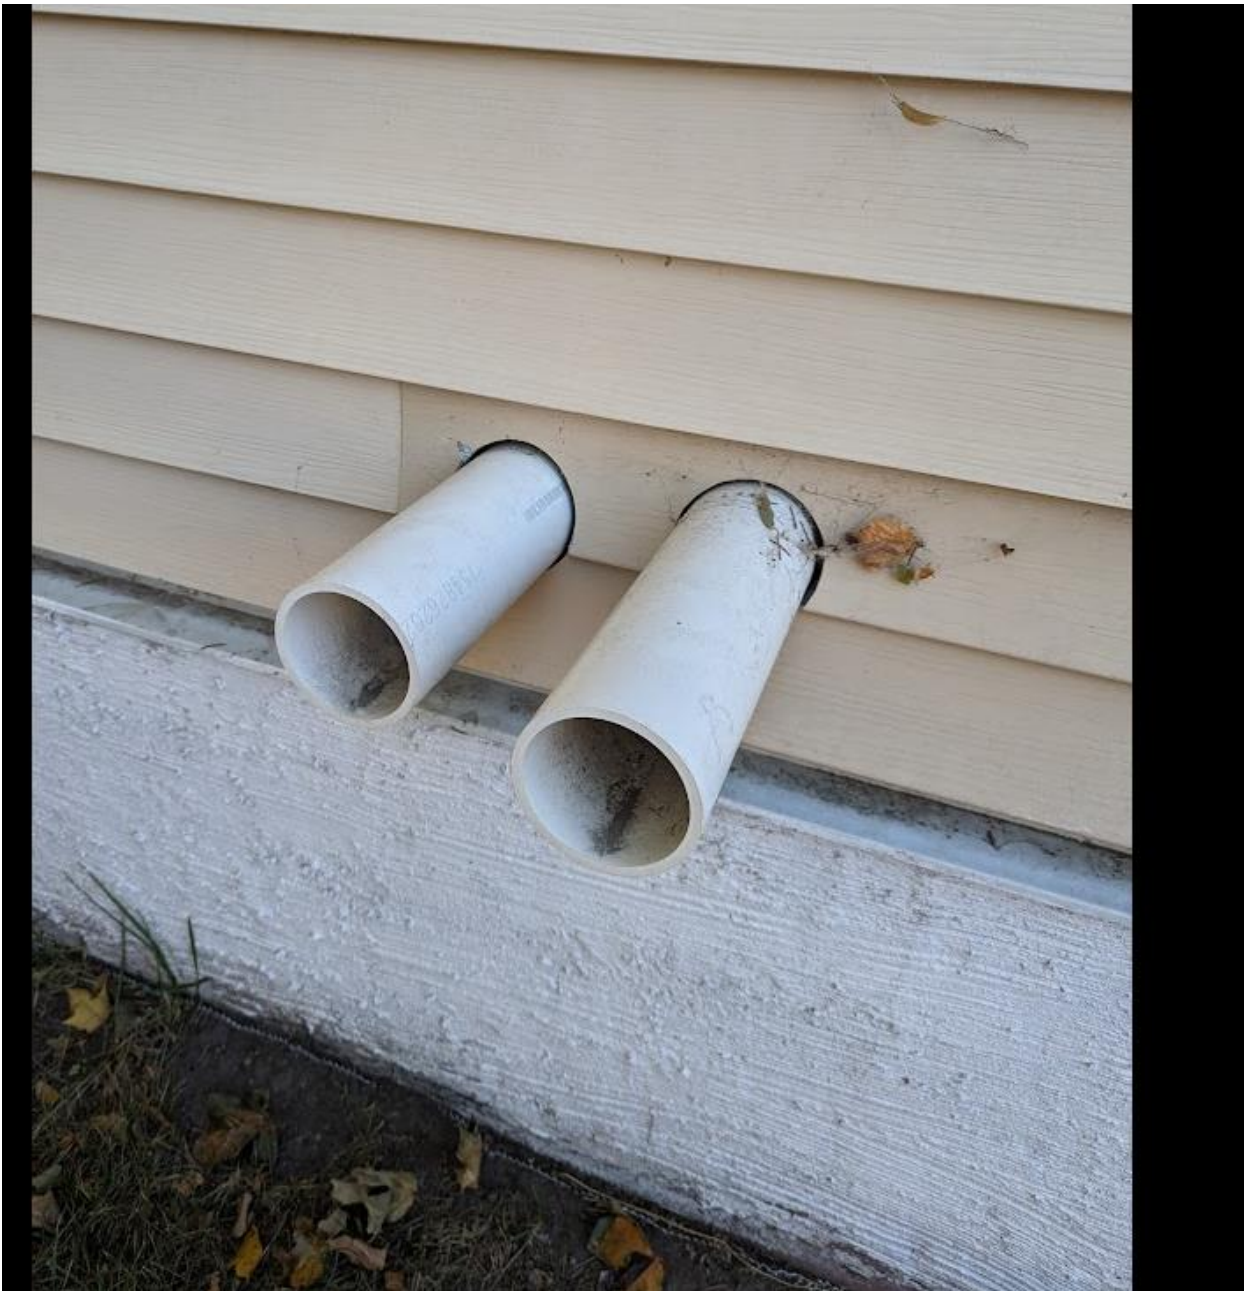
**2015-2021**

Comment #6 about the venting, addresses the above photo where the outside venting did not have elbows (turns) attached. Again, they were purposefully left off because at the time we were in the process of repairing siding on the outside of the home and it was counterproductive to attach (glue) the elbows and then cut them to remove them prior to attaching new long siding pieces. It is precisely why the inspector made this comment: **“Install the water heater gas venting to code.”**

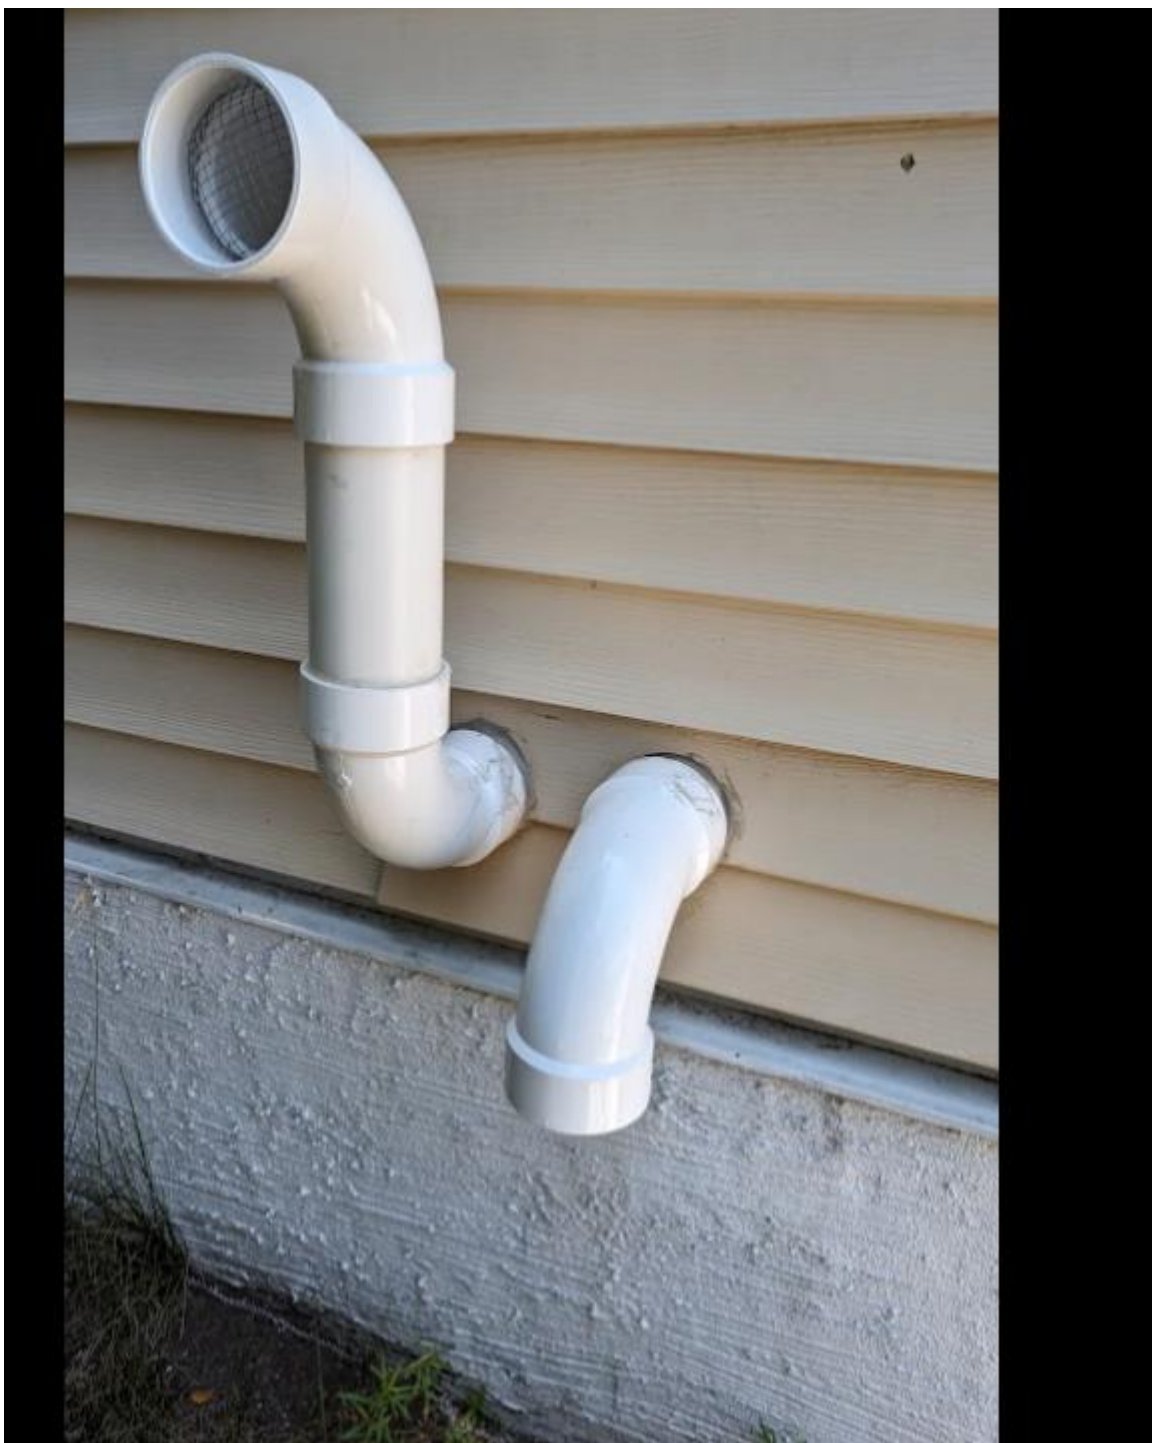
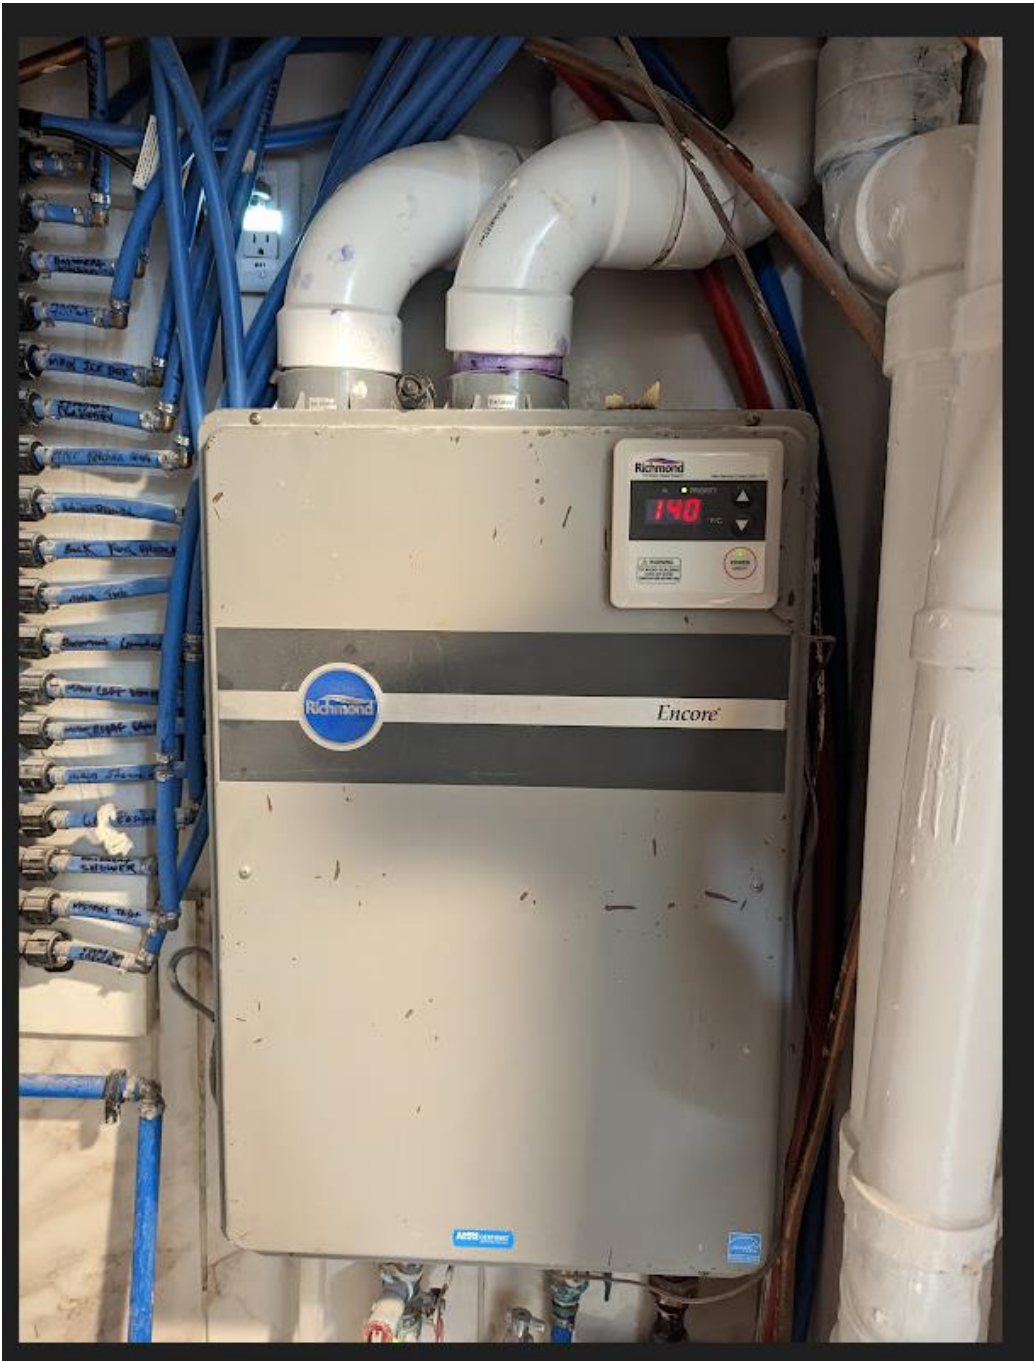
**March 2023**

The aforementioned was corrected and the elbows were secured, but that does not warrant a new directive in 2023 for the Plumbing Inspector, Jim Kaufer, who has already seen and inspected the PVC gas venting pipes in 2015 – to require the homeowner to open up the sheetrock of an already finished basement for the inspector to re-inspect what he already himself inspected and passed in 2015-2016. It should be noted, still, into the first half of 2021, the basement ceilings remained open (not sheetrocked) and the gas venting was still exposed and visible. Thus, for the homeowner to now be required as of June 2023 for **“The walls/ceiling will need to be opened**

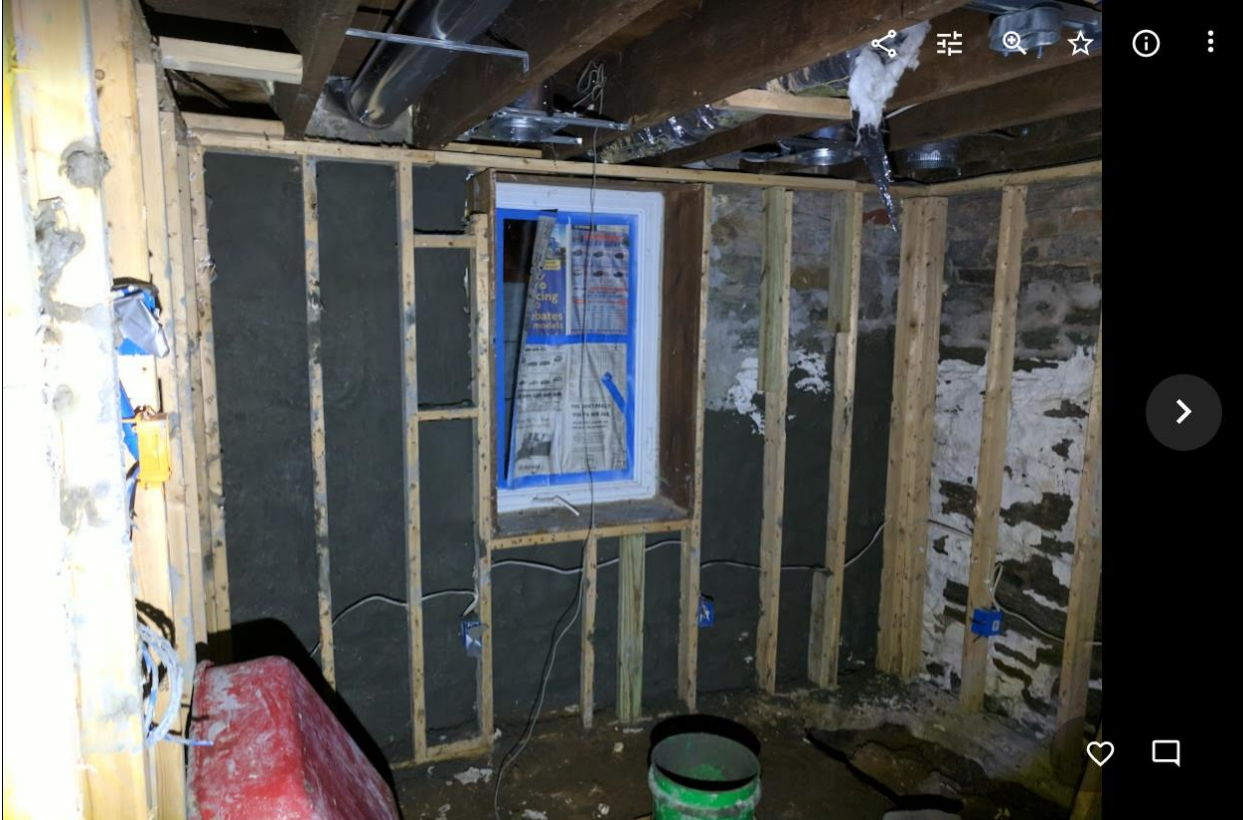
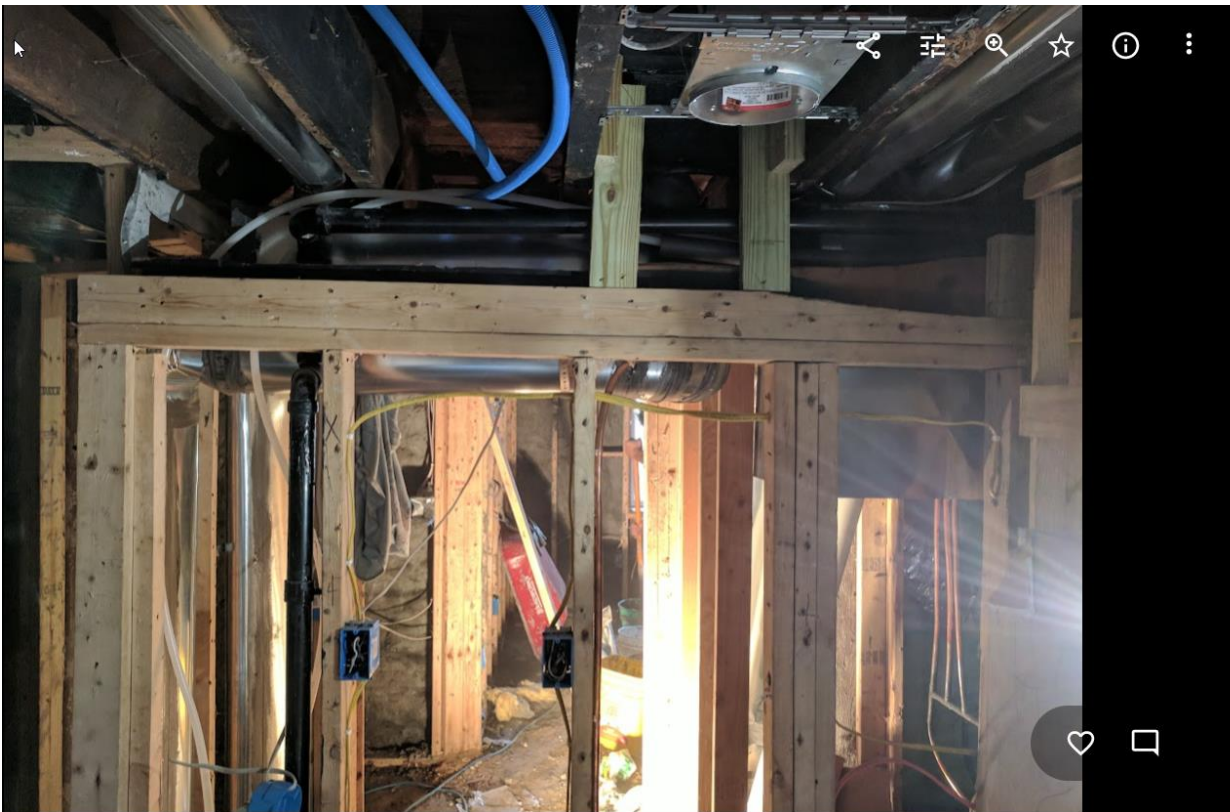
To this end, just like the white PVC gas venting piping in the walls and ceiling, the AC/HVAC Venting ductwork is also visible in these photos and appropriately, was also inspected – **but by a different** Heating Inspector, Erik Witt, **and not the June 2023 inspector**. The only comment about the new ductwork in 2021 is mentioned in #5: “Clean all supply and return ducts.” Accordingly, it is unnecessary that in 2023, the Warm Air Inspector, Chris Wiskur (a

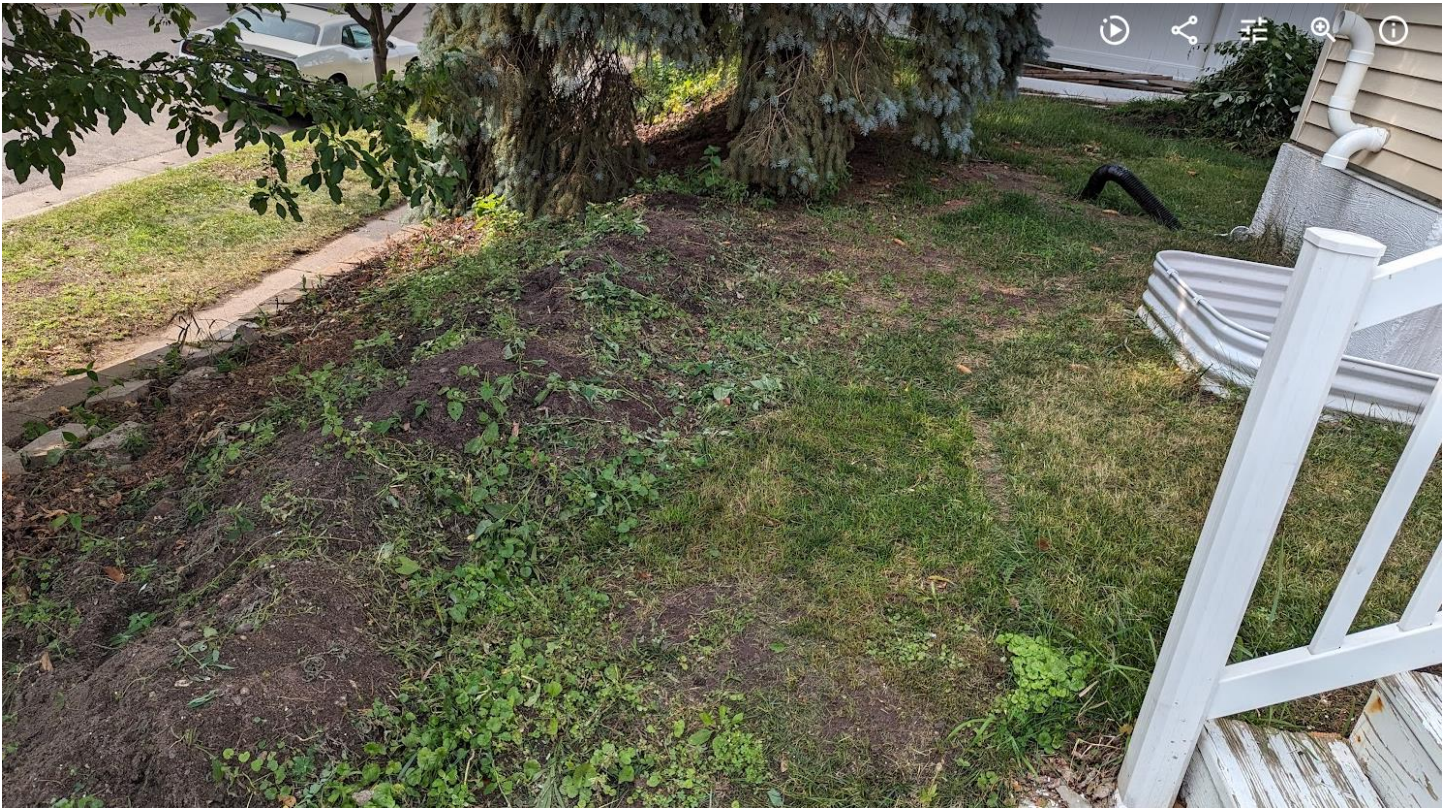
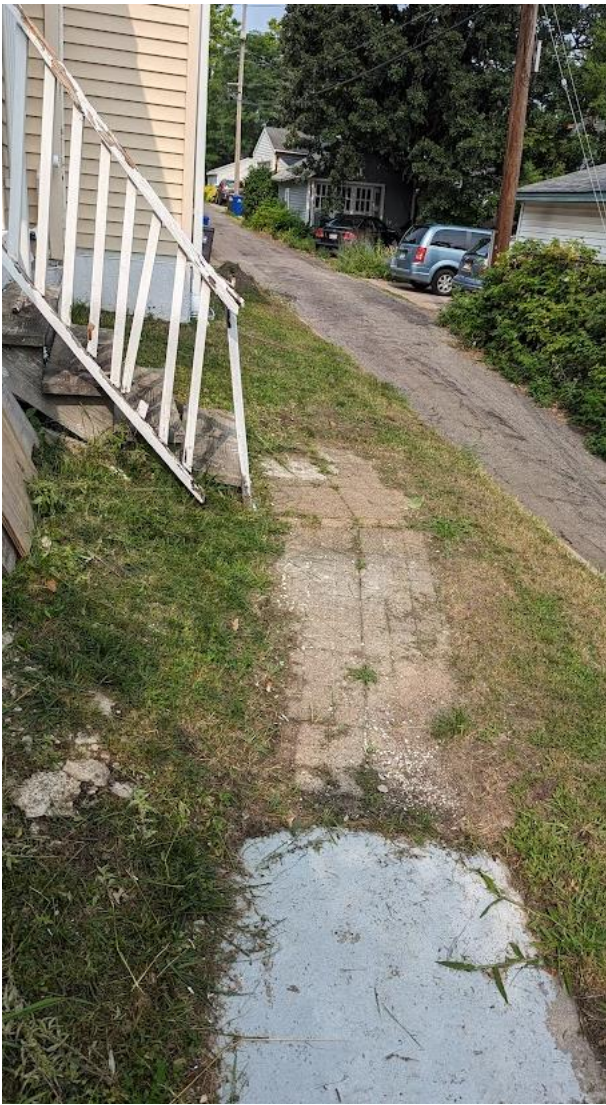
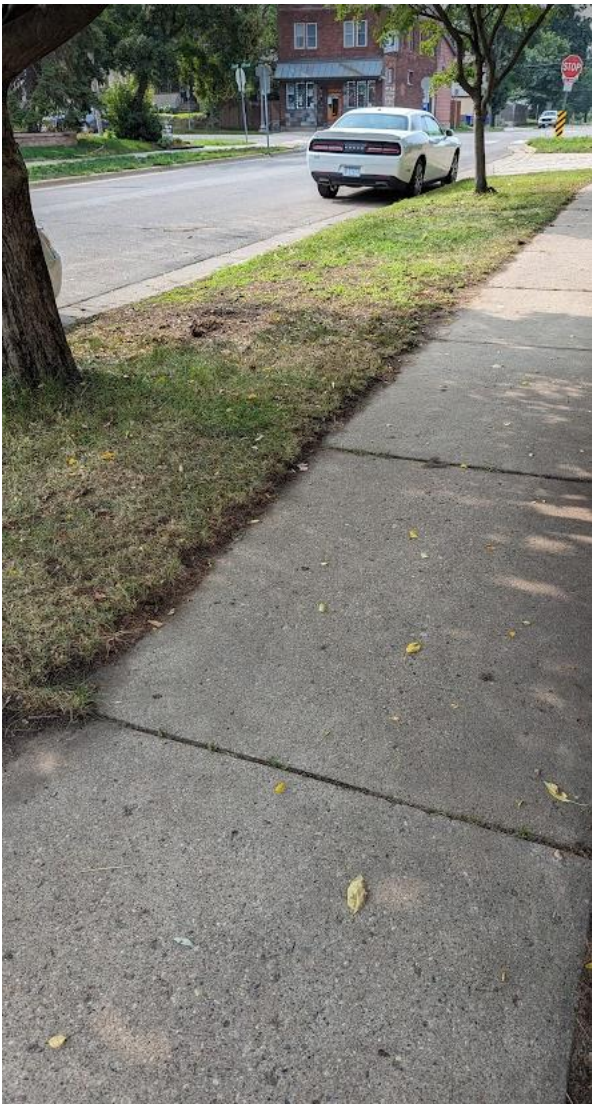
As of this writing, July 23, 2023, all tall grass, weeds and rank plant growth from the yard, boulevard and even my neighbors' boulevard and alley areas have been cut.
