Re: 708 Hawthorne Ave, St. Paul, MN

CBS was brought onsite to inspect the basement foundation wall called out by the City Inspector.

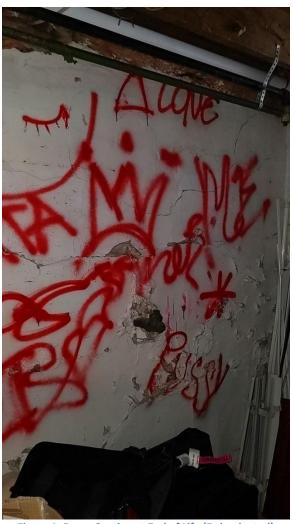
The damaged section of the wall consists of a parge coating that has reached the end of its life. CBS recommends removal of the parge coating and inspection of the block wall. Based on experience, the mortar joints in the wall may need to be tuck-pointed.

Figure 1: Parge Coating at End of Life (Delaminated)

Remove the parge coating and inspect the mortar beds of the foundation. Remove all loose material with a wire brush and tuck-point mortar beds as needed.
