Subject: Our client: Richard and Nancy Nicholson – 260 Summit Avenue
Correction Notice issued regarding Walnut Street Stairway

Council File: 11-127250

DEPARTMENT OF PUBLIC WORKS - CITY OF ST. PAUL, MINNESOTA
PROJECT ESTIMATE (BRIDGE)

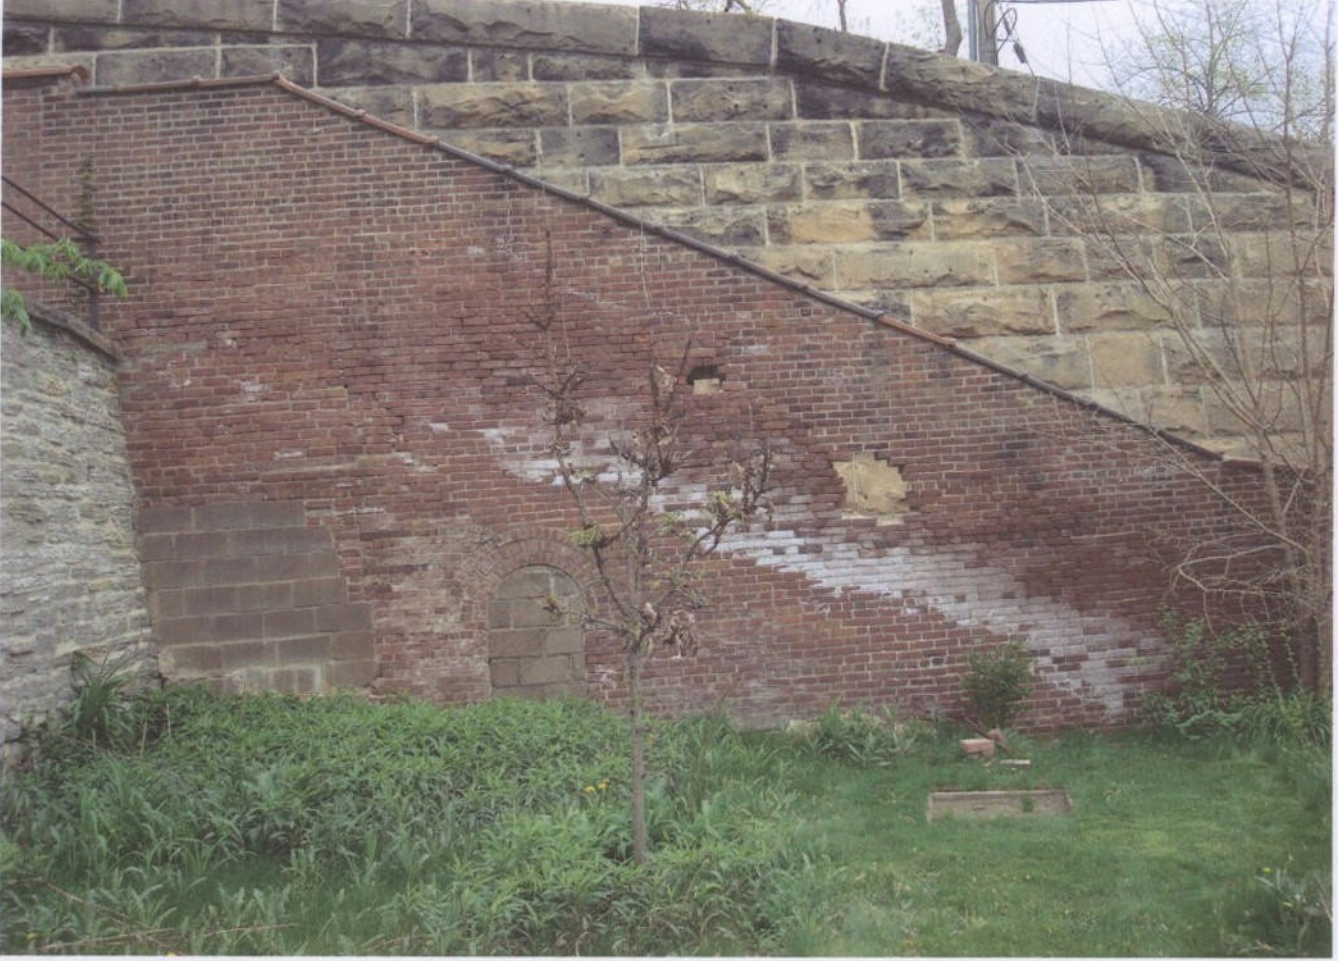
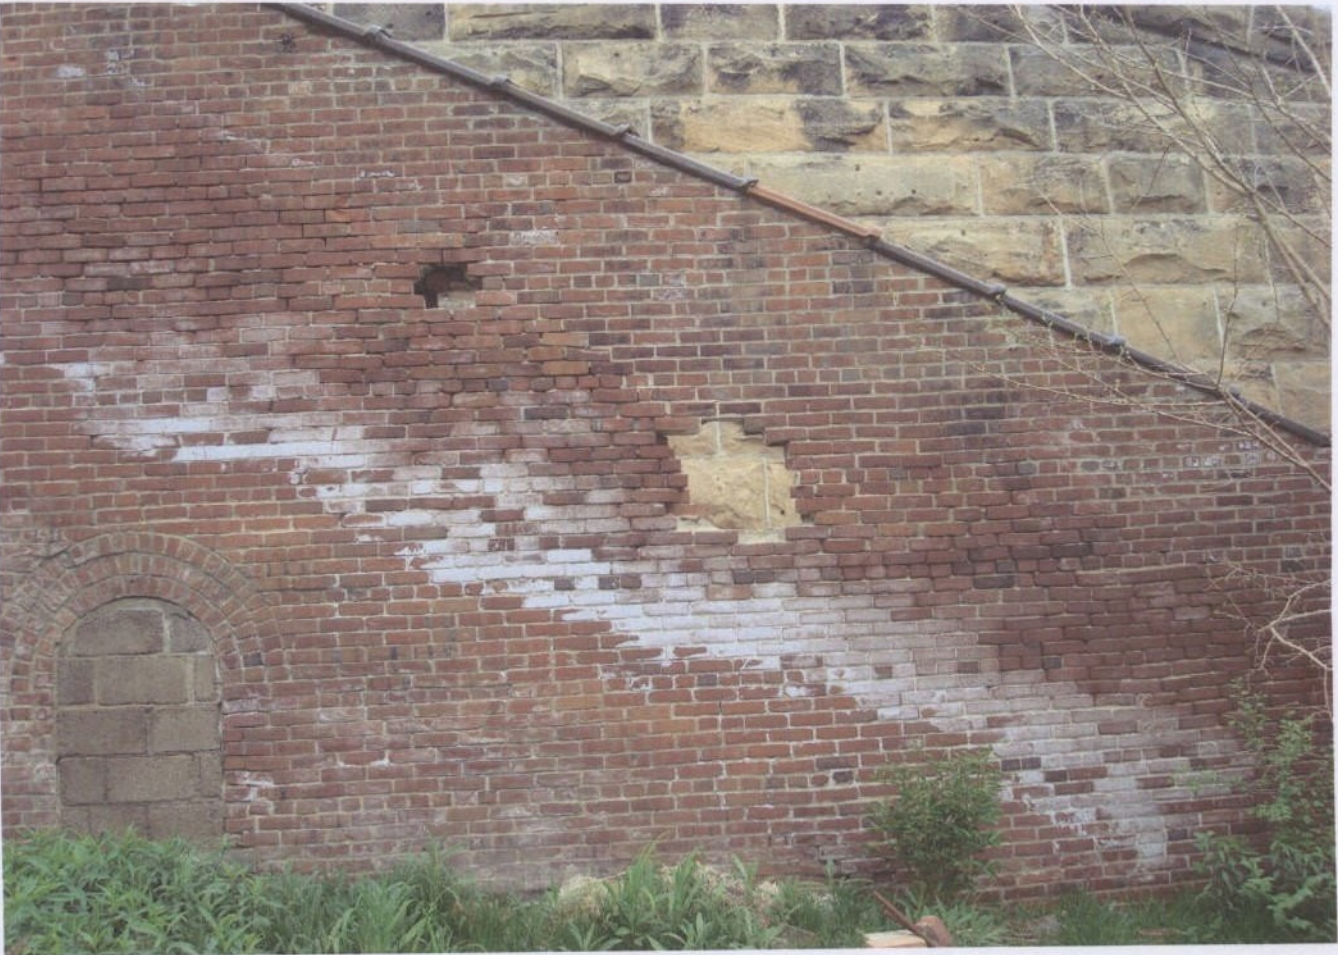
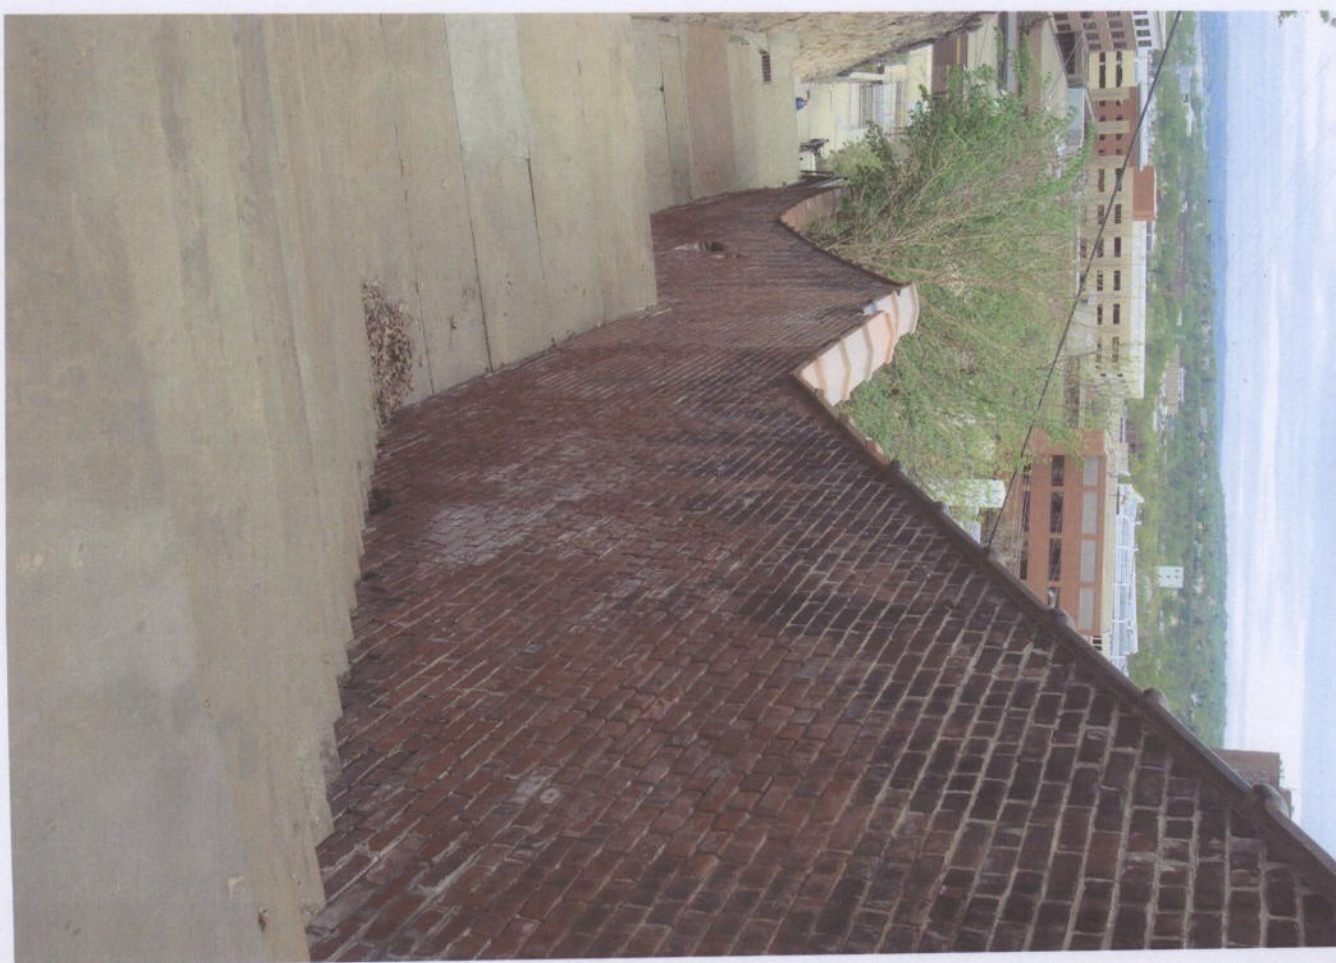
EXHIBIT H

In the spring of 2011 it was evident that additional portions of the stairway wall were deteriorating and the City of St. Paul issued the citation to Mr. Nicholson which is the subject of this appeal. For reference, we are attaching pictures taken on May 13, 2011 which show the deteriorating wall from both the south and north sides.⁹ These pictures indicate a wall that is deteriorating as a result of its age and damage from the elements and winter salt. The pictures show significant deterioration in brick and holes in the wall where bricks are falling out. The pictures also indicate a serious bulging of the wall on the north side. As set forth above and detailed in the report of structural engineer Meghan Elliott, the wall is currently unstable and in need of repair. Based on the cost of repair in 2008, it is clear that the current cost of stabilizing the wall will be significant.

⁹ See photos attached hereto as Exhibit H.
