CITY OF SAINT PAUL
HERITAGE PRESERVATION COMMISSION RESOLUTION
FILE NUMBER: 936 Earl Street, Historic Resource Review
DATE: June 9, 2011

**CITY OF SAINT PAUL
HERITAGE PRESERVATION COMMISSION STAFF REPORT**

FILE NAME: 936 Earl Street
OWNER: Federal National Mortgage Association
MEETING DATE: June 14, 2011
CLASSIFICATION: Historic Resource Review
STAFF INVESTIGATION AND REPORT: Becky Willging
DATE: June 1, 2011

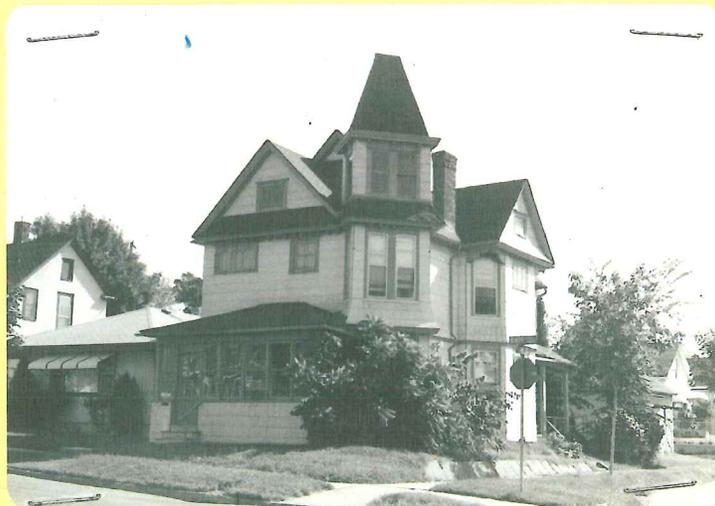
Photographs

19. Other significant details:
Double wooden front doors, incised carving on window surrounds. Small ornamental brackets under eaves. Dentils above some windows. Band of three small arched windows on front facade. Diamond tracery on upper sash of front picture window. Interesting three story bay window on front facade which forms a tower. Two story bay window projection on south side of house with dentils, brackets and scalloped ornamentation. Rear porch.
