**CITY OF SAINT PAUL
HERITAGE PRESERVATION COMMISSION STAFF REPORT**

FILE NAME: 466 Iglehart Avenue
OWNER: Burton A. Murdock and Diane A. Murdock
AGENCY: Department of Safety and Inspections- Code Enforcement
DATE OF HEARING: June 14, 2012
HPC SITE/DISTRICT: Hill Historic District
CATEGORY: Contributing
CLASSIFICATION: Demolition
STAFF INVESTIGATION AND REPORT: Christine Boulware, Hilary Holmes
DATE: June 7, 2012

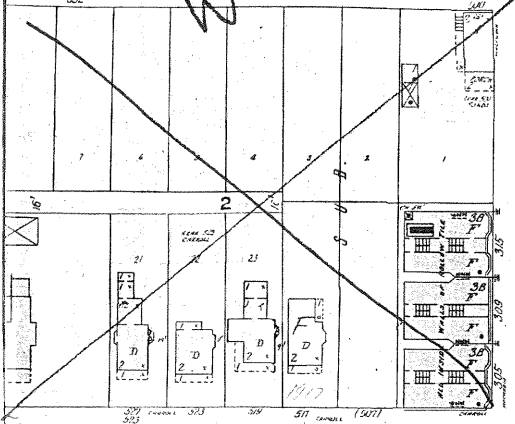
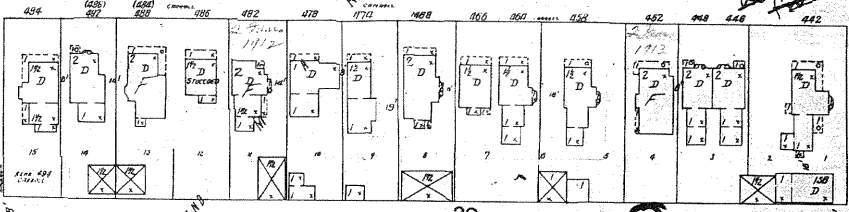
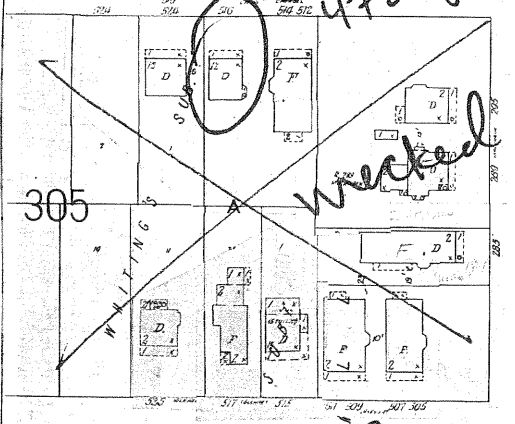
306
ST. PAUL, MINN.

The Sanborn Insurance map for this structure (which was originally located at 455 Iglehart Avenue) indicates the footprint of the house has changed slightly since 1925, with the removal of a full-width two-story rear porch.

The block face on the south side of Iglehart Avenue appears to be contiguous, meaning there are no vacant lots and are an eclectic collection of architectural examples from the period of significance for the Hill Historic District. All but one house (the George Luckert house, both an individual Heritage Preservation Site and listed on the National Register of Historic Places, built in 1858-1859) on the south side of Iglehart, are not original to the site. In anticipation of the construction of Interstate 94 to the north of the area and as part of urban renewal in the late 1960's and 1970's, the blocks north of Iglehart (Carroll Avenue and Rondo Avenue) were cleared, along with select lots along Iglehart. A number of houses were relocated from Carroll Avenue to Iglehart Avenue, the demolitions of the original structures are shown on building permit index cards for this block of Iglehart. Many of the structures on the north side of the block were demolished between 1966 and 1977, and double-townhomes were constructed on the site in 1981.
