### **BOARD RESOLUTION NO. 15-681**

Pertaining to an agreement with the Board of Regents of the University of Minnesota to provide further investigation of microbial communities in water mains and their possible link to pipe failure.

### **Microbial Communities Study Agreement with The University of Minnesota**

April 14, 2015

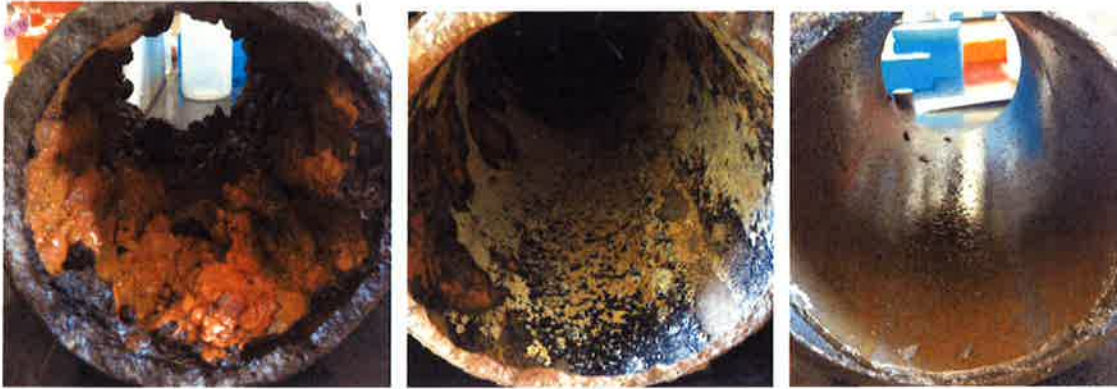
**Figure 3: Sampled pipe types**

- a. Tuberculated unlined cast-iron pipe
- b. Non-tuberculated unlined cast-iron pipe
- c. cement mortar-lined cast-iron pipe

Also of interest is how deep the corrosion is penetrating the interior surface of the pipe and the rate this is occurring, as deeper corrosion could weaken a pipe. Different types of pipe corrode at different rates, and some do not corrode at all due to modern fabrication techniques. Examples are shown in attached Figure 3 from the 2012-2014 study.
