From: Richard Ekobena
Sent: Wednesday, January 17, 2024 3:46 PM
To: Marcia Moermond
Subject: 1062 Minnehaha Ave E

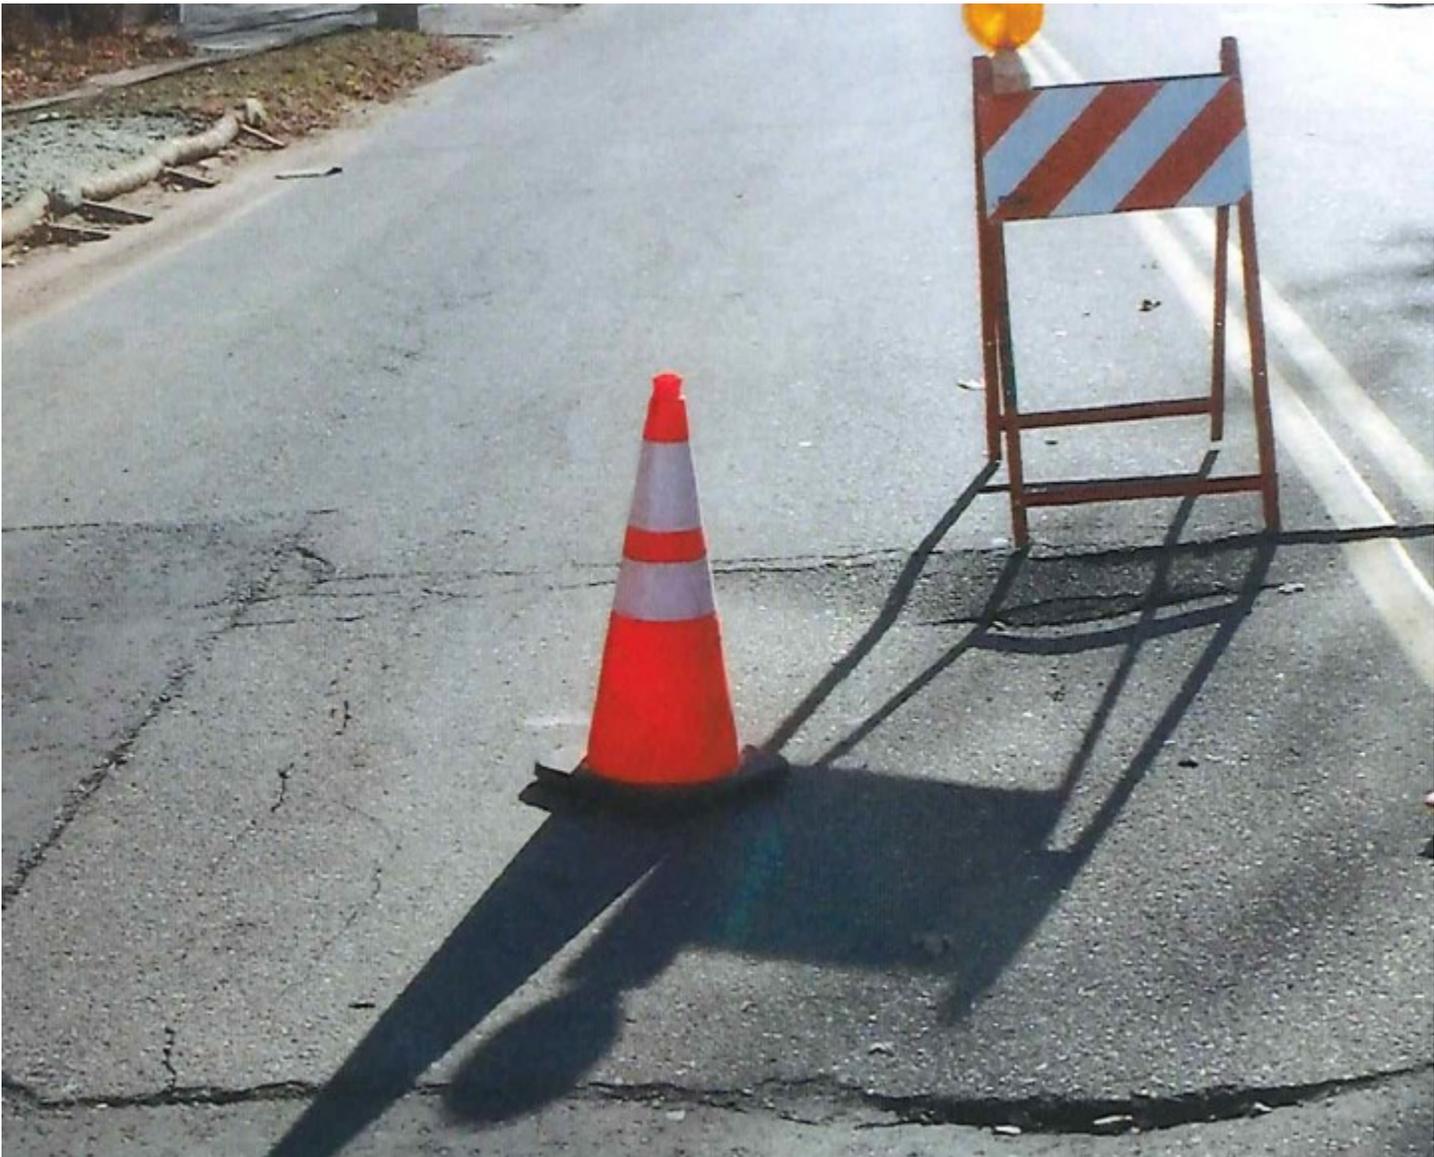
The first picture below shows the actual situation at 1062 Minnehaha Ave E. You can see that traffic loads which are heavy on Minnehaha can easily puncture the road surface that now has little support because of the void that has developed underneath due to soil escaping through the broken sewer pipe in the ground.

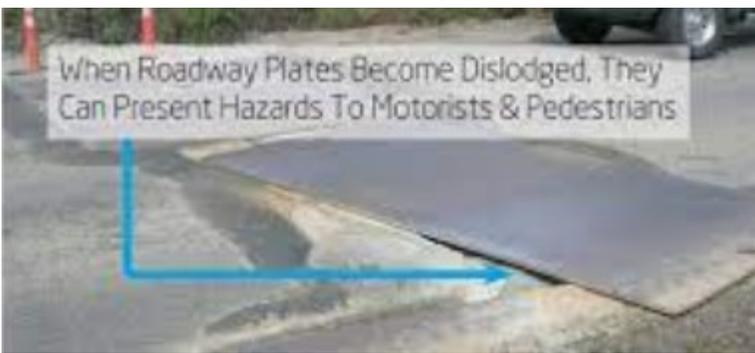
The second picture shows the typical steel plate that is used to prevent a collapse (one was placed on Minnehaha but I do not have the picture). The problem is that when such a steel plate is covered by snow, it can cause damage to plow trucks when they hit them.
