## St. Paul Heritage Preservation Commission - Building Inventory Form

| Street Number: <u>461</u> Street <u>BEAUMONT ST</u> | Property RSN: <u>178728</u> |

Surveyor(s) Mead & Hunt  
 Survey Date 06/13/2011 Survey Level Reconnaissance  
 Updated Survey?  Building Occupied?  Publicly Accessible?   
 Photographer Mead & Hunt  
 Photo Date 6/13/2011

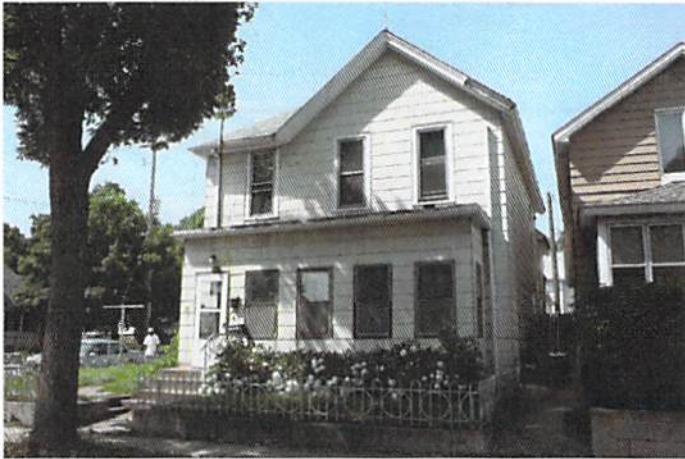
**Notes on Exterior:** This two-story dwelling features Greek Revival details and has a hipped gable roof and enclosed front porch. The house has 1/1 double-hung windows, all of which are replacements. The original siding has been replaced with asbestos siding. A historic gable addition is at the rear.
