**From:** Ekobena, Richard (CI-StPaul)  
**Sent:** Tuesday, June 26, 2018 4:29 PM  
**To:** Moermond, Marcia (CI-StPaul)  
**Cc:** Vang, Mai (CI-StPaul); Cahanes, Pat (CI-StPaul); Martin, Lisa (CI-StPaul)  
**Subject:** Re: 198 Stevens St W

Sewer Utility staff reviewed the 198 West Stevens Street private sewer pipe video and concluded that the connection point of the private pipe to the city mainline pipe is broken (defective) and in need of repair. The location of this broken connection point happens to be directly underneath where the hole developed on the street surface above (see image of hole below).

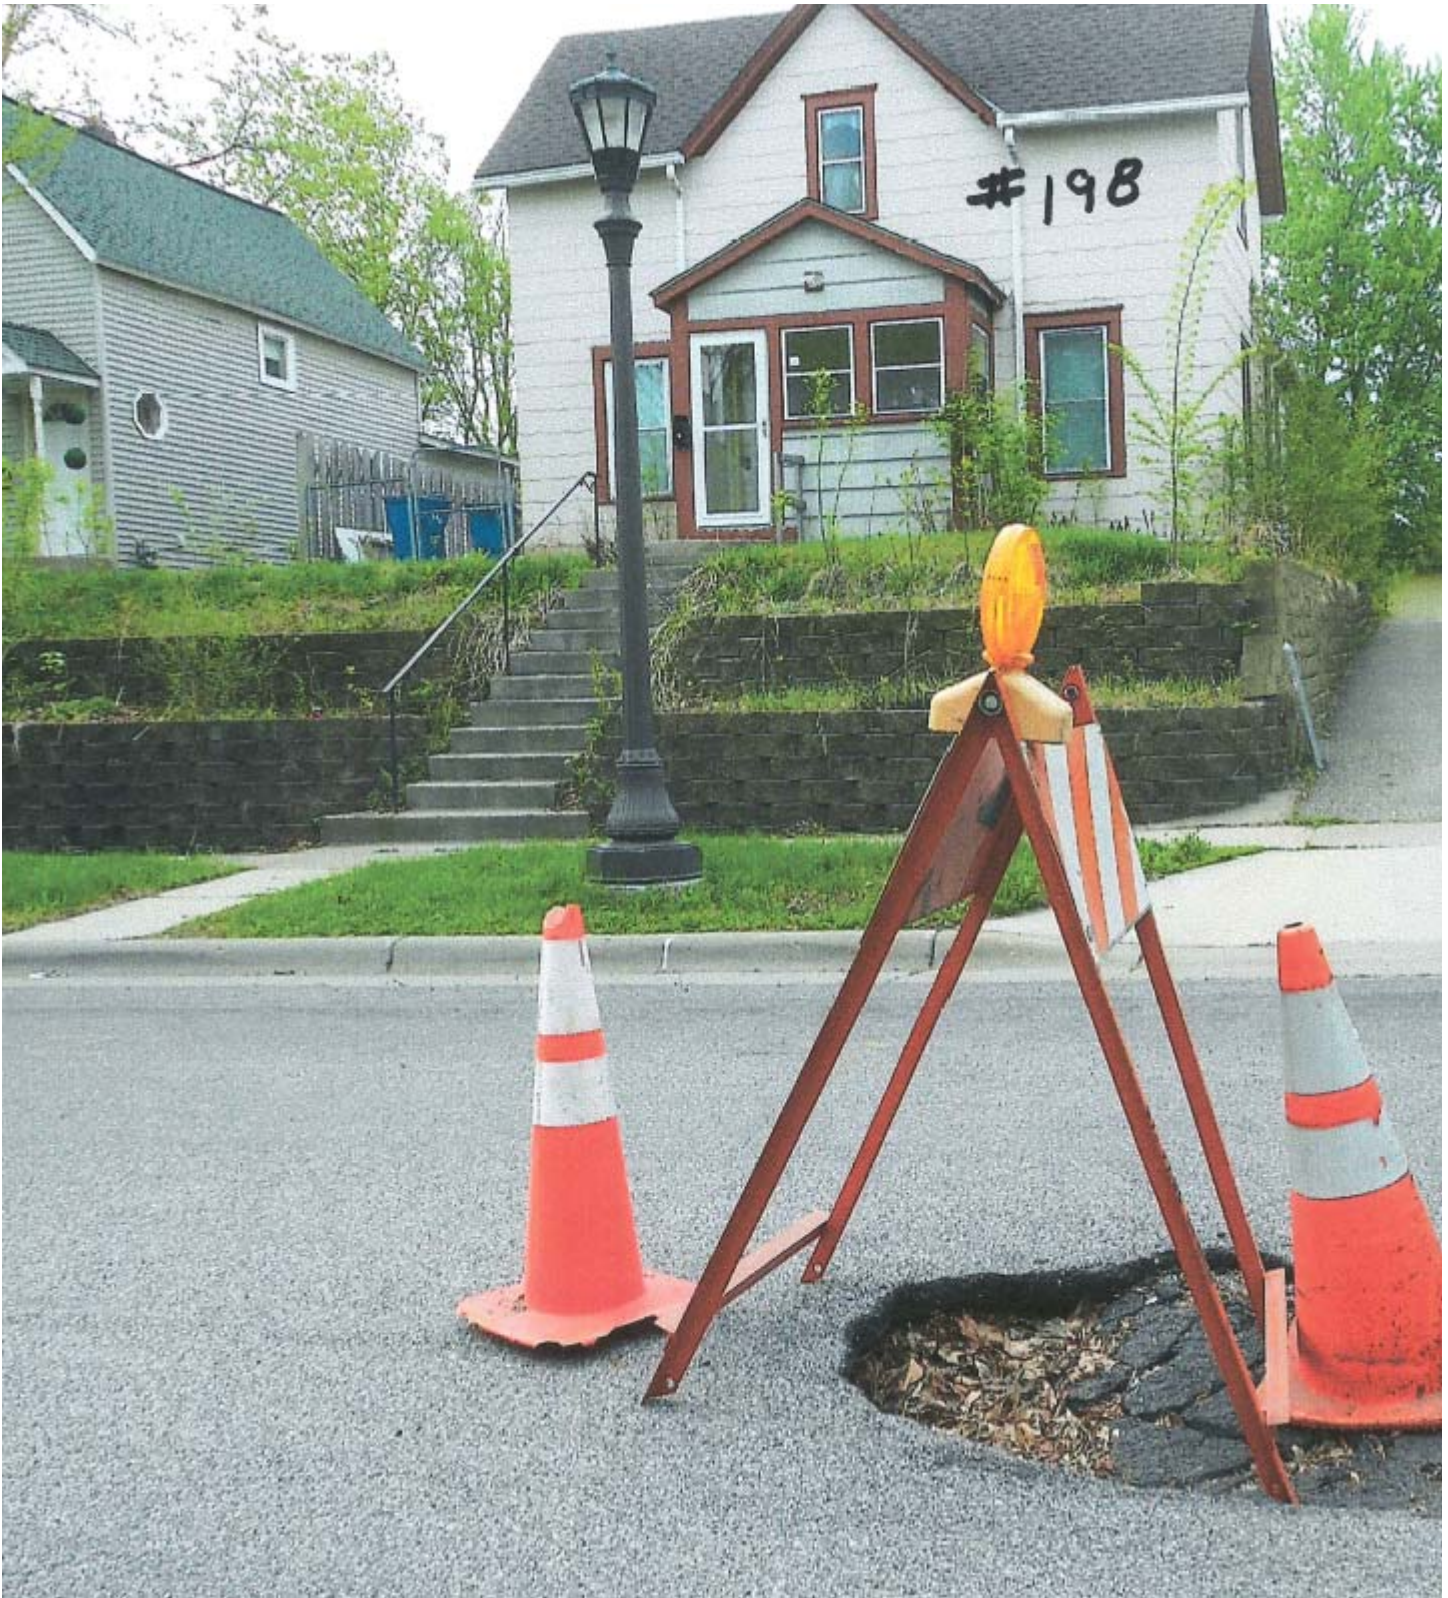
Sewer staff also observed that the operator of the private video equipment had a tough time getting his camera through the broken connection point, an indication that the private pipe and the city mainline pipe are no longer aligned or are separated at their connection point.

When a private sewer pipe shears away from a city mainline pipe, the result is typically a small opening that allows soil around the private pipe to escape into the sewer system. As more and more soil escapes from above the private sewer pipe, a void is created which leads to the street ultimately caving in as shown in the image below.

Although it is sometimes not so obvious when seen on still pictures, I have attached images of the defective connection as seen from the city video and the property owner video.

I will like to inform you that a city sewer crew today dye tested the hole on the street on top of the 198 Stevens sewer pipe and were able to confirm beyond any doubt that the pipe was defective and in need of repair.

The dye test consists of pouring a colored type liquid (dye) into the hole on the street and watching to see if the dye appears inside the city sewer. The only way the dye can travel and be seen inside the city sewer is by entering through a break in the 198 Stevens pipe and traveling through it to get to inside the city pipe.
