Centerville Water Supply Assessment

Determine a direction for the Centerville Water Supply System

Saint Paul Regional Water Services and Bolton & Menk Consultants

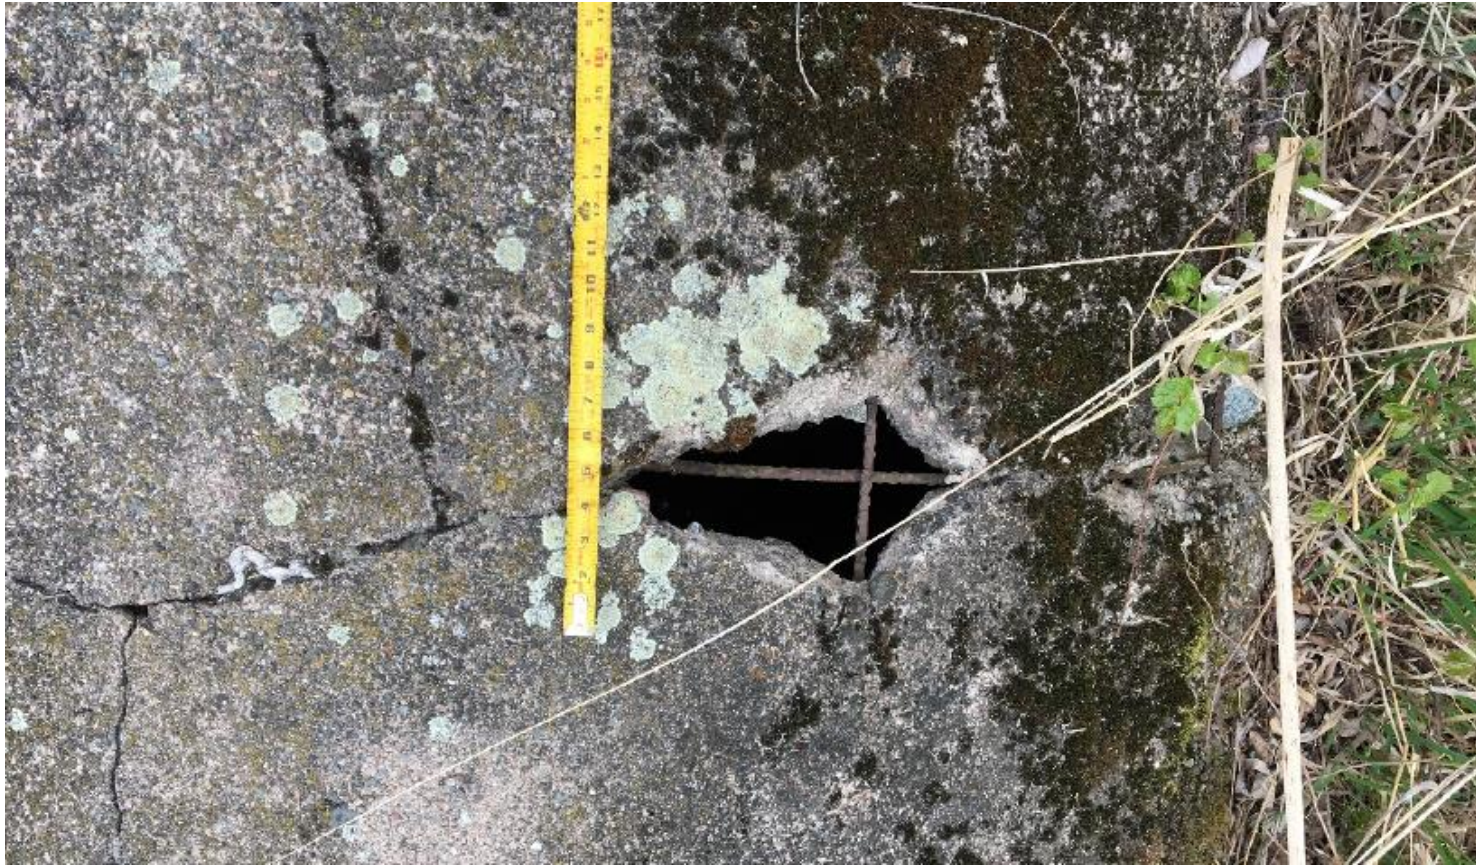
Inspection of
pumping stations,
intake structures,
conduits.

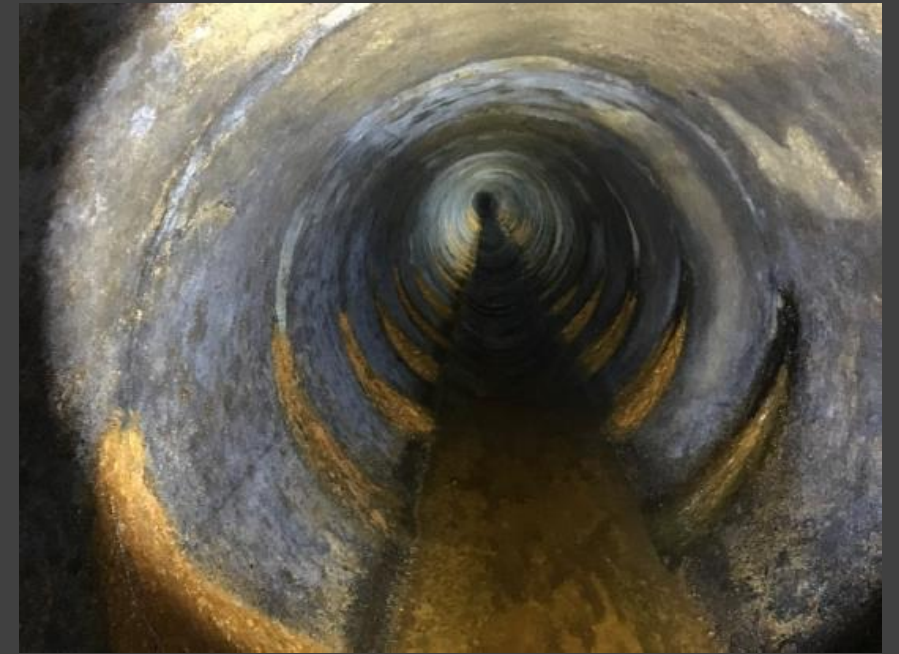
Infrastructure Condition
Assessment

Centerville Conduit System Conditions

- Centerville conduit – generally good condition with some rehab. needed
- Otter Lake conduit – Mostly not inspectable due to water filling conduit
- Deep Lake conduit – some severe deterioration, not operable at present

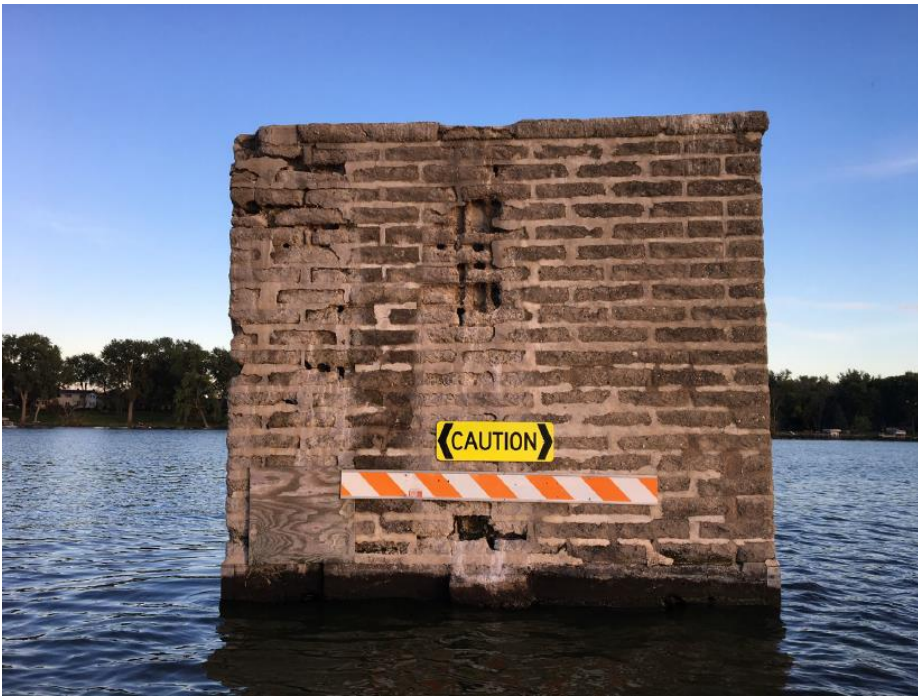
Pump Station and Intake Structure

- *“The motors and pumps are considered to be in good condition.”*
- *“The electrical and control systems for the pumping station appear to be in poor condition and operationally questionable”*
- *“The intake structure is in poor condition...”*

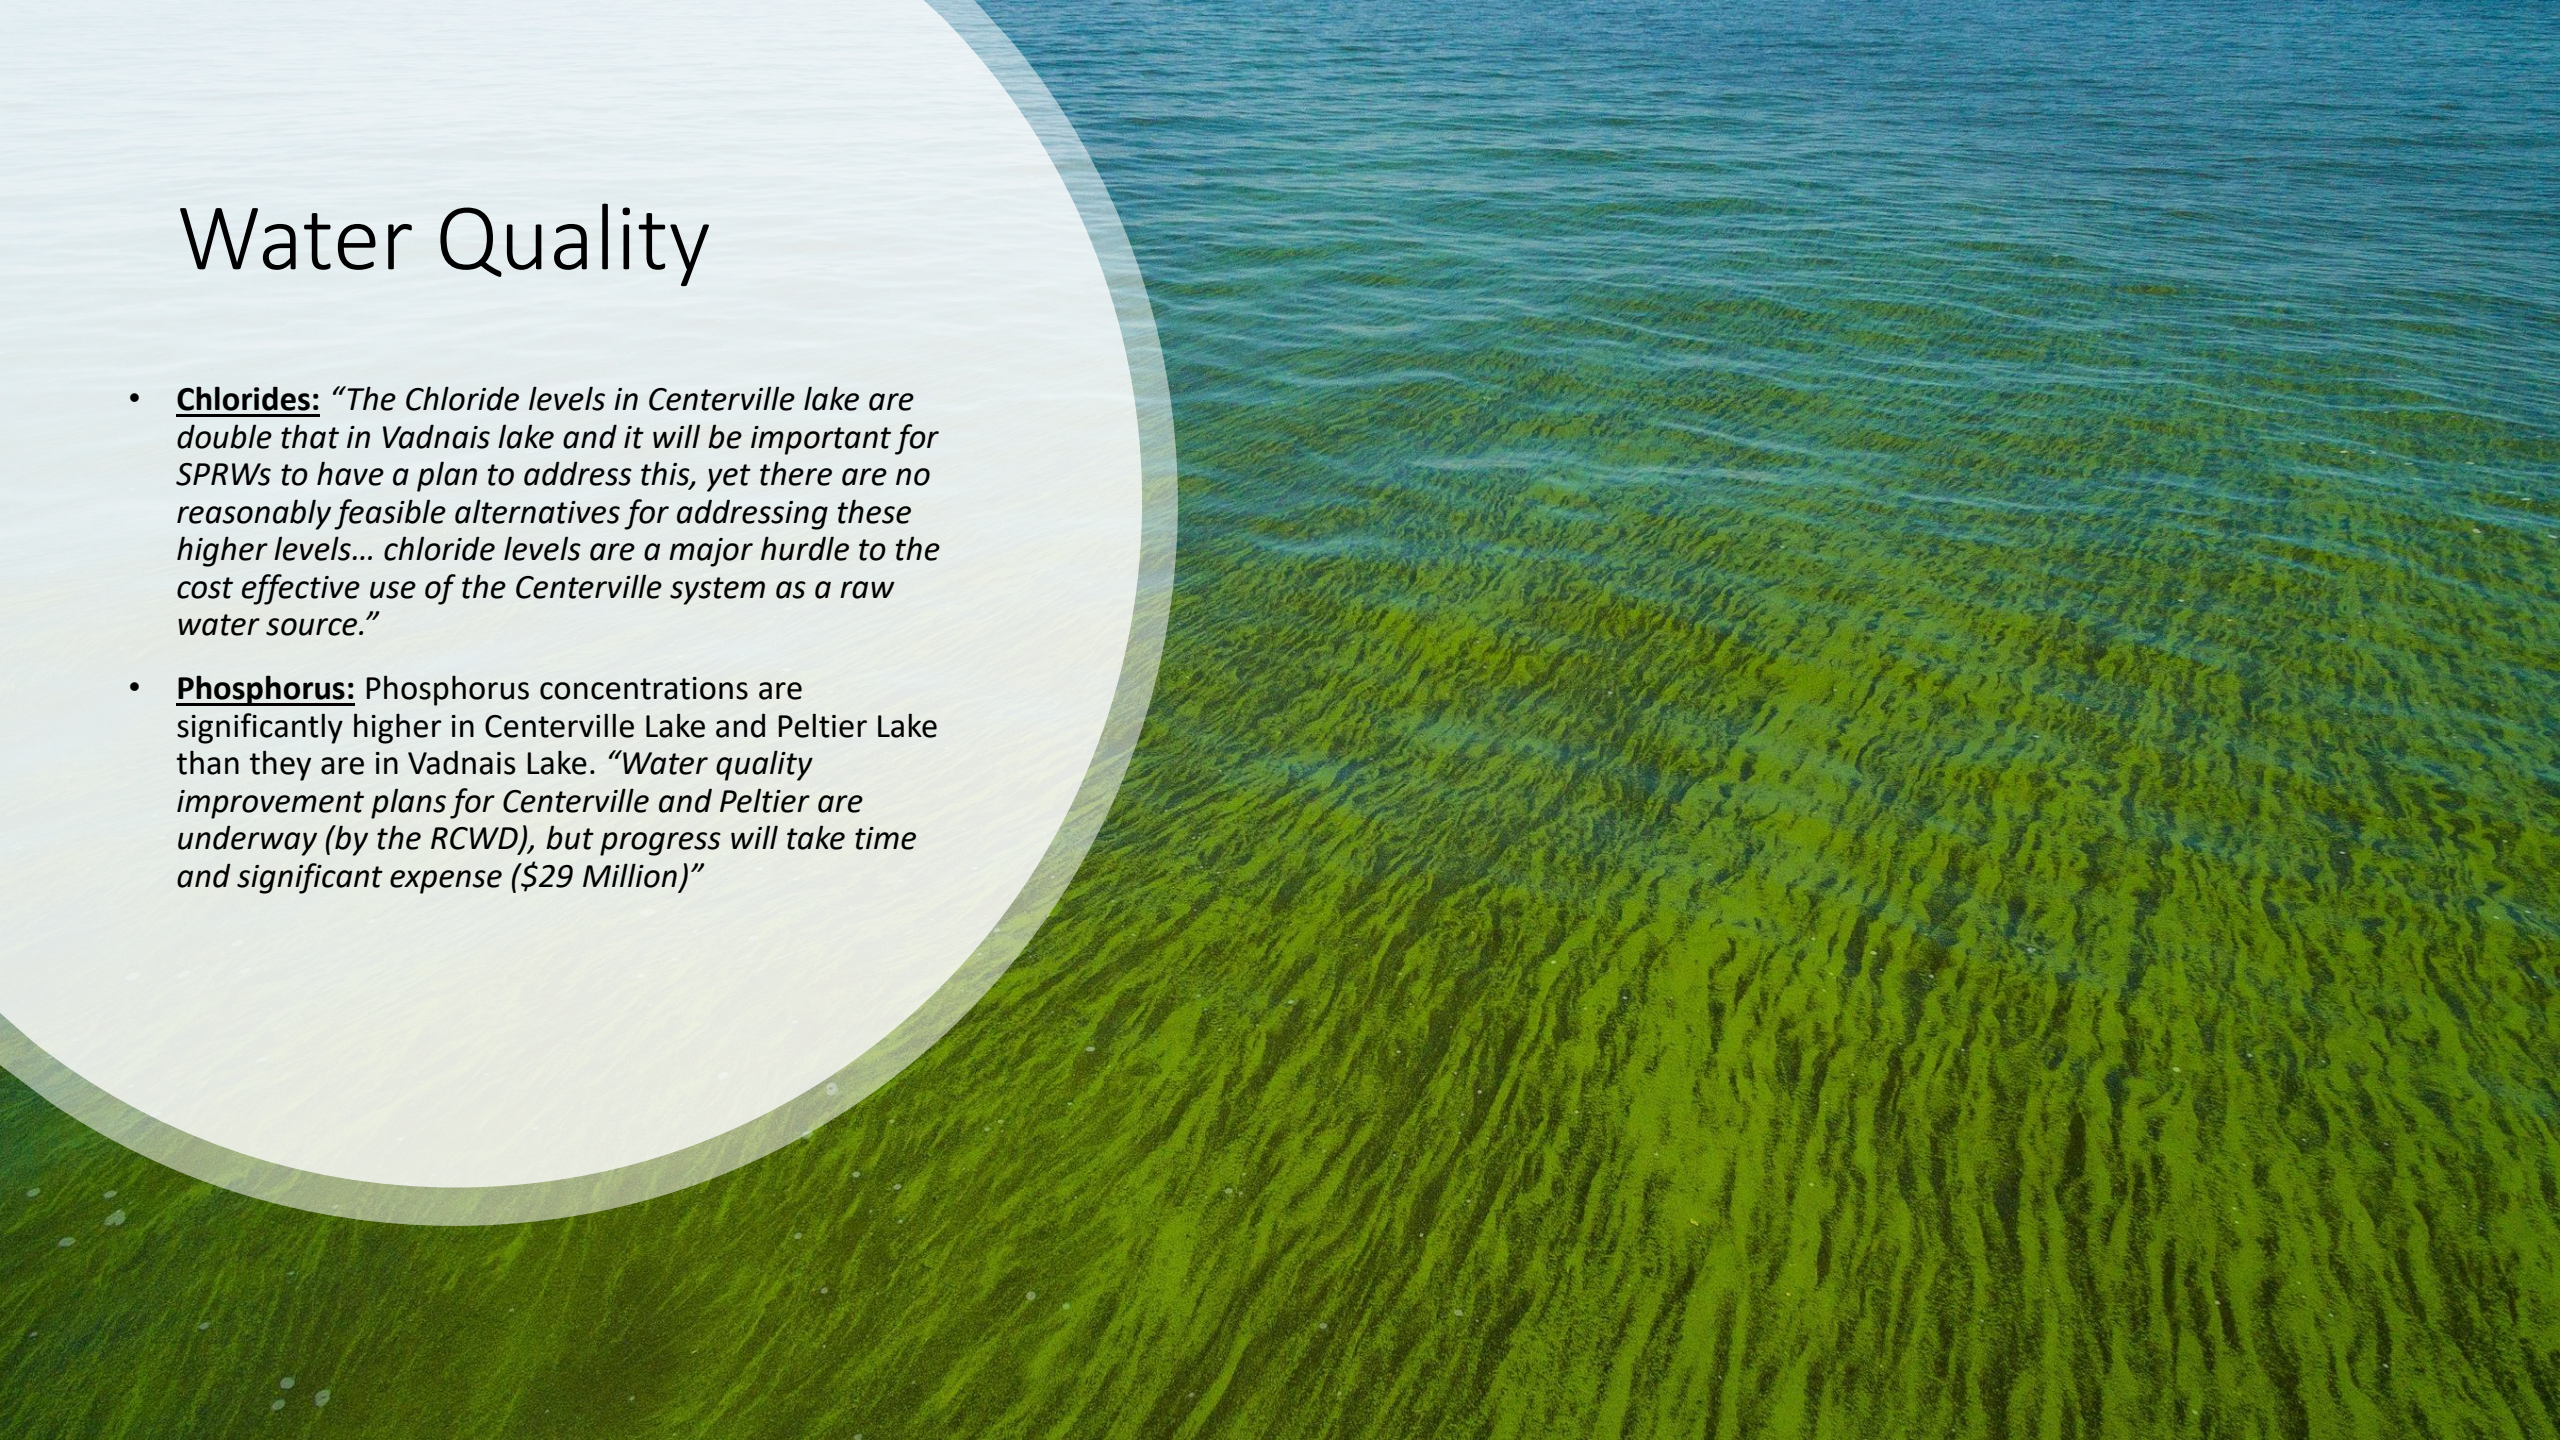
Water Quality

- **Chlorides:** *“The Chloride levels in Centerville lake are double that in Vadnais lake and it will be important for SPRWs to have a plan to address this, yet there are no reasonably feasible alternatives for addressing these higher levels... chloride levels are a major hurdle to the cost effective use of the Centerville system as a raw water source.”*
- **Phosphorus:** Phosphorus concentrations are significantly higher in Centerville Lake and Peltier Lake than they are in Vadnais Lake. *“Water quality improvement plans for Centerville and Peltier are underway (by the RCWD), but progress will take time and significant expense (\$29 Million)”*
